**Houston Fire Department
Emergency Response Internal Review
October 23, 2015**

May 26, 2015 - Incident No. 1505260728

- A Houston Fire Department Rescue Boat capsized during a Swift Water Rescue -Two Firefighters and Four Civilians entered the water resulting in three survivors and three deceased.

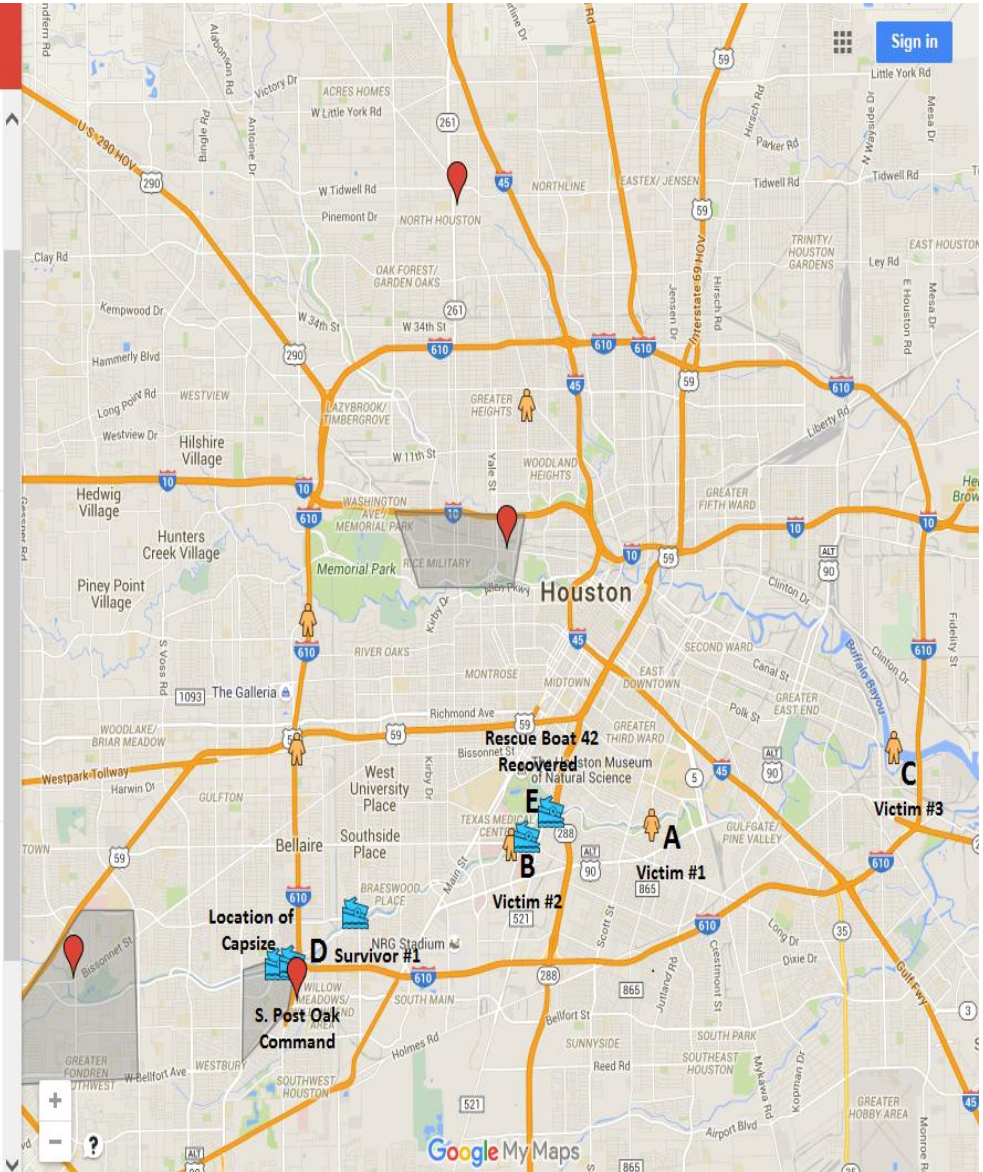
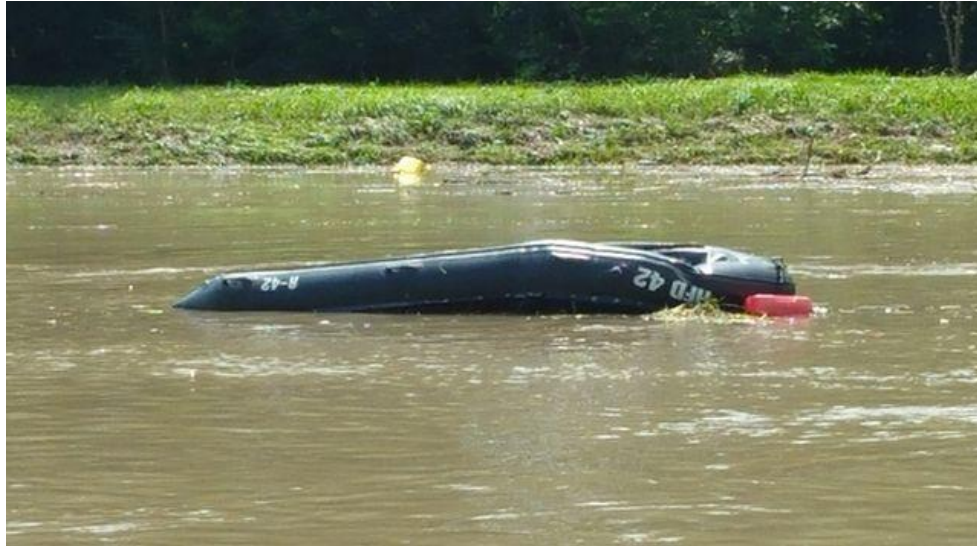
Rescue Boat 42 incident

- 85 year-old White Female
- Recovered; May 26, 2015 – 0950 hours
- Location: Brays Bayou (approximately 8.26 miles from the incident)

- 50 year-old Asian Male
- Recovered; May 26, 2015 – 1630 hours
- Location: Brays Bayou (approximately 5.01 miles from the incident)

- 87 year-old White Male
- Recovered; May 28, 2015 – 2030 hours
- Location: Port of Houston (approximately 15.03 miles from the incident)

- 55 year-old White Female
- Rescued; May 26, 2015 – 0715 hours
- Location: Brays Bayou (approximately 0.5 miles from the incident)

- Original Evacuation location
- Location of capsize
- Rescue Boat 42 recovered
- HFD Lifejacket found
- HFD Lifejacket found

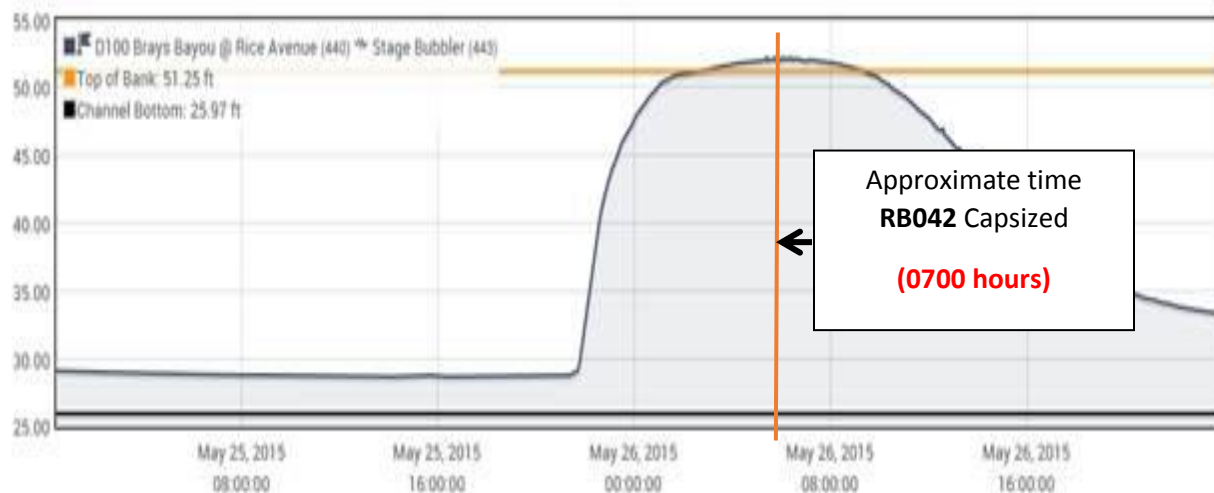
Brays Bayou Water Flow Levels

Note: Peak water flow 30.00 cfm at 4.75 to 5.5 mph

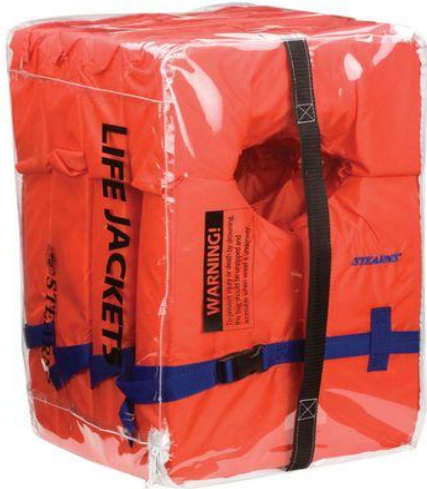
Type-II PFD offers up to 22 lbs. of floatation and is most often used offshore in rough or remote waters. Type-II PFDs offer the most buoyancy, body coverage, and protection, particularly for unconscious wearers. This PFD is also available in child size which carries 11 lb. of floatation. This PFD carries a US Coast Guard Certification through testing by Underwriters Laboratories (UL). Though more bulky than other types, these Navy-style wrap-around jackets will turn a person face-up in the water so that he or she can still breathe even when unconscious. They can also keep a person floating for a long period of time until rescued. [8] NFPA does not make specific recommendations.

1. All Personal Floatation Devices (PFD's), both Rescuer and Civilian, need to be inventoried, inspected, and replaced if needed.
 - a. PFD's should be assigned based on the nature of the event.
 - b. Type-V PFD's should be considered for every style of boat operated by HFD. At a minimum the following should be followed:
 - i. TYPE-II PFD's should be available and worn by every civilian placed on an HFD Evacuation Boat and or HPD High Water Rescue Vehicle.

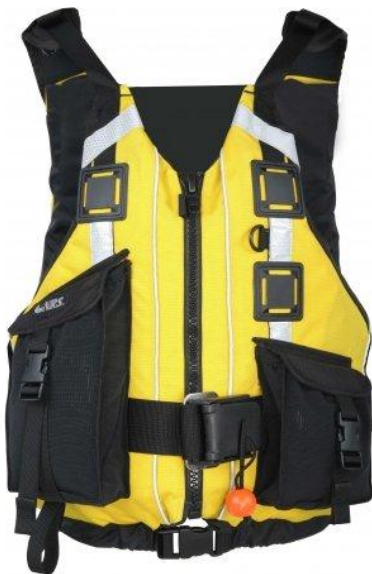
Type-V PFD provides 22 lbs. of floatation and offers adjustability to fit chest sizes from 30 to 58 inches. This jacket carries a US Coast Guard Certification through testing by Underwriters Laboratories (UL). This PFD also provides a Quick-release rescue belt, with stainless steel ring that can be used for "live bait" and other swift-water rescue techniques. [5]

- ii. TYPE-V PFD's should be available and worn by every Rescuer and Civilian placed on an HFD Swift Water Rescue Boat.
 - c. Design trailers for water rescue cache (i.e., Type-II Personal Flotation Devices - PFD's) that can be staged in areas of the city that are prone to widespread flooding.
