CERTIFICATE OF APPROPRIATENESS

Property: 1120 East 14th, per HCAD legally described as, LT 5, BLK 118, North Norhill, the property has a 1,064 SF house on a 5,200 SF lot

Significance: Contributing circa 1926 Bungalow in the Norhill Historic District

Proposal: Demolition – Applicant proposes to demolish the house

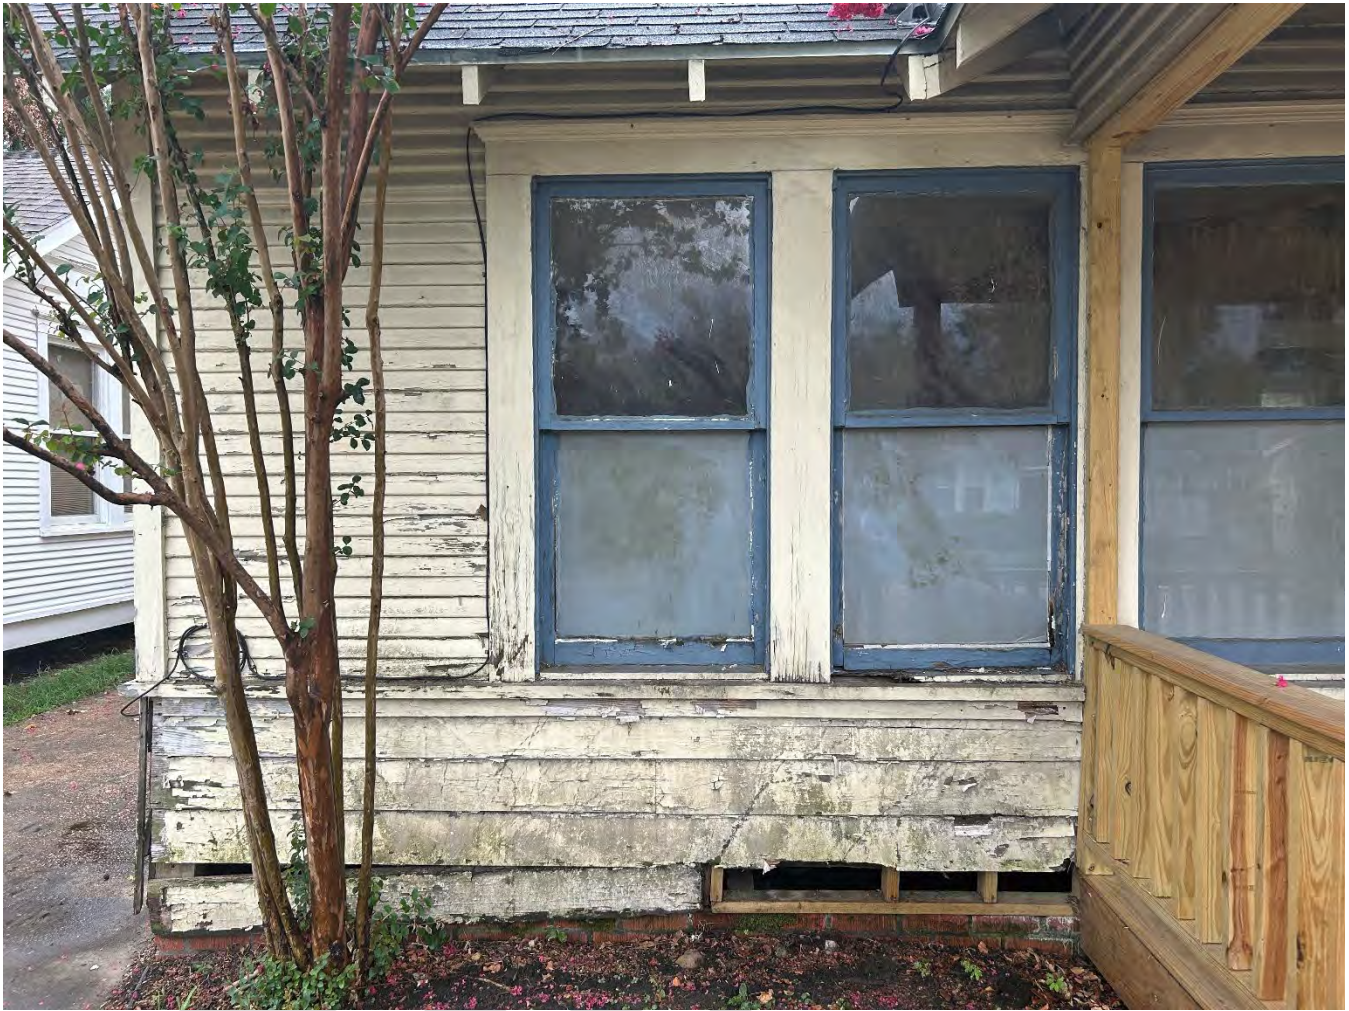
Figure 3 - Staff photo front left of house

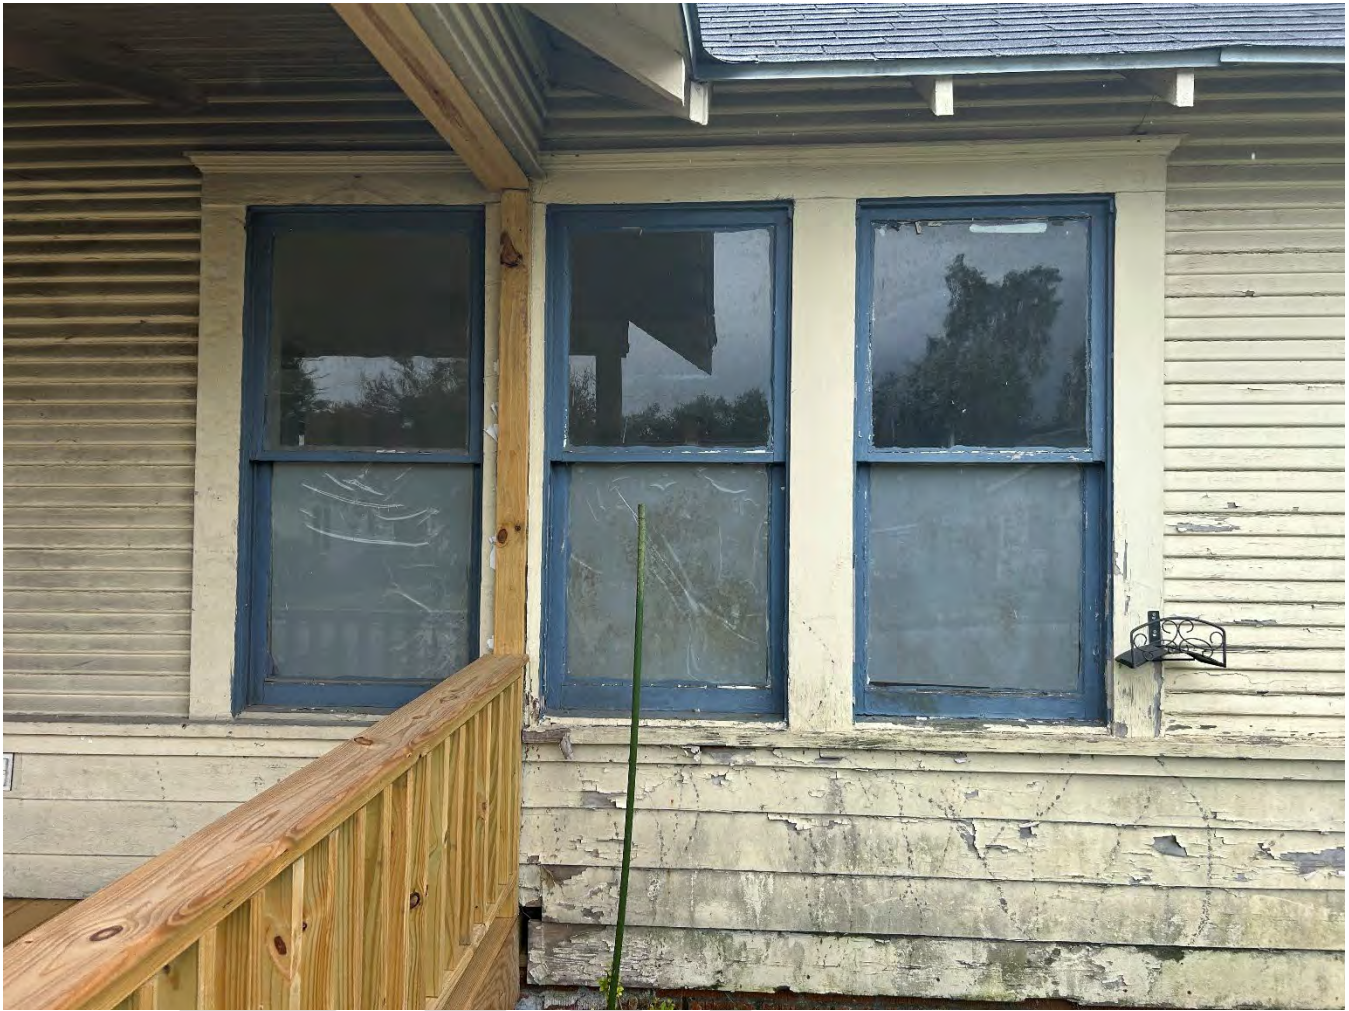
Figure 4 - Staff Photo Front Right of House

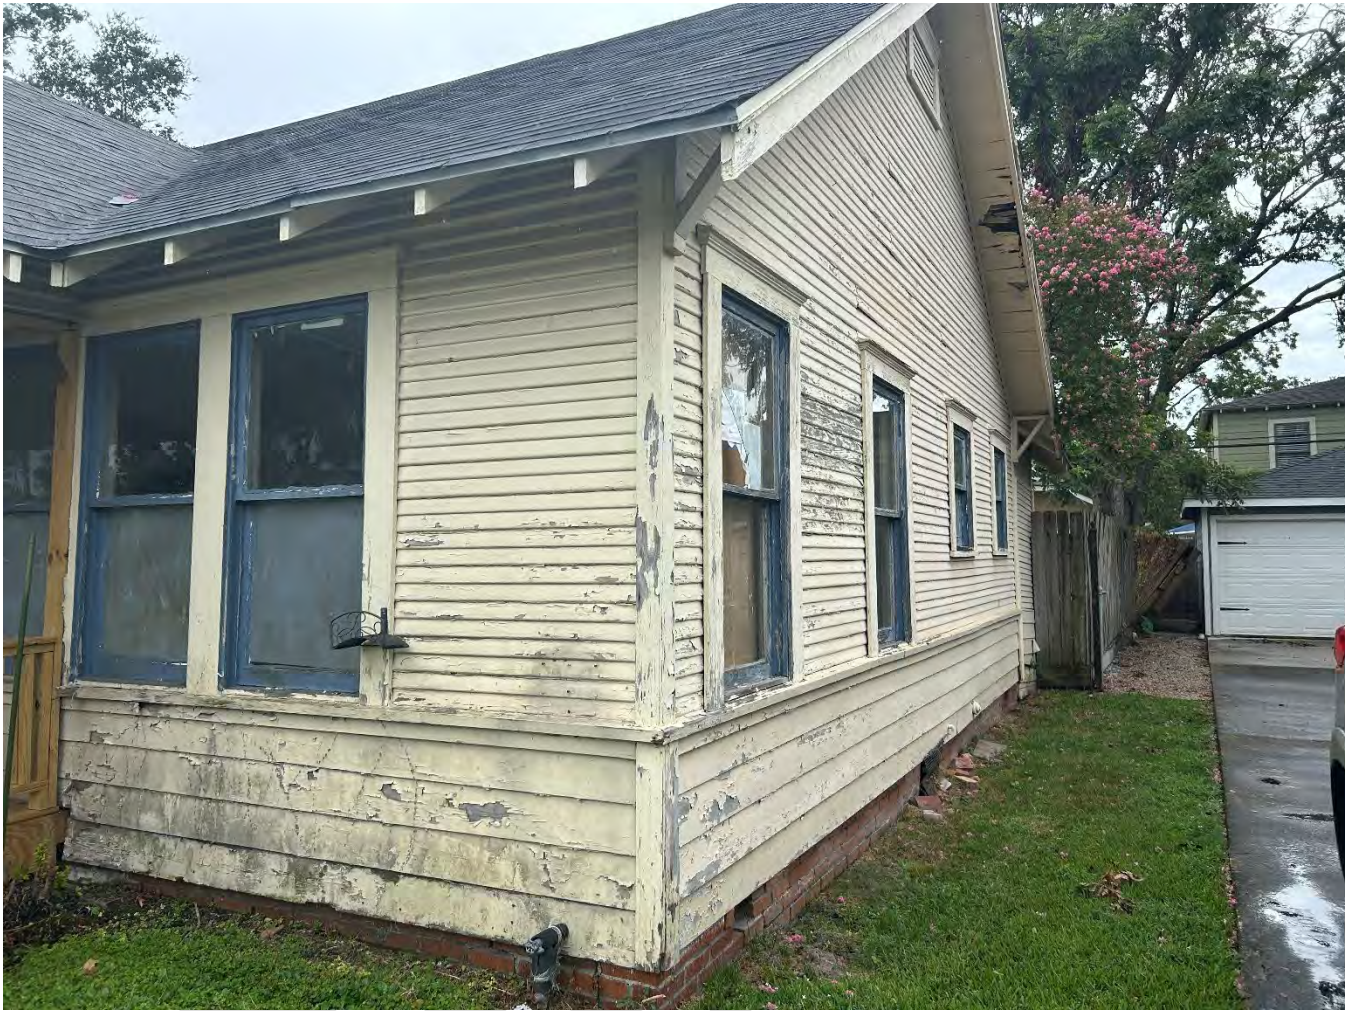
Figure 5 - Staff Photo West Elevation Corner

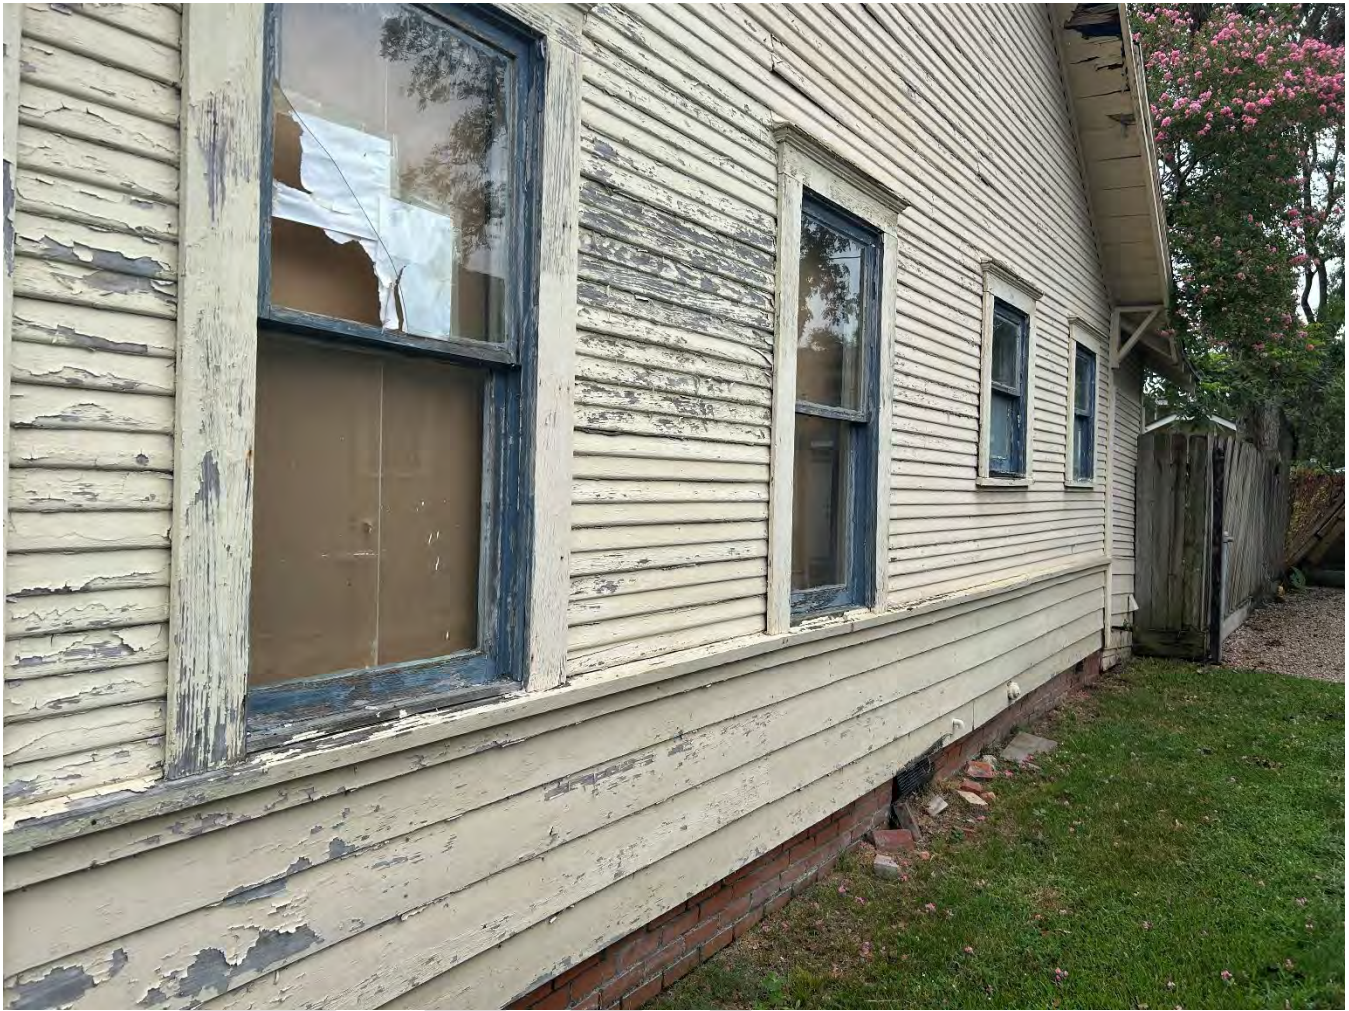
Figure 6 - Staff Photo West Elevation

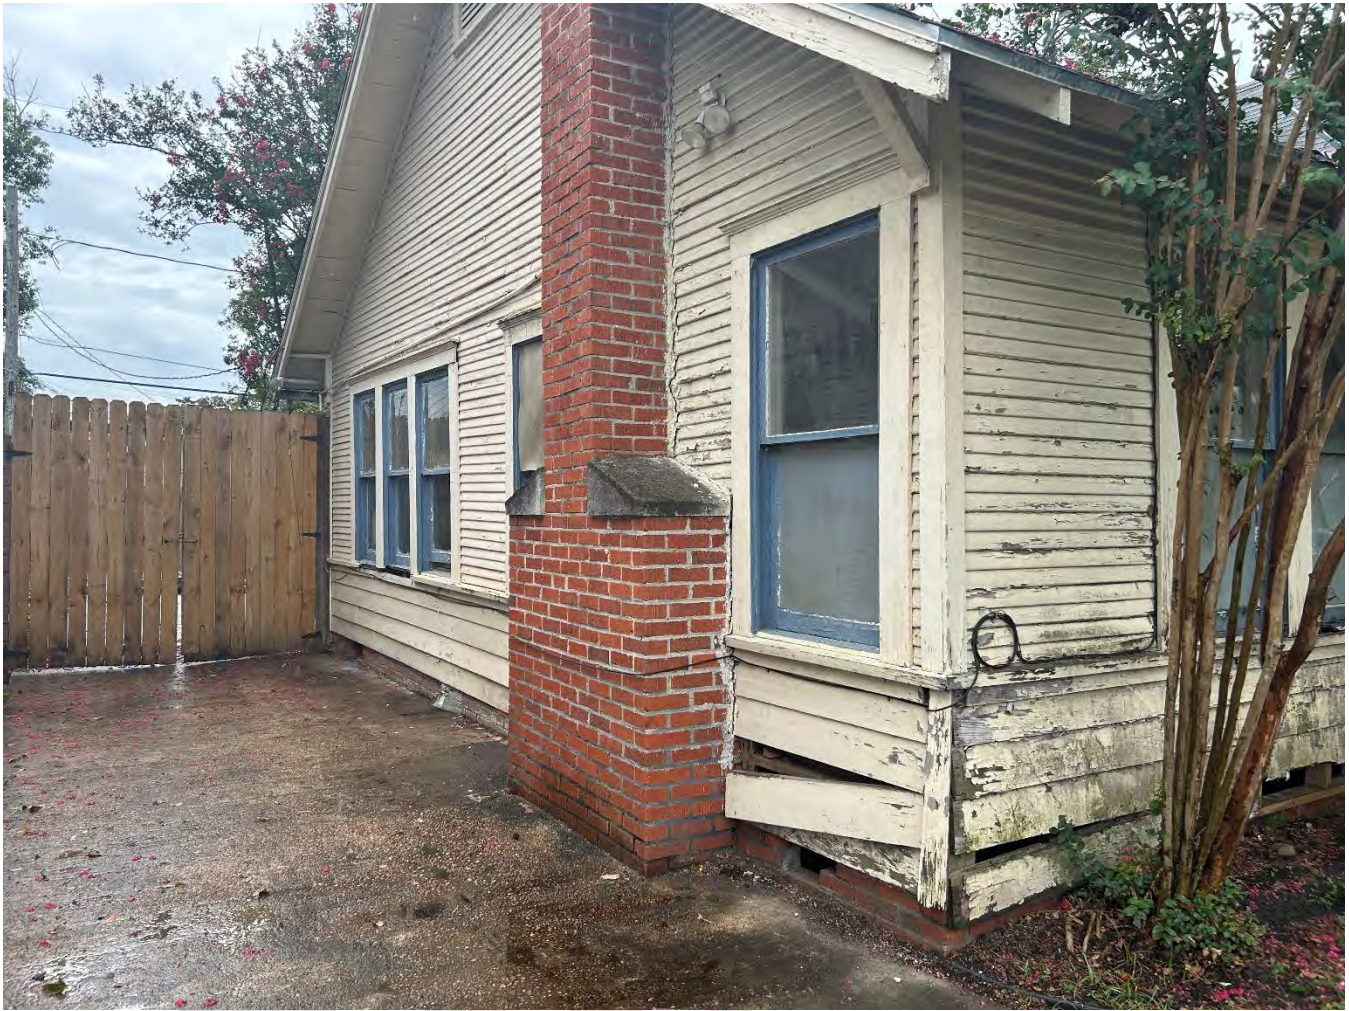
Figure 7 - Staff Photo East Elevation Corner

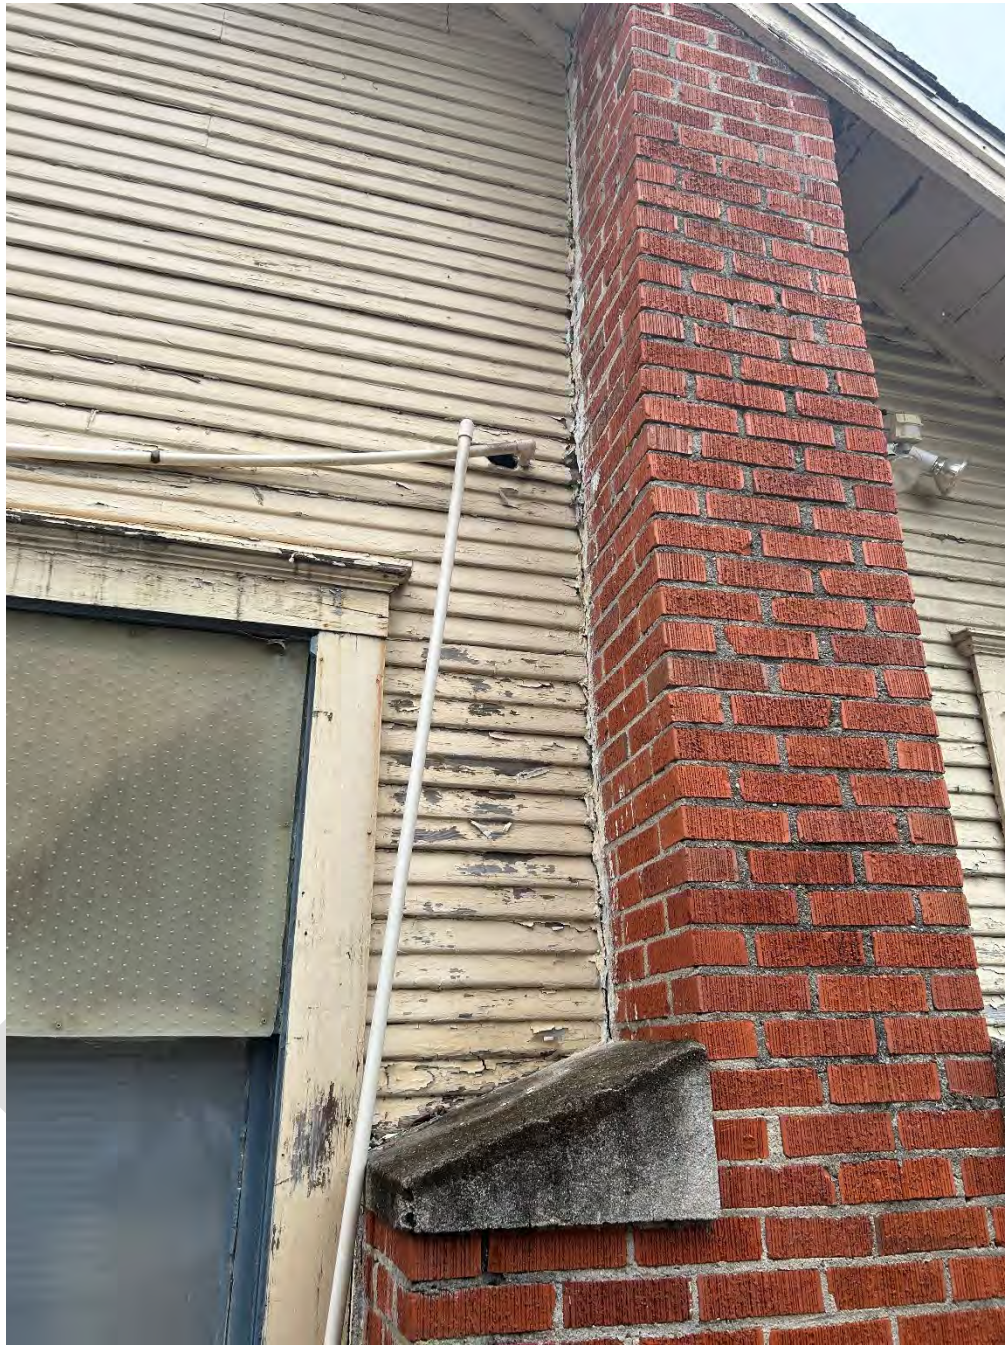
Figure 8- Staff Photo East Elevation Detail

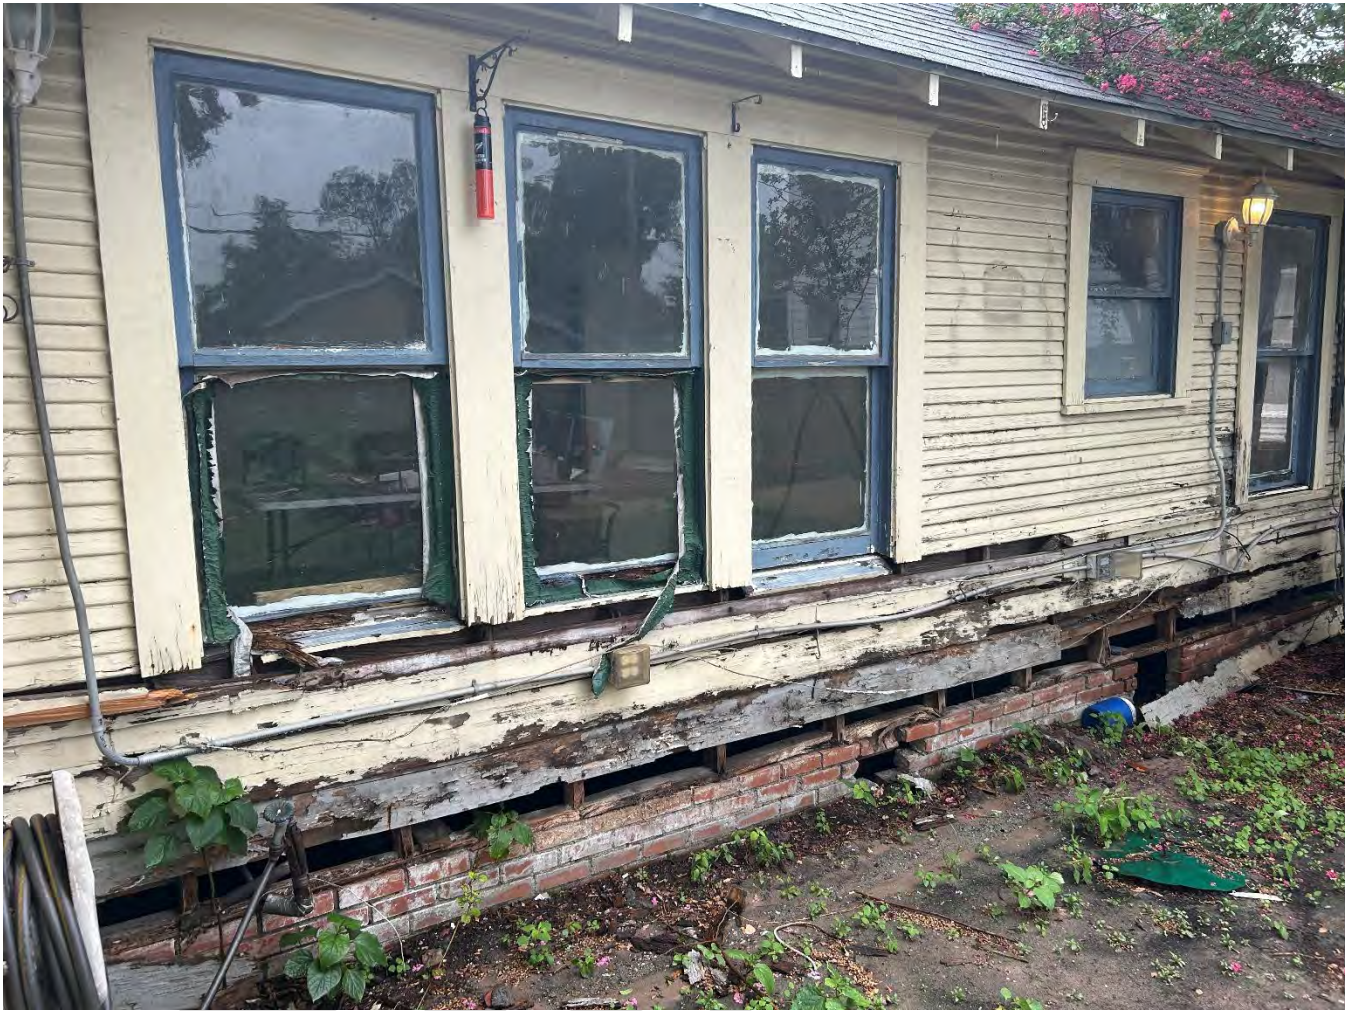
Figure 9 - Staff Photo Rear Elevation Partial

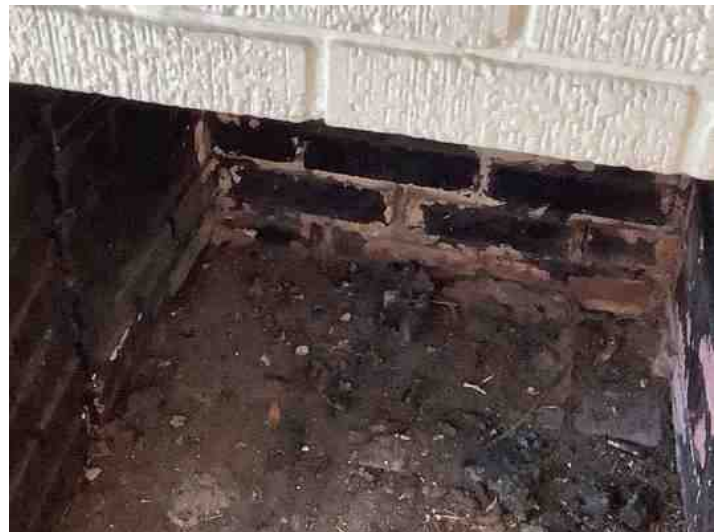
Fireplace Damaged

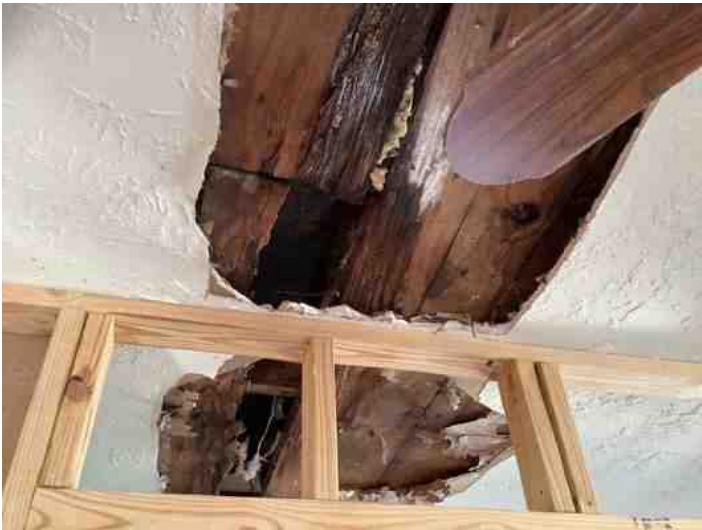
Roof/Ceiling Damage

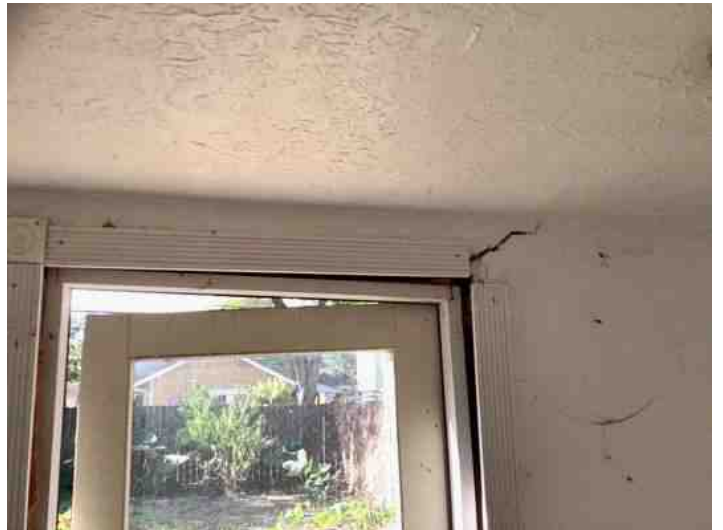
Foundation Issues

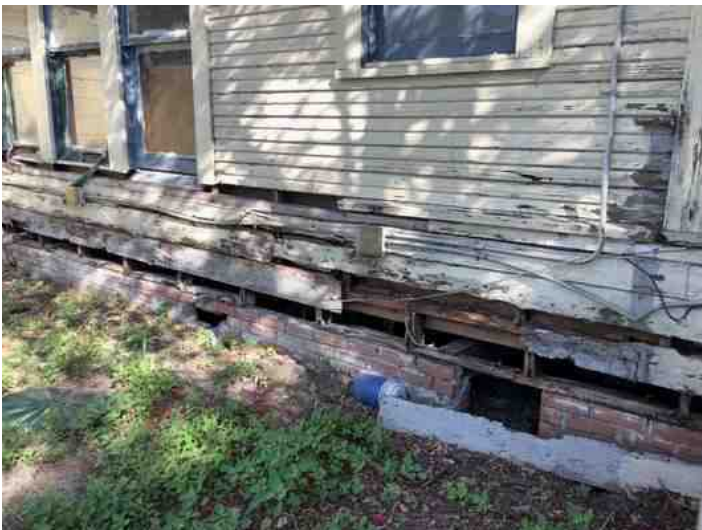
Exterior Damage

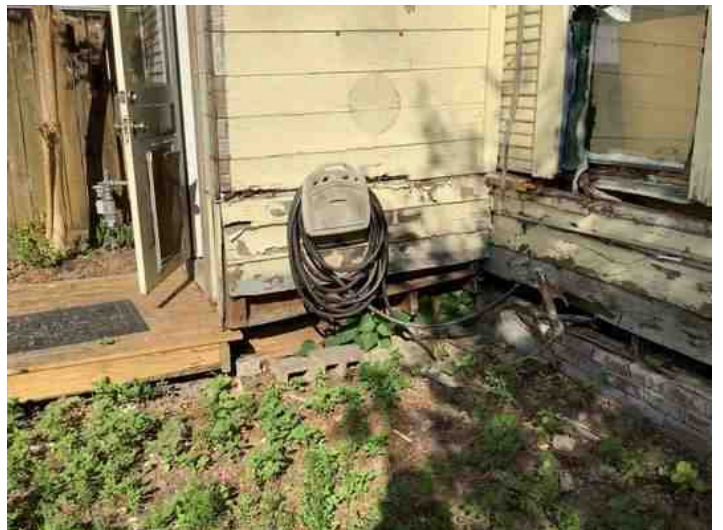
Exterior Damage

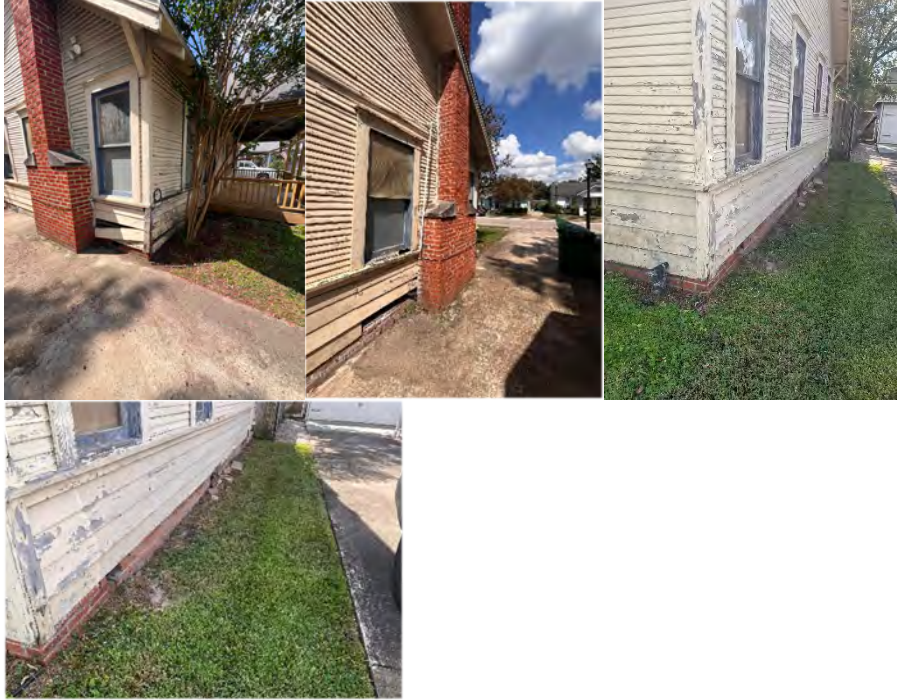
Foundation area for the subject property.

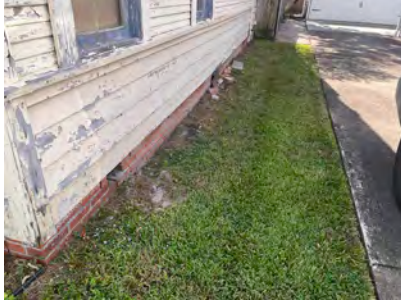
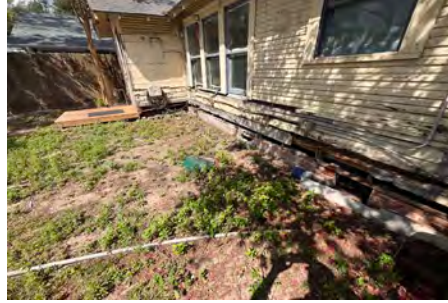
Foundation support for the subject property.

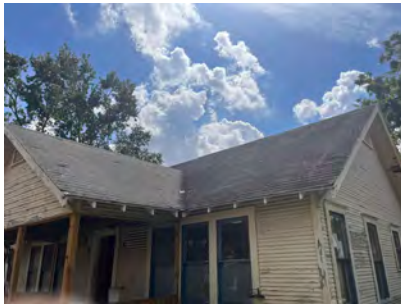
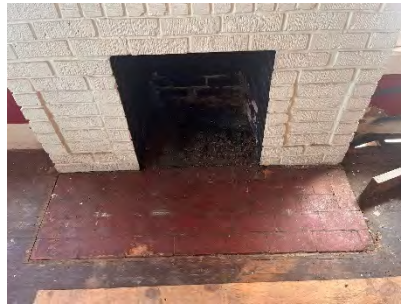
The roofline of the subject property and interior flooring condition.

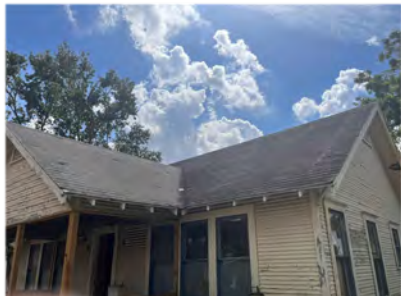
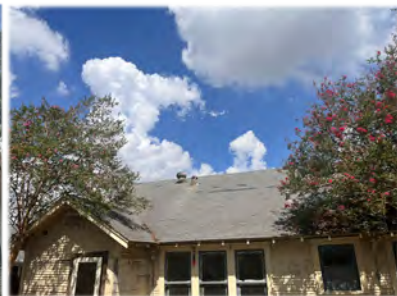
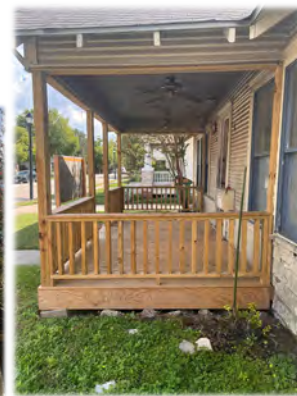
Roofing conditions of the subject property.

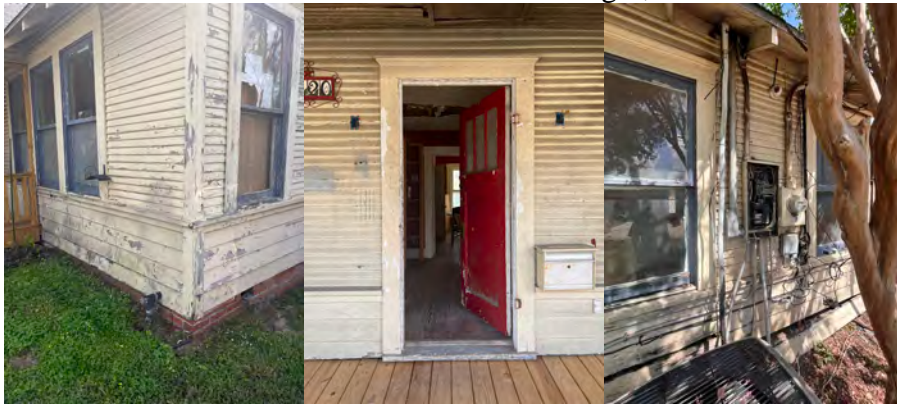
View of subject property exterior siding.

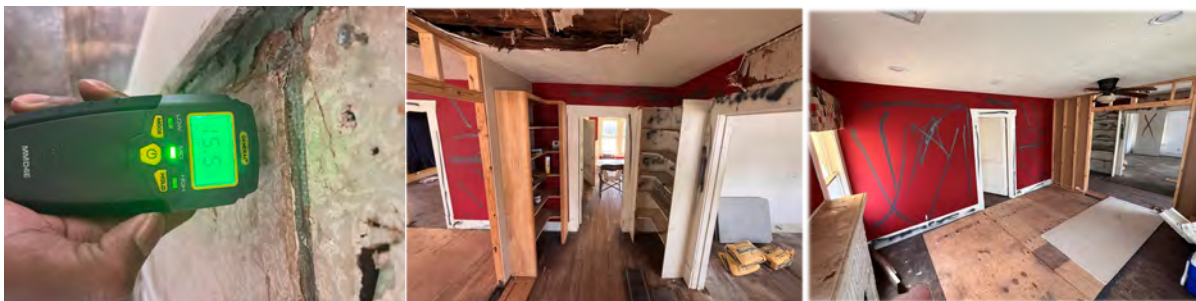
Subject property interior walls and conditions.

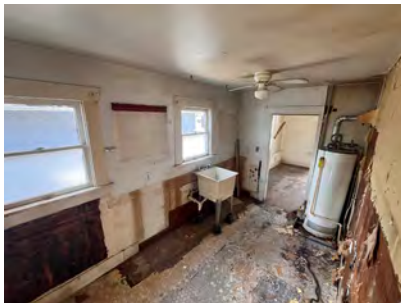
Kitchen area with nonfunctional water heater.

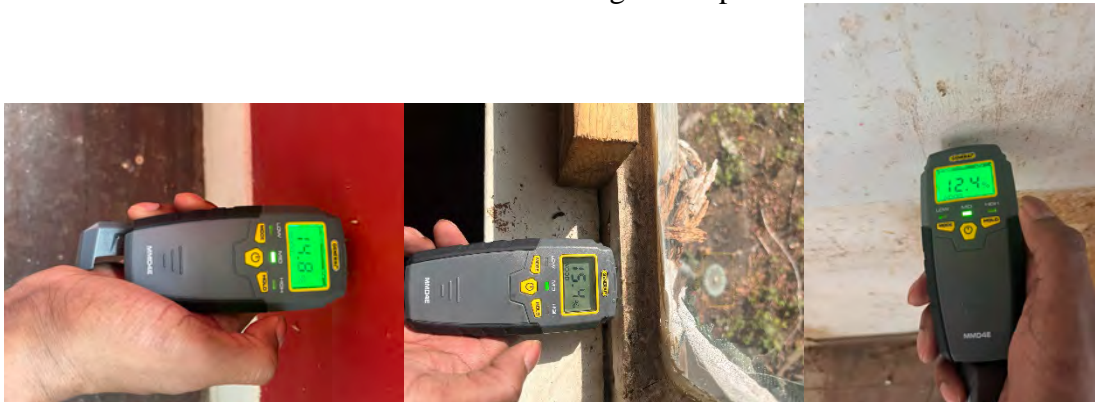
Moisture reading in drywall.

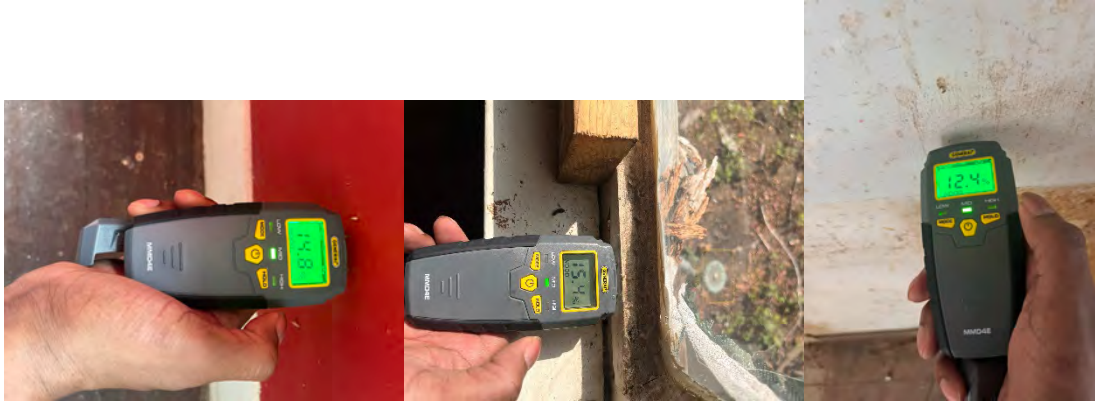
Moisture reading in drywall.
