CERTIFICATE OF REMEDIATION

Property: 901 Cortlandt Street, Lot 12, Block 229, Houston Heights Subdivision. The property includes a historic 1,260 square foot, one-story wood frame single-family residence situated on a 3,300 square foot (50' x 66') corner lot.

Significance: Contributing Bungalow duplex residence, constructed circa 1920, located in the Houston Heights Historic District South.

Proposal: Alteration – Without HAHC authorization, four windows have been removed and large sections of siding have been replaced by the previous owner. The current owner proposes to reverse the unauthorized window and siding alterations back to the original pattern/configuration. The property has been Red Tagged multiple times for Permitting Violations including COA/Historical issues.

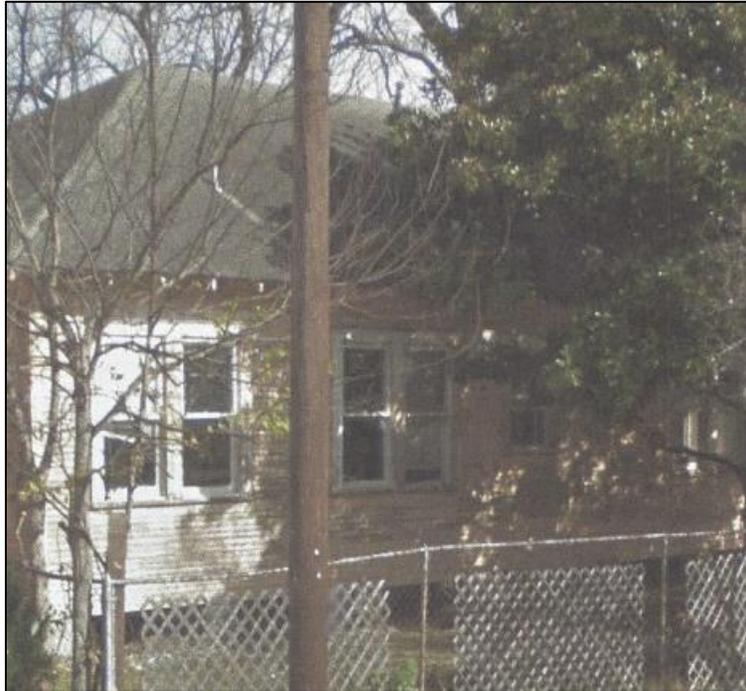
SOUTH ELEVATION – FACING E. 9TH STREET
ORIGINAL CONDITION

On the south elevation (facing E. 9th St), the rear pair of 30" x 63" windows was removed and sided over. The single 24" x 48" window was also removed and sided over. The original openings will be reopened and salvaged wood windows matching the original 30" x 63" and 24" x 48" will be installed. On the north elevation, the 24" x 48" window was removed, the opening reduced in size, and a smaller window installed. The original opening will be reopened and salvaged wood window matching the original 24" x 48" will be installed. The non-original door and opening have been removed and will not be returned. See photos for more detail.

Portions of the original siding were removed by the previous owner. On the north and south side elevations, the siding below the window sills was removed. It has since been replaced with new 117 wood siding to match existing. Wood siding was also installed over three of the existing window opening on the south side elevation and patched over the reduced window opening on the north elevation. All wood siding on the rear was replaced. See photos for more details.

- Restore the original fenestration pattern using salvaged windows to match original
- Retain the new replaced 117 wood siding as currently installed
