CERTIFICATE OF APPROPRIATENESS

Property: 1410 Studewood Street, Lot 14, Block 112, North Norhill Subdivision. The property includes a historic 1,066 square foot, one-story wood frame single-family residence and a detached garage situated on a 5,000 square foot (50' x 100') interior lot.

Proposal: Alteration – Porch

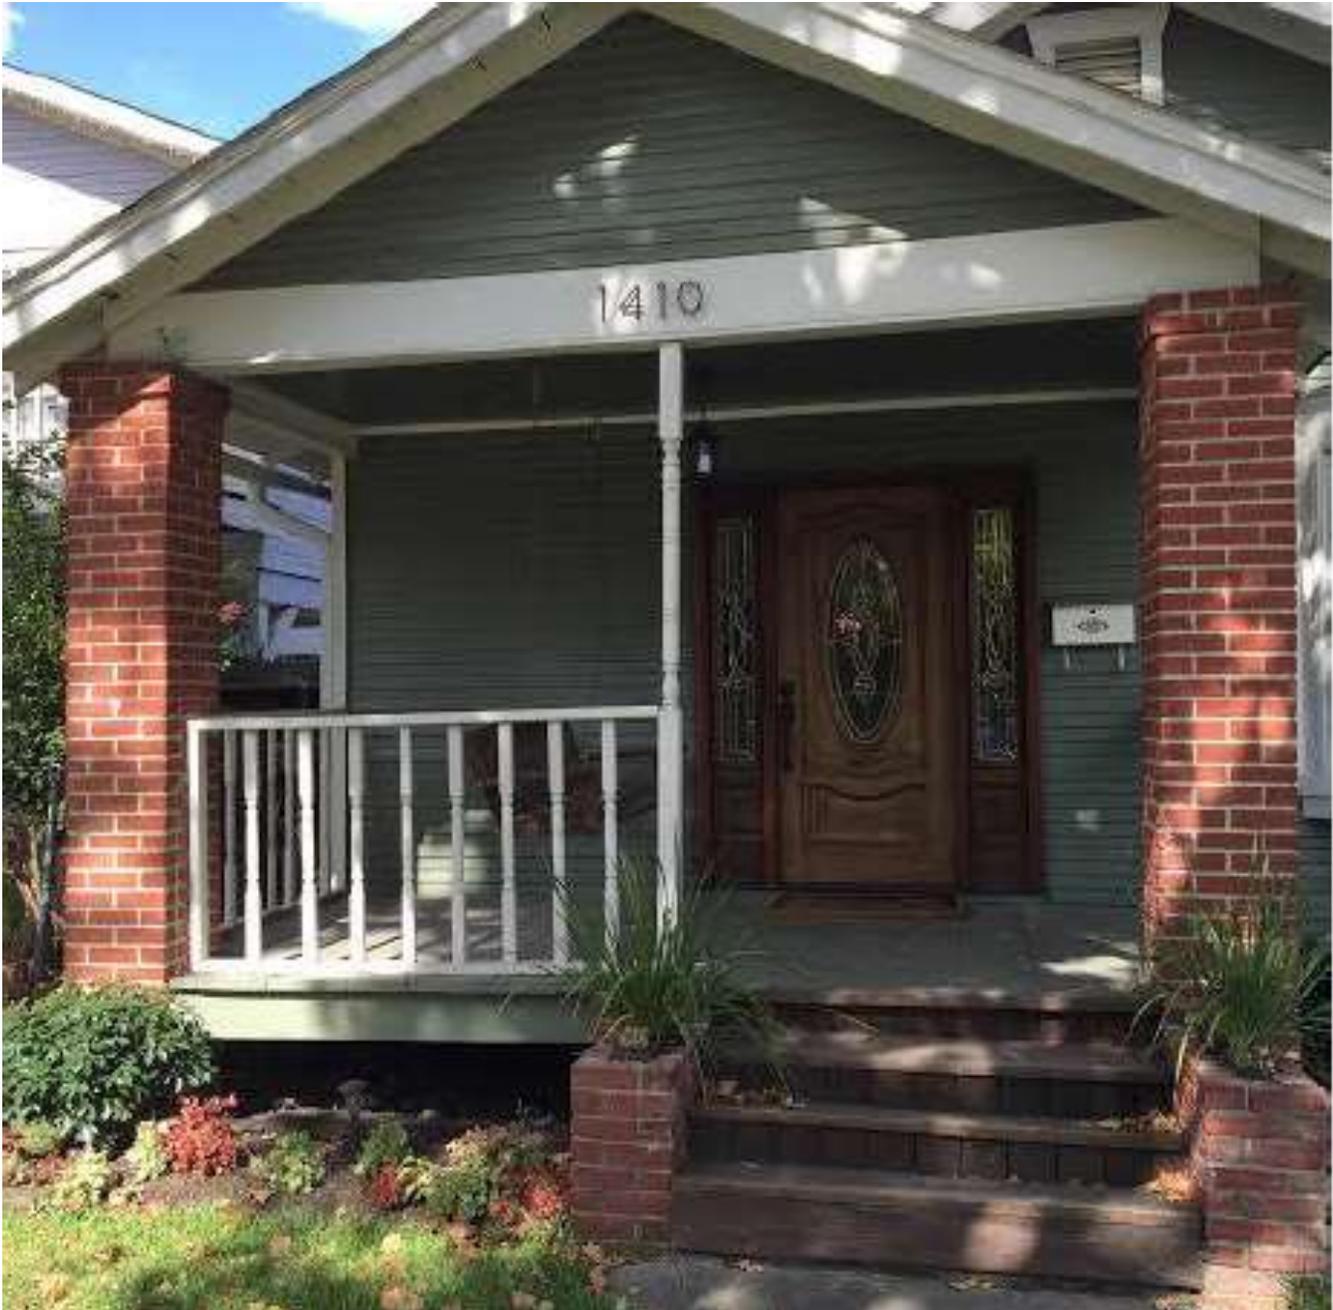
EXISTING FRONT PORCH

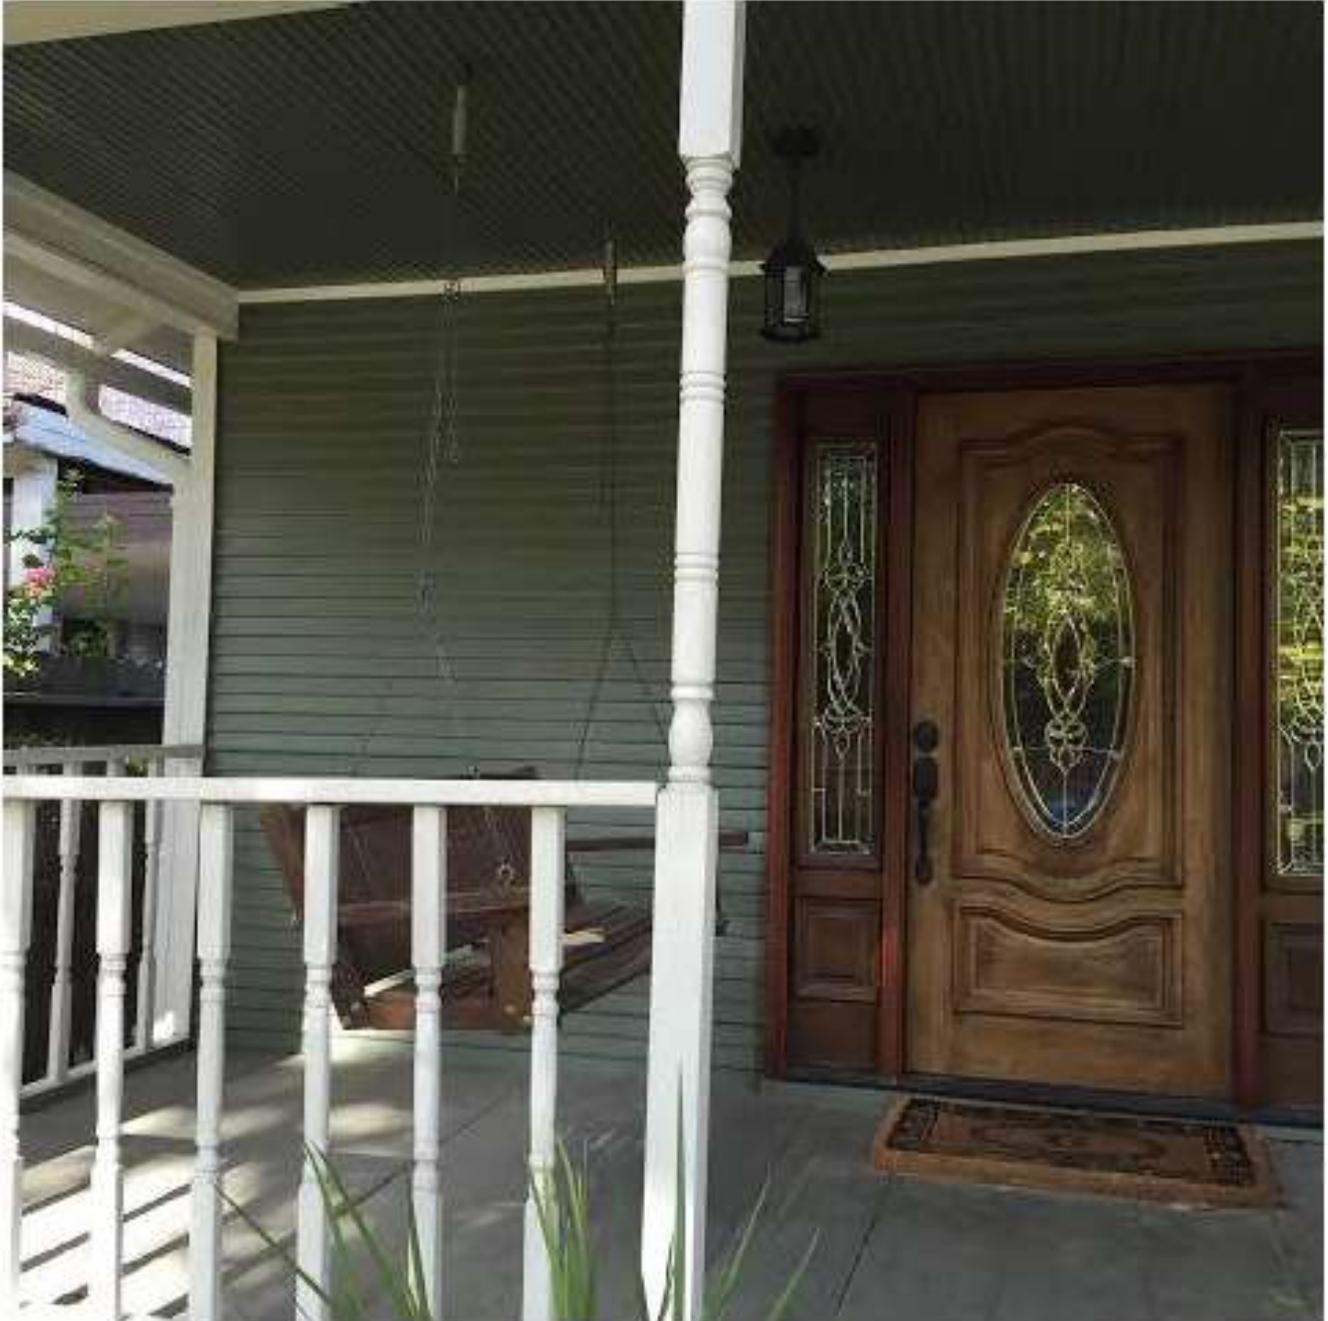
EXISTING NON-ORIGINAL PORCH COLUMN

- Remove the non-original wood turned column and install a brick porch pier to match the original brick porch pier.
- Replace the existing non-original turned style porch guardrails with turned style post with a new guardrail with square posts.
- Replace the existing 2"x12" wood slat porch flooring with new wood 2"x12" wood slat porch flooring; the existing floor had rot and termite damage.

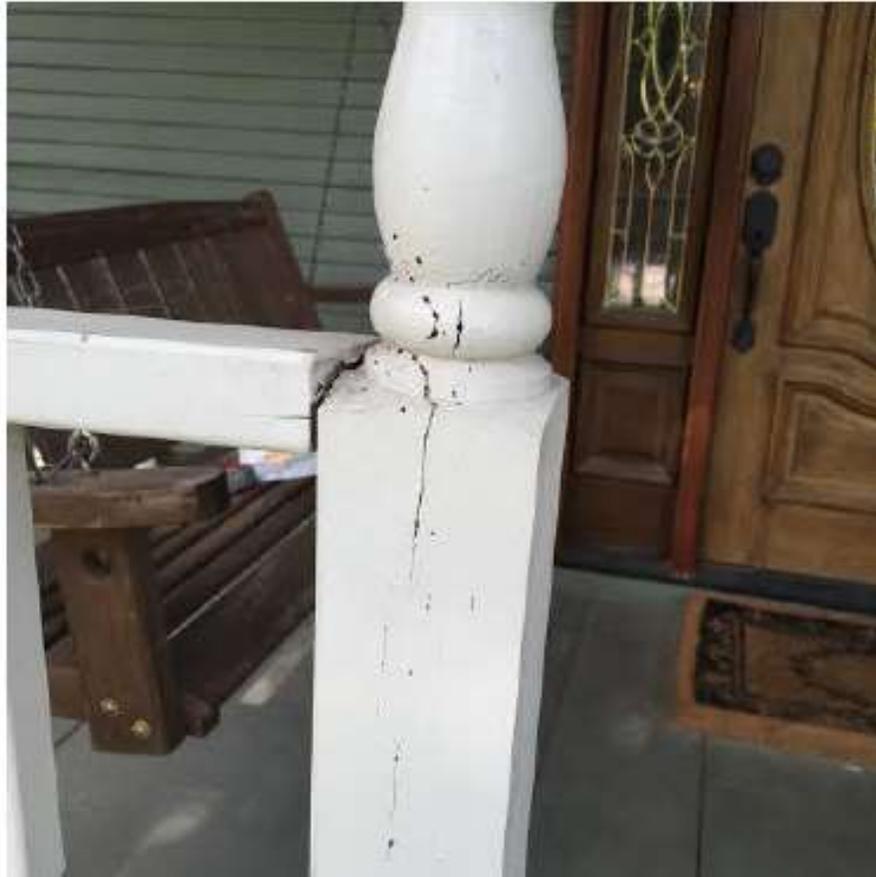
NON-ORIGINAL PORCH COLUMN CONDITION

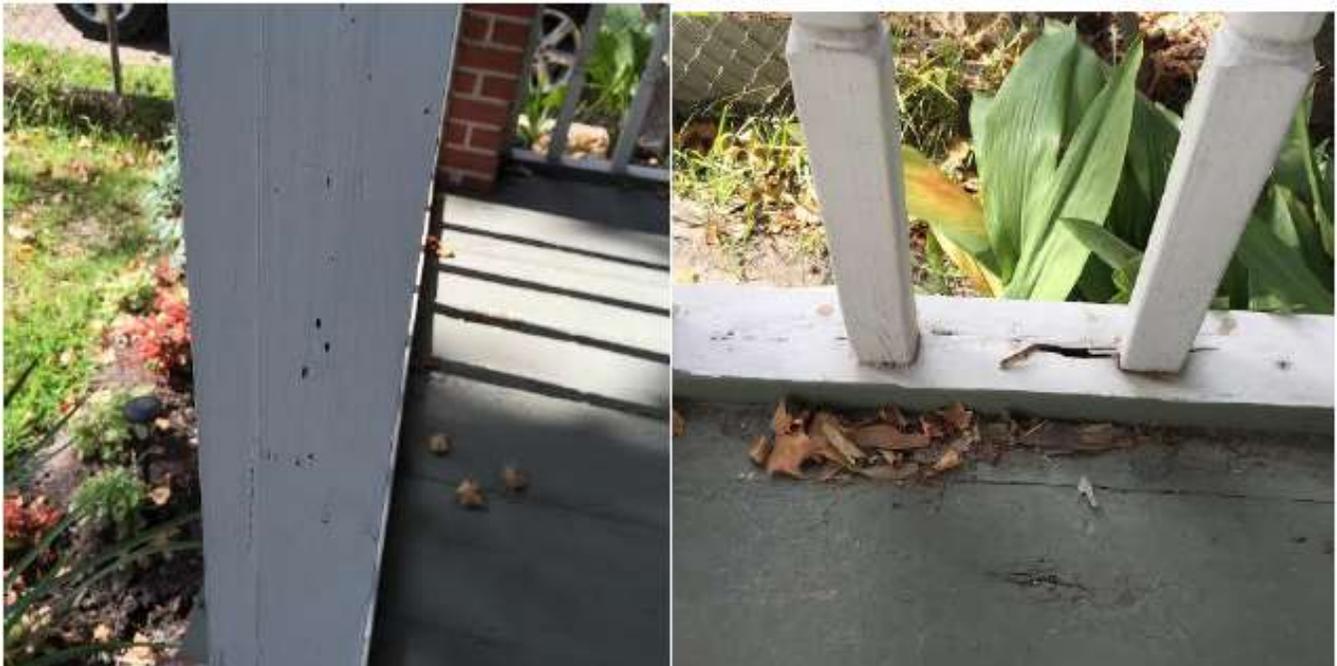
TERMITE AND ROT DAMAGE ON EXISTING PORCH ELEMENTS

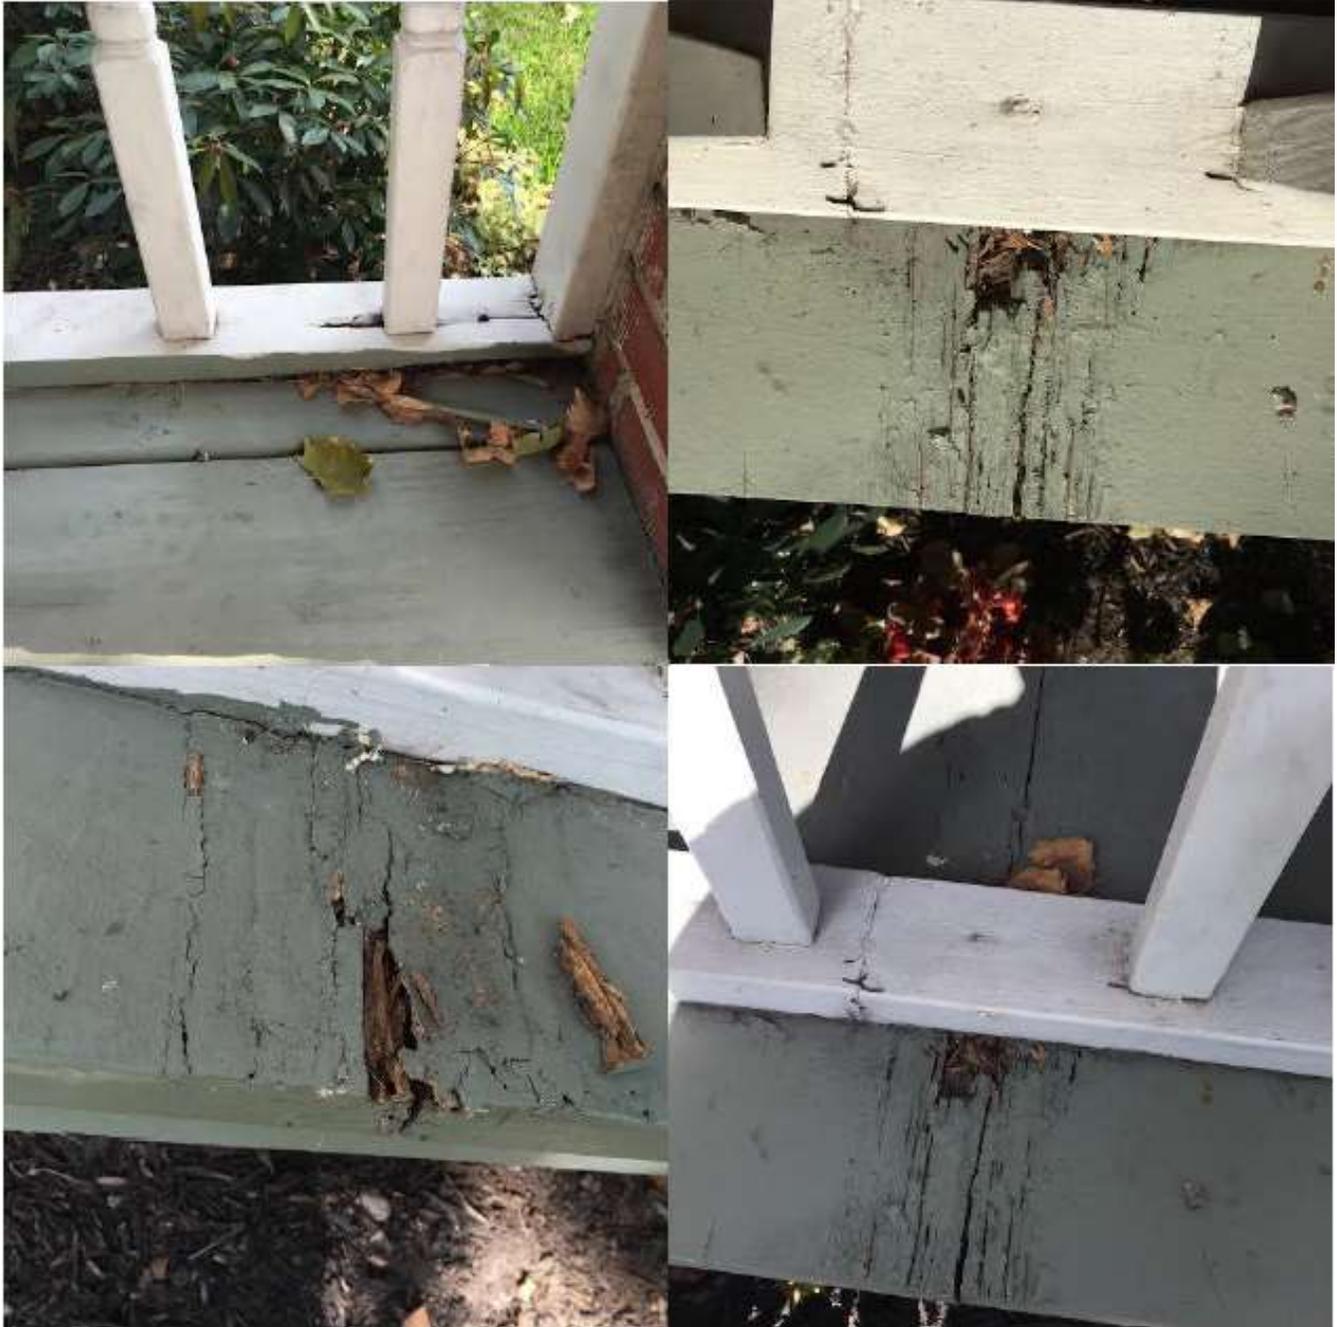
TERMITE AND ROT DAMAGE ON EXISTING PORCH ELEMENTS

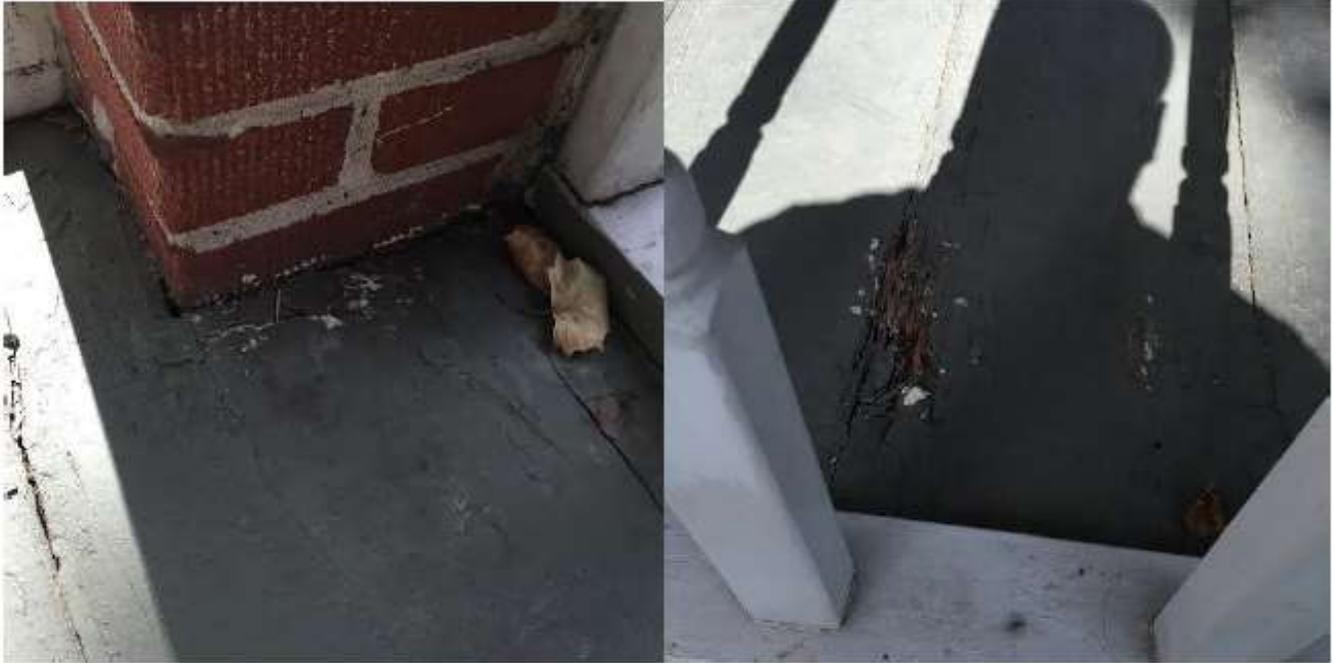
ROT DAMAGE ON EXISTING PORCH ELEMENTS
