#### CERTIFICATE OF APPROPRIATENESS

Property: 3711 Audubon Place, Tracts 21 & 22A, Block 16, Montrose Neighborhood

**Proposal:** Alteration: Windows

September 12, 2024 HPO File No. 2024\_0208

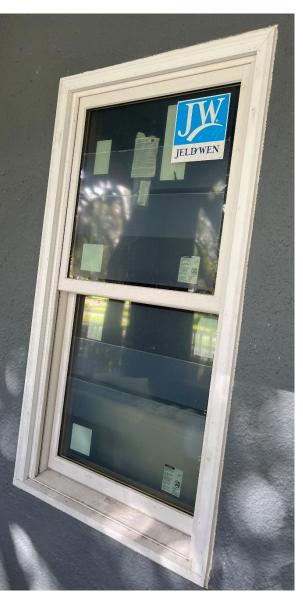
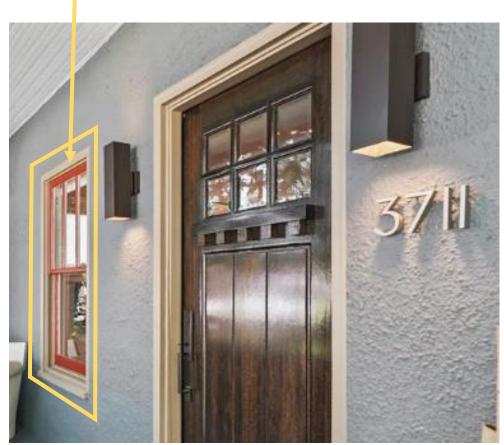
## Front Elevation - Left of Front Door

Replaced windows on front and right elevations without a COA or permit

- Red tagged 5 times since 5-10-2024
- Replaced 5 windows with Jeld-Wen wood windows, 1-over-1 lite pattern, DH, inset & recessed
- Grogan spec sheet states that was ordered in 09-2023 with three vertical grids on upper sashes but never installed due to cost per applicant
  - Applicant states that pieces of wood would be surface mounted to replicate the three vertical grid patterns
  - Applicant chose not to install windows as indicated on the Grogan spec sheet with the vertical grids on upper sashes

(3)	The proposed activity must recognize the building, structure, object or site as a product of its own time and avoid alterations that seek to create an earlier or later appearance; The completed activity did not recognize the structure as a product of its own time as the upper sashes are without the vertical grilles that are evident on all remaining historic windows.

Recommendation: Denial and Issuance of COR: Re-install an original window on the front left elevation. If a window on the rear elevation fits, that may be used, or a new all wood window matching the window lite pattern that was removed. Replace all the windows that were removed on the front right elevation and right side with wood windows that match the lite pattern and style of the windows removed.
