CERTIFICATE OF APPROPRIATENESS

Property: 510 Highland St, Houston, TX, 77009; Tract 2 & 3A, Block 20, Woodland Heights Subdivision. The

Proposal: Alteration & New Addition

510 Highland Street Woodland Heights

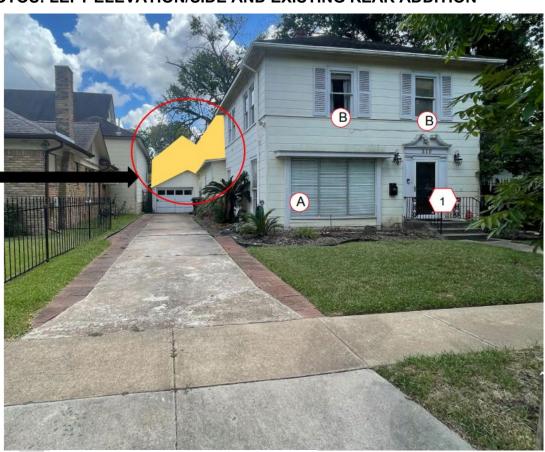
All exterior doors are not original and will be removed.

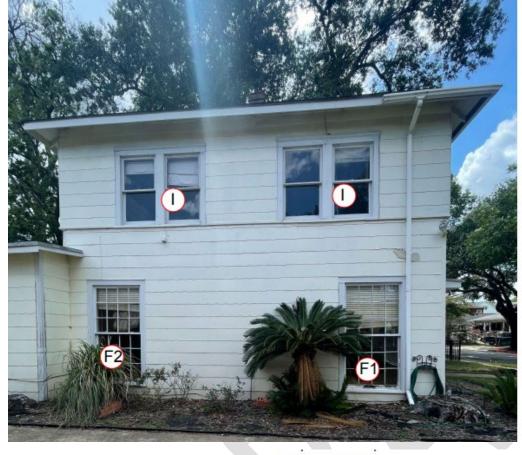
Windows to be replaced, as they are damaged beyond repair.

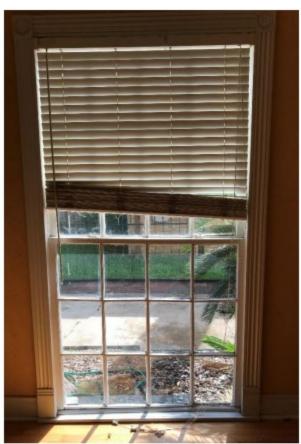
WINDOW F1

Figure 8 WINDOW F1: Window is inoperable, frame is rotten

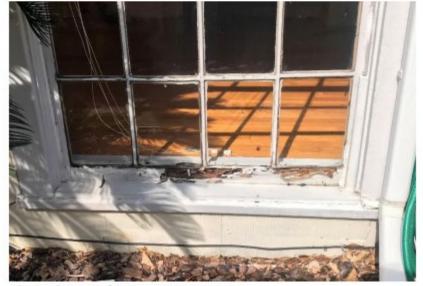
Figure 9 WINDOW F1: Rotten Frame

| | DAMAGE TO EXISTING WINDOWS | | | | | | | | | |
|---|---|--|--|--|--|--|--|--|--|--|
| F1 | Window is inoperable, frame is rotten | | | | | | | | | |

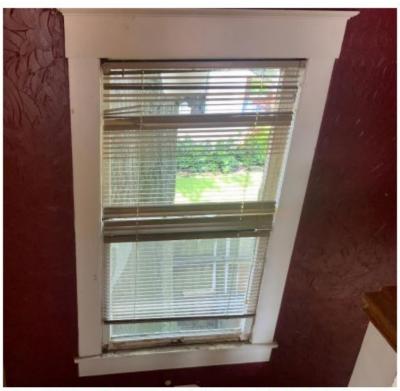
WINDOW B2

Figure 6 WINDOW B2: Glass is broken, window is inoperable, and frame is broken

| | DAMAGE TO EXISTING WINDOWS | | | | | | | | | |
|---|---|--|--|--|--|--|--|--|--|--|
| B2 | Glass is broken, window is inoperable, and frame is broken | | | | | | | | | |

- B E Windows to be repaired
- B2 G Windows to be replaced, as they are damaged beyond repair.

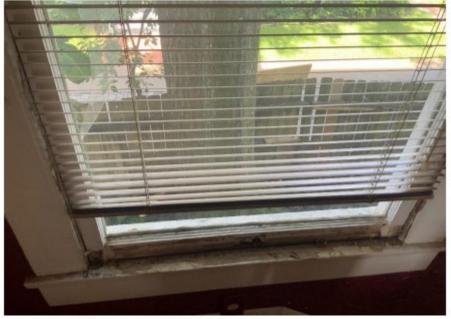
Figure 7 WINDOW B2: Rotten Frame

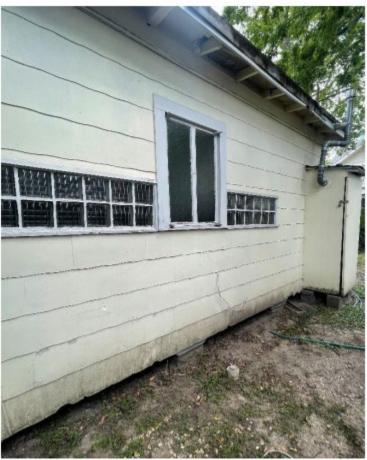
WINDOW H

Figure 14 WINDOW H: Not original window to be removed.

(H) Windows to be removed
