CERTIFICATE OF APPROPRIATENESS

Property: 1806 Decatur, Tracts 7A & 8A, Block 44, Baker W R SSBB Subdivision. The property includes a historic 1,285 square foot, one-story wood frame single-family residence situated on a 3,000 square foot interior lot. Remodeled c. 2008. Carport added c. 1992

Proposal: Alteration – Openings

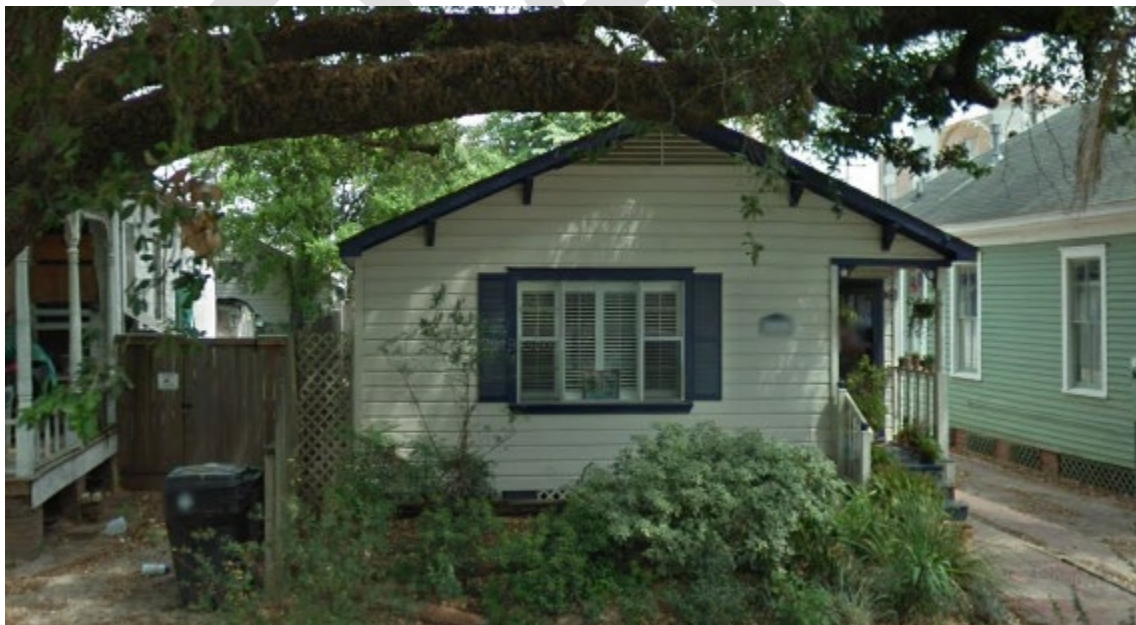
NO INVENTORY PHOTO – GOOGLE STREET VIEW C. 2011

(non historic shutters to be removed)

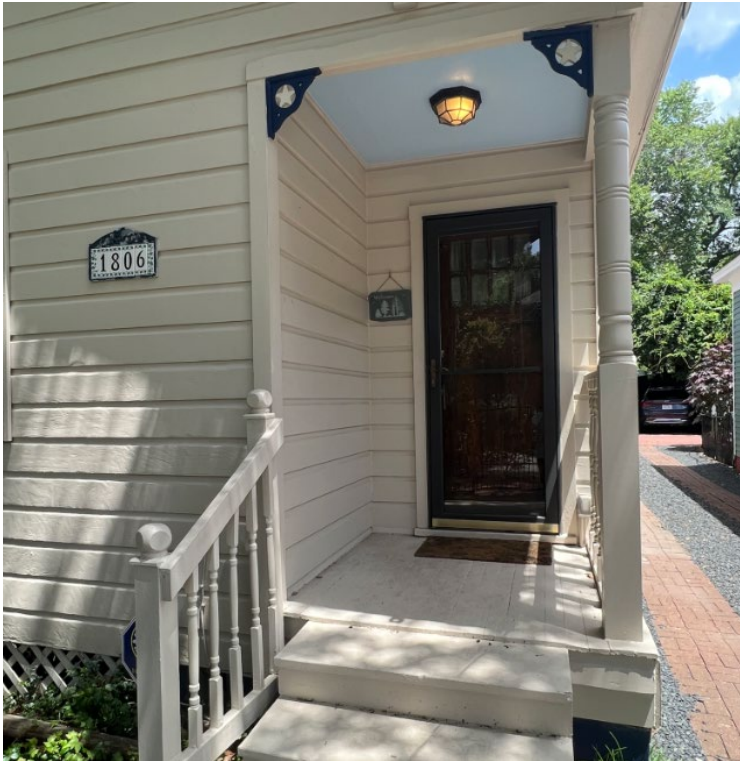
CURRENT PHOTO (DOOR TO REMAIN/WALLED FROM INSIDE)

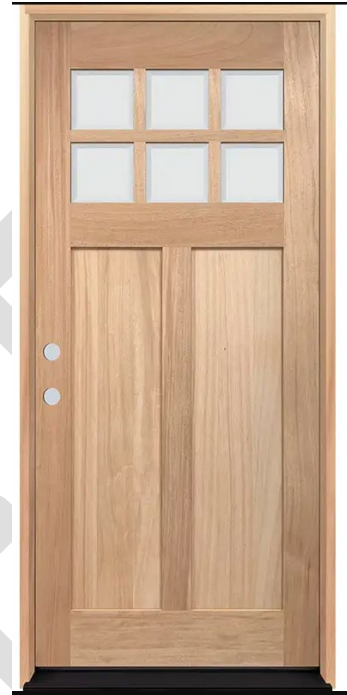
(SECOND DOOR TO BE INSTALLED ON LEFT)

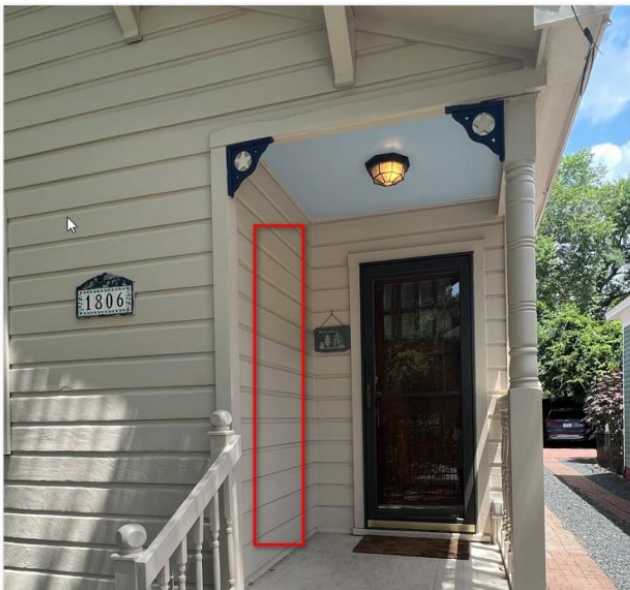
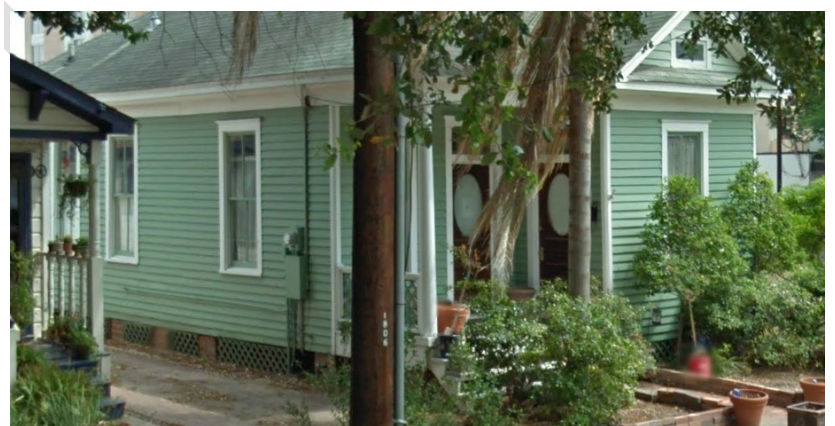
PROPOSED:

New Door will go in the red block.

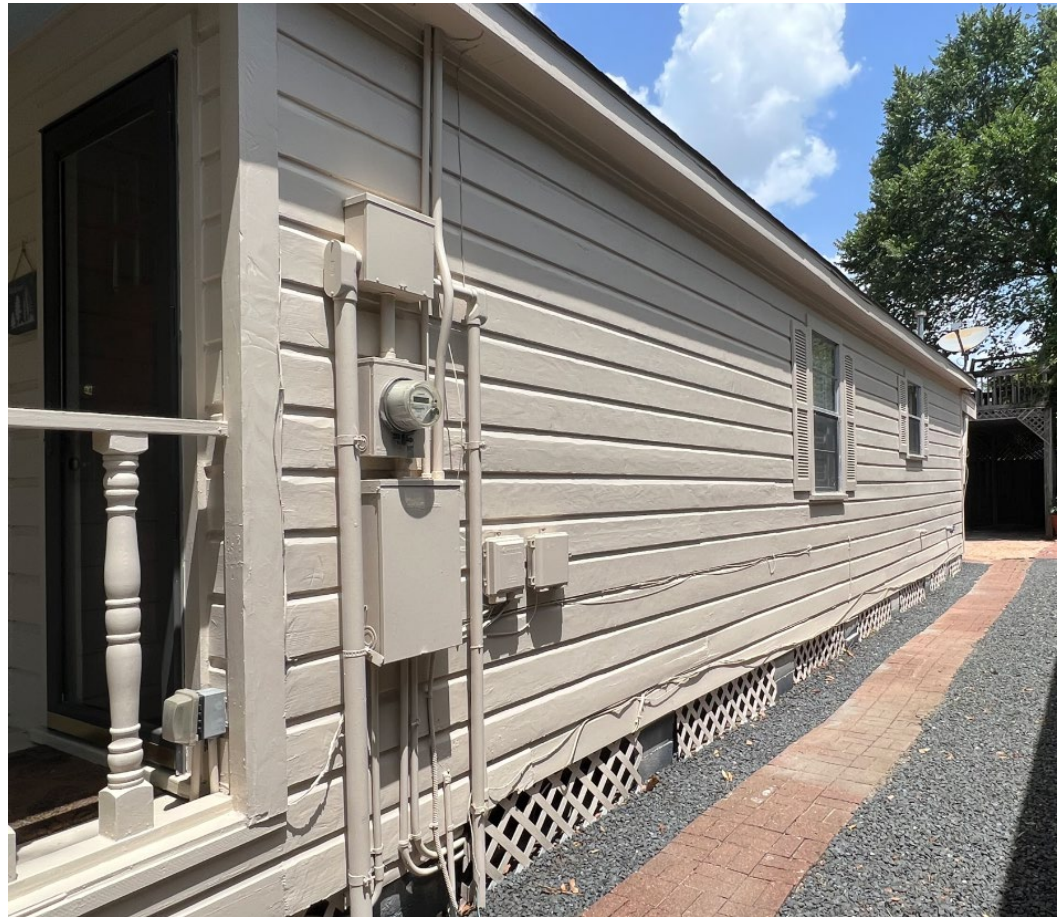
DOUBLE ENTRY SIMILAR TO 1804 DECATUR

Proposed front window lite pattern matches existing noncontributing, all other windows match 1/1 simplified lite pattern currently on the home. Proposed additional front door is similar to many existing contributing structures in Old Sixth Ward with two front entrances.

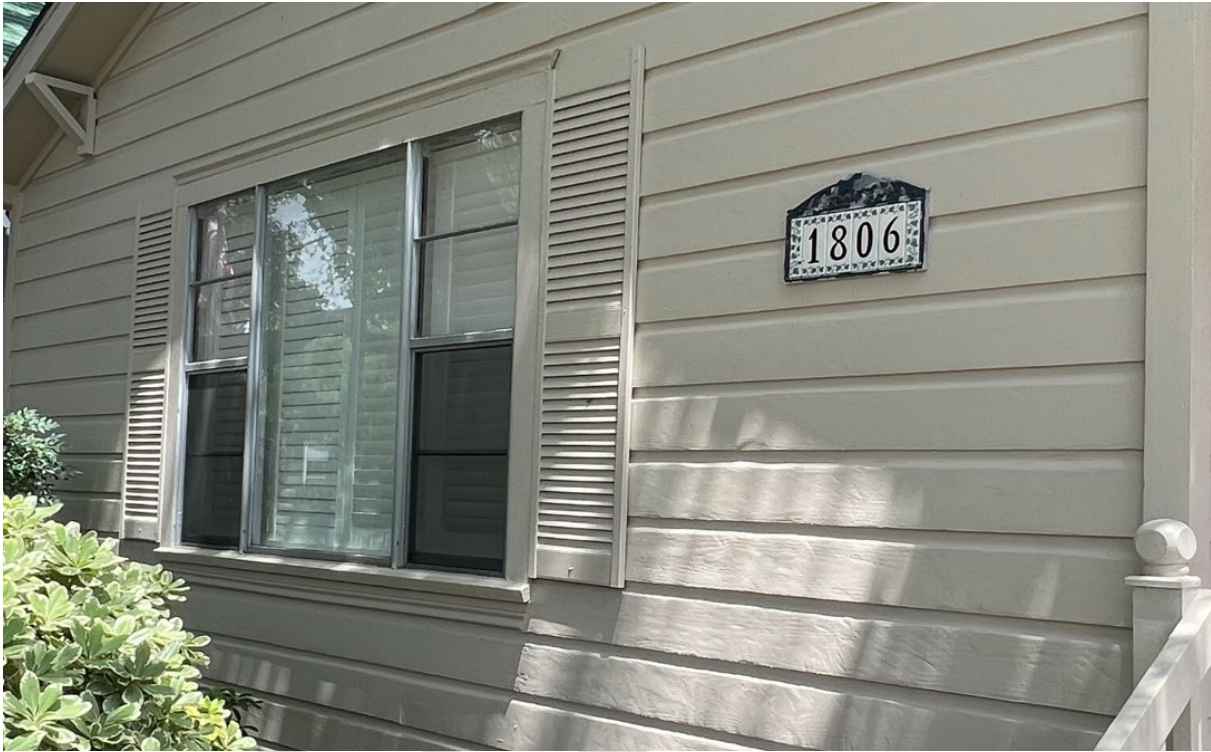
SOUTH ELEVATION – FRONT FACING DECATUR STREET
EXISTING

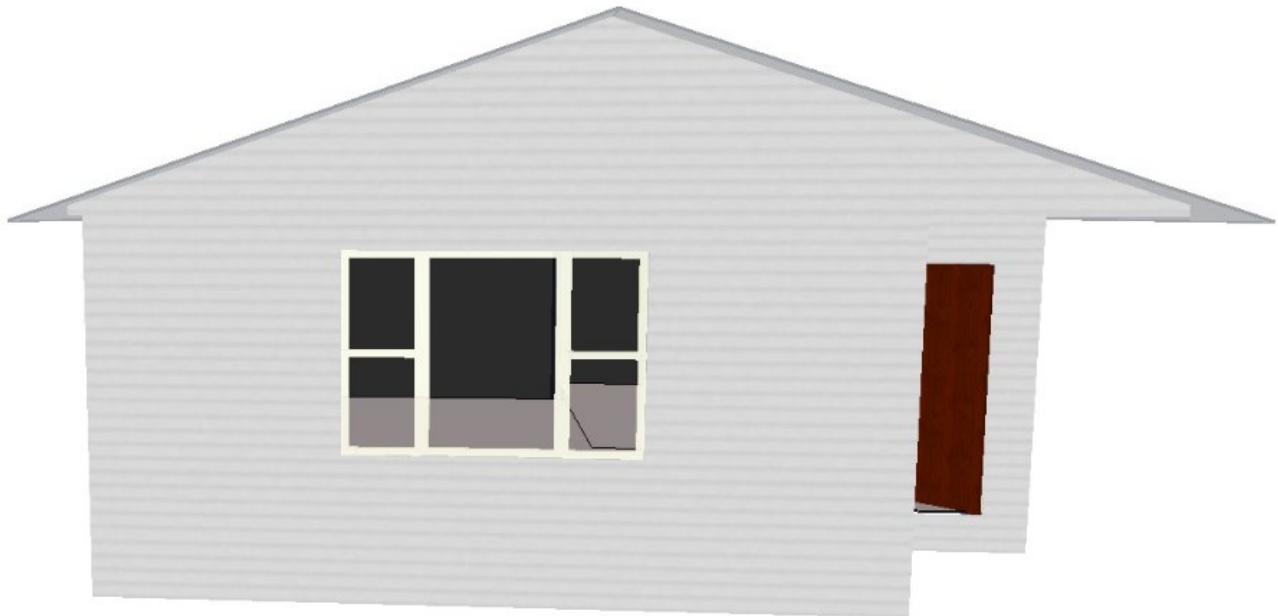
PROPOSED – SAME LITE PATTERN FOR FRONT WINDOW (83" X 56")

- Replace existing aluminum 3-part window on front elevation with same lite pattern and aluminum material.
- Side and rear elevation windows to be replaced with 1/1 vinyl windows (see image pg 8)
- Secure existing door in place, make repairs as necessary and wall in from the inside, maintaining current appearance.
- Create a new opening to the left of the front entrance with similar style of wood door.
- Remove non-original shutters
- **Information subject to change before final report.**

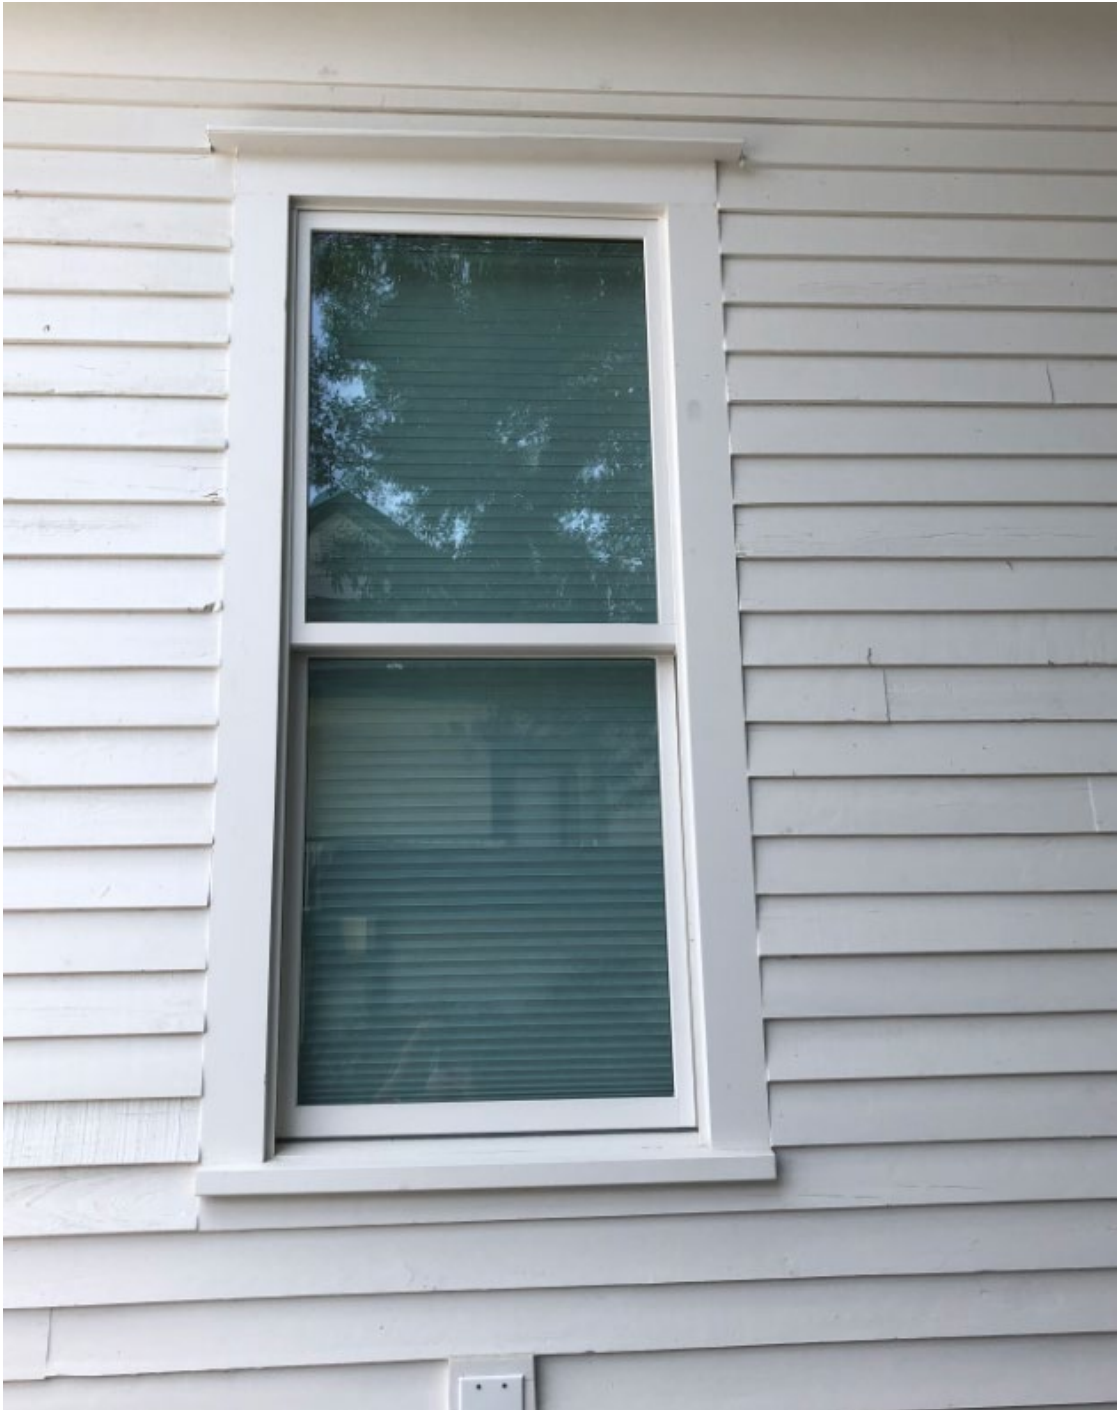
PROPOSED NEW WINDOWS FOR SIDE ELEVATIONS/REAR

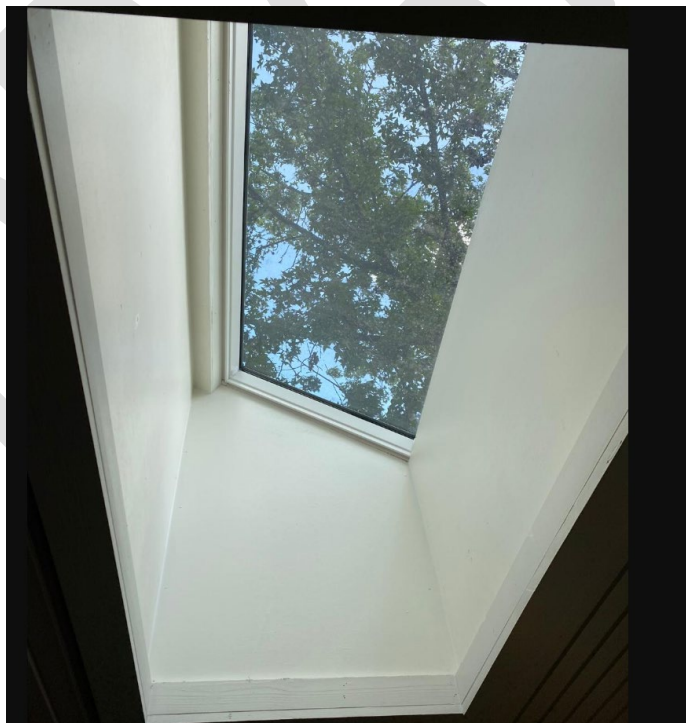
SKYLIGHT LOCATION – EXEMPT, NOT VISIBLE FROM STREET

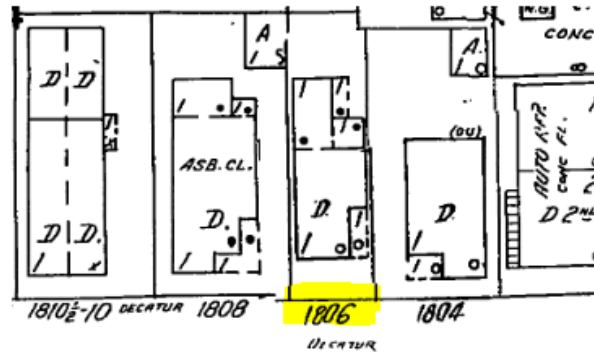
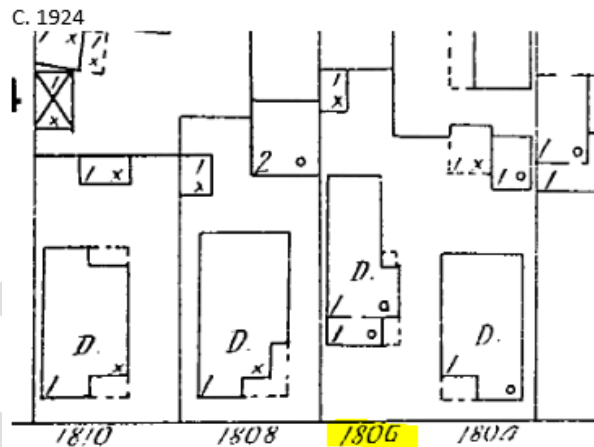
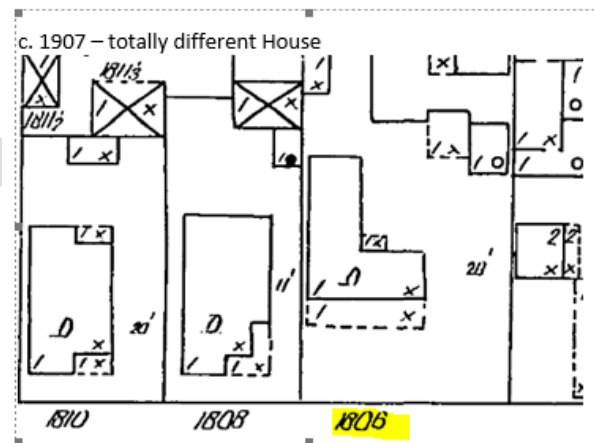
SANBORN MAP RESEARCH – COULD HAVE BEEN BUILT EARLIER THAN C. 1950

HCAD STATES 1955

here is the Sanborn from C. 1950 looks like it's older than 1955 at least..
(looks like it was moved forward from the c. 1924 version.
