**CERTIFICATE OF APPROPRIATENESS**

**Property:** 210 Marshall Street, Lot 7, Block 8, Westmoreland Neighborhood Subdivision. The property includes a historic 4,614 square foot, two-story wood frame multi-family residence and a detached apartment situated on a 6,250 square foot (50' x 125') interior lot.

**Proposal:** Alteration: Siding, Windows, Doors

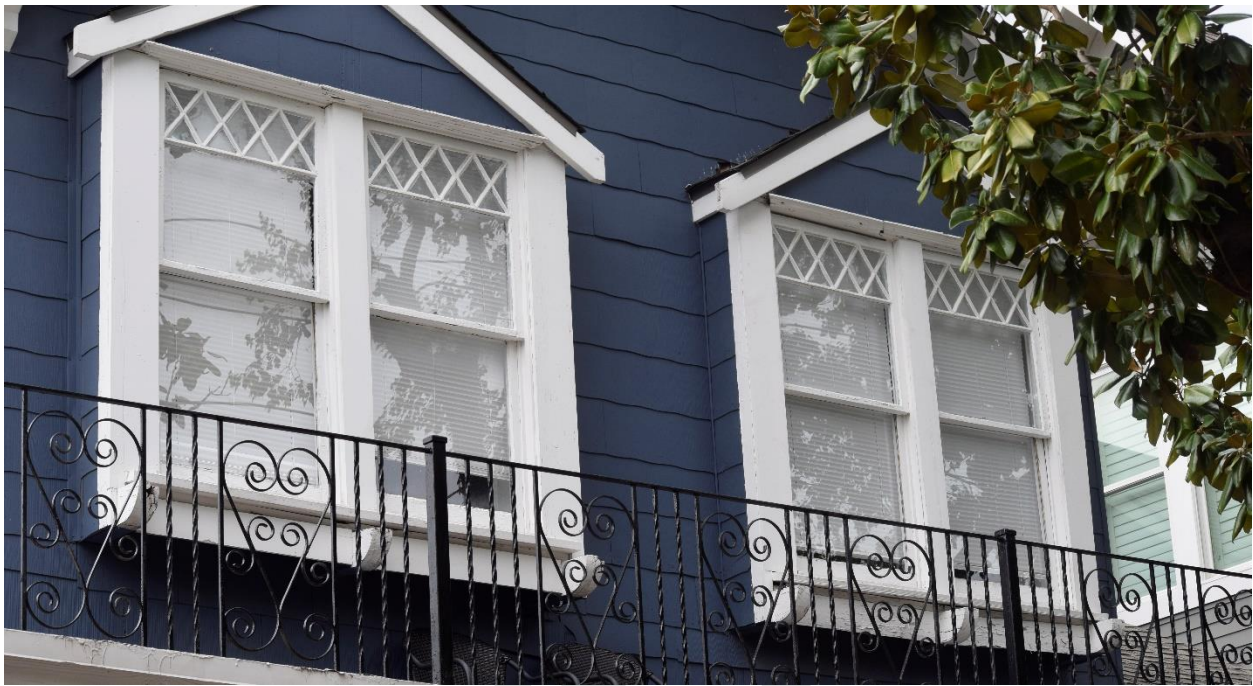
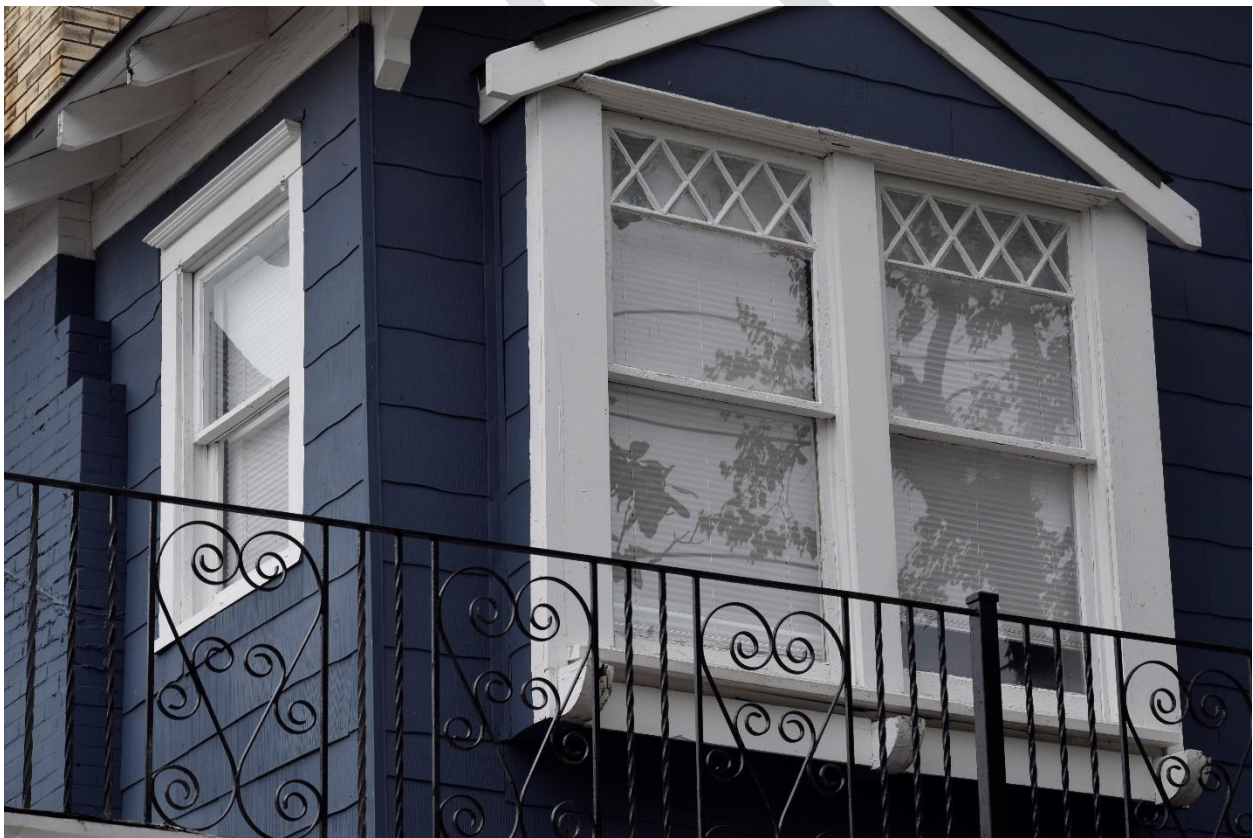
Front Elevation Upper Floor – Photos Provided By Staff (8-23-2022)

| <input type="checkbox"/> | <input checked="" type="checkbox"/> | <input type="checkbox"/> | (4) The proposed activity must preserve the distinguishing qualities or character of the building, structure, object or site and its environment; <b>The existing windows as seen from the public right-of-way are historic with its distinctive fenestration patterns. The existing windows are in good condition and require ordinary maintenance and repair, that is, be restored.</b> |

<p><b>Recommendation:</b> Partial Approval: Approval to replace existing asbestos siding &amp; doors. If original siding is found underneath asbestos siding, MUST contact historic staff for a site visit to inspect.</p>
--

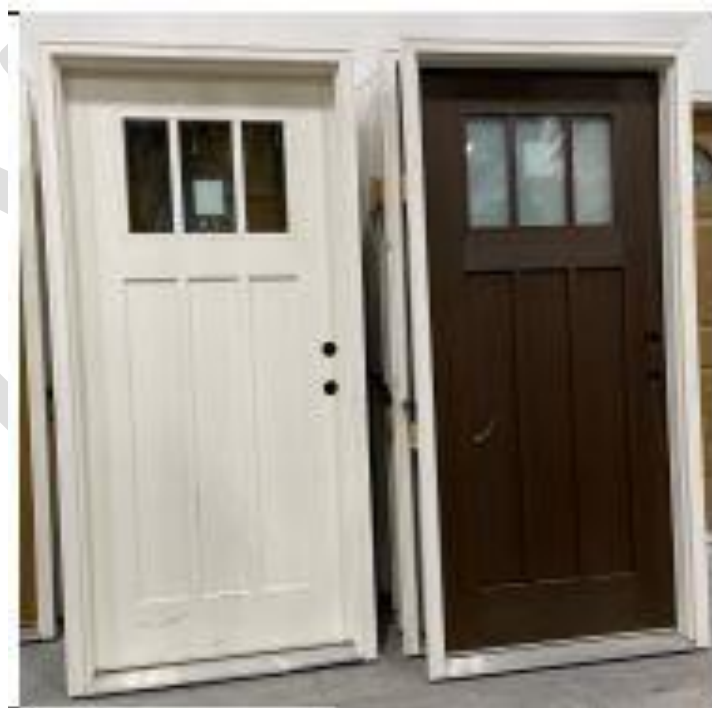
Replacement Doors

| <input checked="" type="checkbox"/> | <input type="checkbox"/> | <input type="checkbox"/> | (3) The proposed activity must recognize the building, structure, object or site as a product of its own time and avoid alterations that seek to create an earlier or later appearance; <b>The proposed replacement of the doors and siding maintains the Craftsman style as a product of its time.</b> |
