**Houston Fire Department
Emergency Response Internal Review
October 23, 2015**

May 26, 2015 - Incident No. 1505260728

- A Houston Fire Department Rescue Boat capsized during a Swift Water Rescue -Two Firefighters and Four Civilians entered the water resulting in three survivors and three deceased.

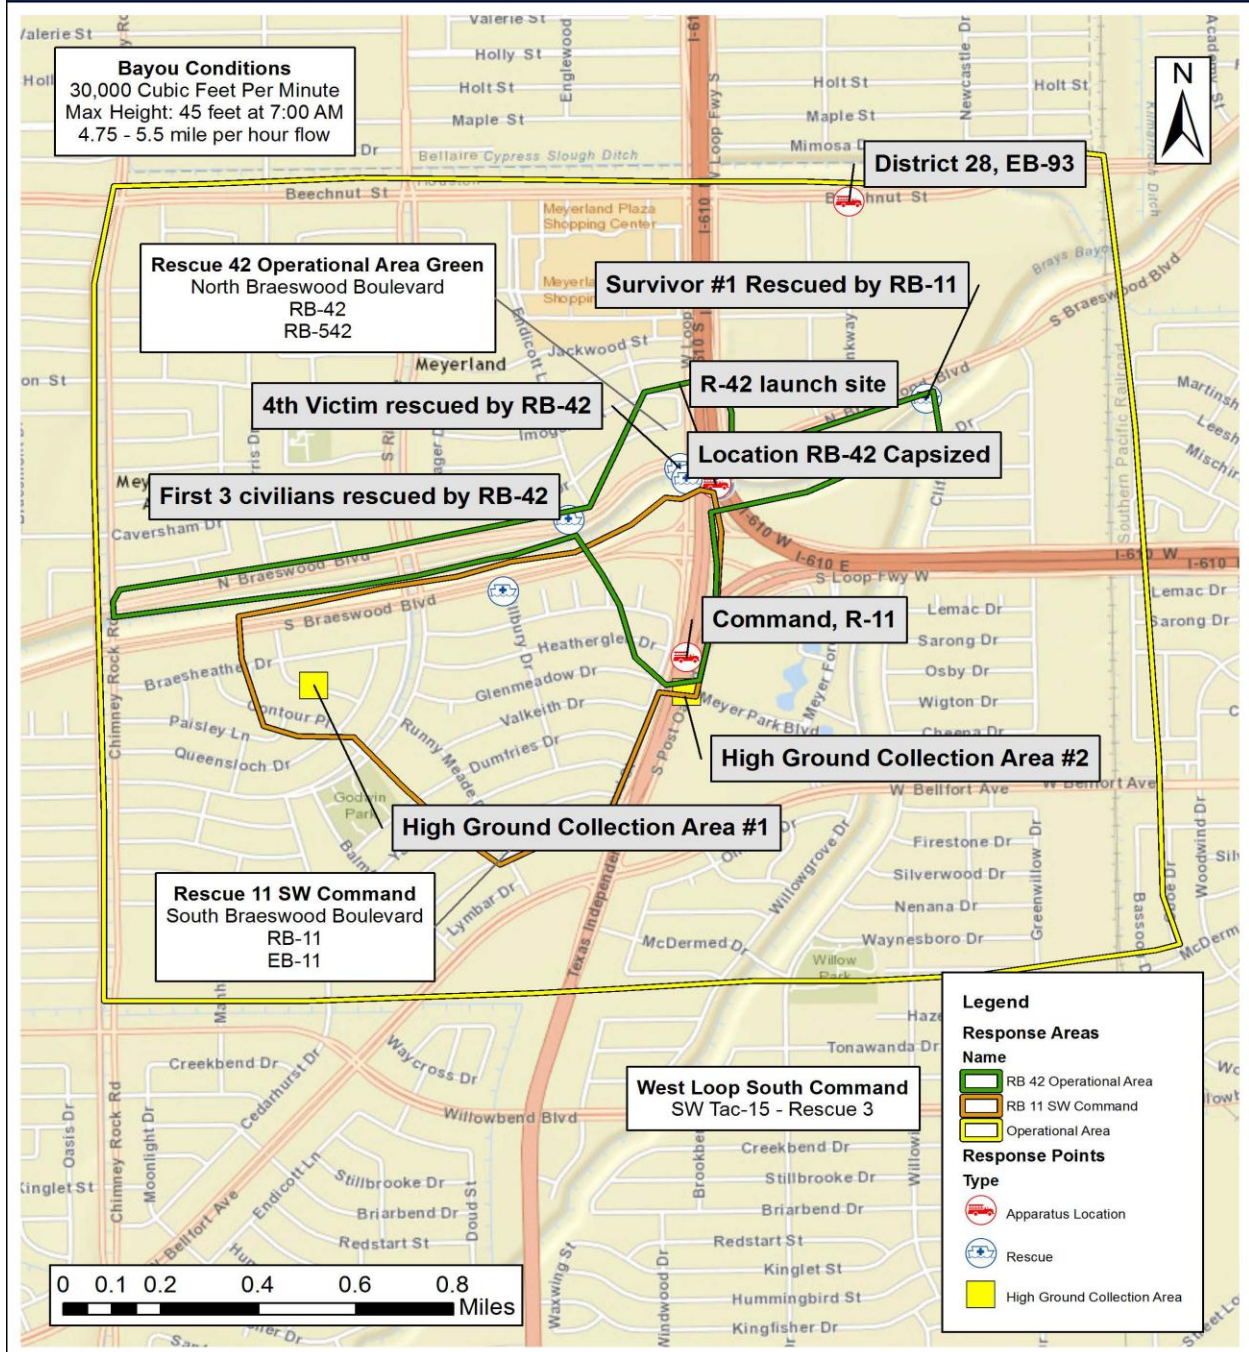
Rescue Incident AAR Map

- Original Evacuation location
- Location of capsize
- Rescue Boat 42 recovered
- HFD Lifejacket found
- HFD Lifejacket found

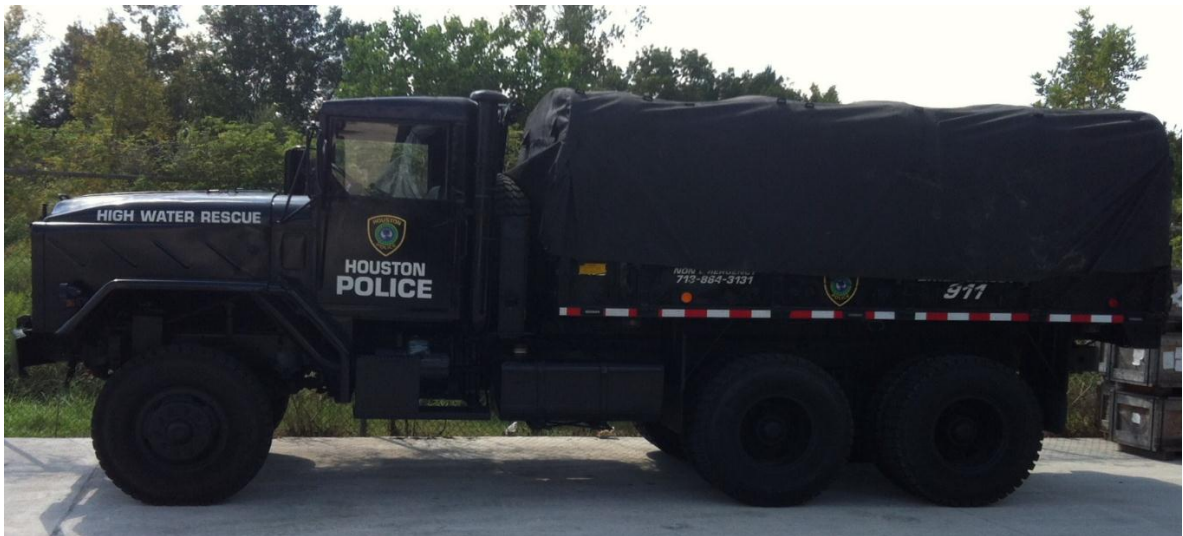
Example (High Water Rescue Vehicle) [9]

2. The Houston Police Department has recently acquired decommissioned military vehicles through a Department of Defense excess property program available to law enforcement agencies. These vehicles have been converted to High Water Rescue Vehicles. (The example shown below is an actual High Water Rescue Vehicle available in HPD's fleet). These assets will be painted to match the HPD fleet and be used as High Water Rescue Vehicles throughout the city. Currently, the intent is for these assets to be stored at HPD facilities and driven by their officers into affected areas when needed. The Houston Fire Department is developing operational guidelines and training for its members, so they can work in a joint effort with HPD when they are placed in service. In addition, the HFD Technical Rescue Command has been working with HPD to equip these vehicles with additional PFDs and other loose equipment that will be needed for deployment.
