CERTIFICATE OF REMEDIATION

Property: 901 Cortlandt Street, Lot 12, Block 229, Houston Heights Subdivision. The property includes a historic 1,260 square foot, one-story wood frame single-family residence situated on a 3,300 square foot (50' x 66') corner lot.

Significance: Contributing Bungalow duplex residence, constructed circa 1920, located in the Houston Heights Historic District South.

Proposal: Alteration – Without HAHC authorization, four windows have been removed and large sections of siding have been replaced by the previous owner. The current owner proposes to reverse the unauthorized window and siding alterations back to the original pattern/configuration. The property has been Red Tagged multiple times for Permitting Violations including COA/Historical issues.

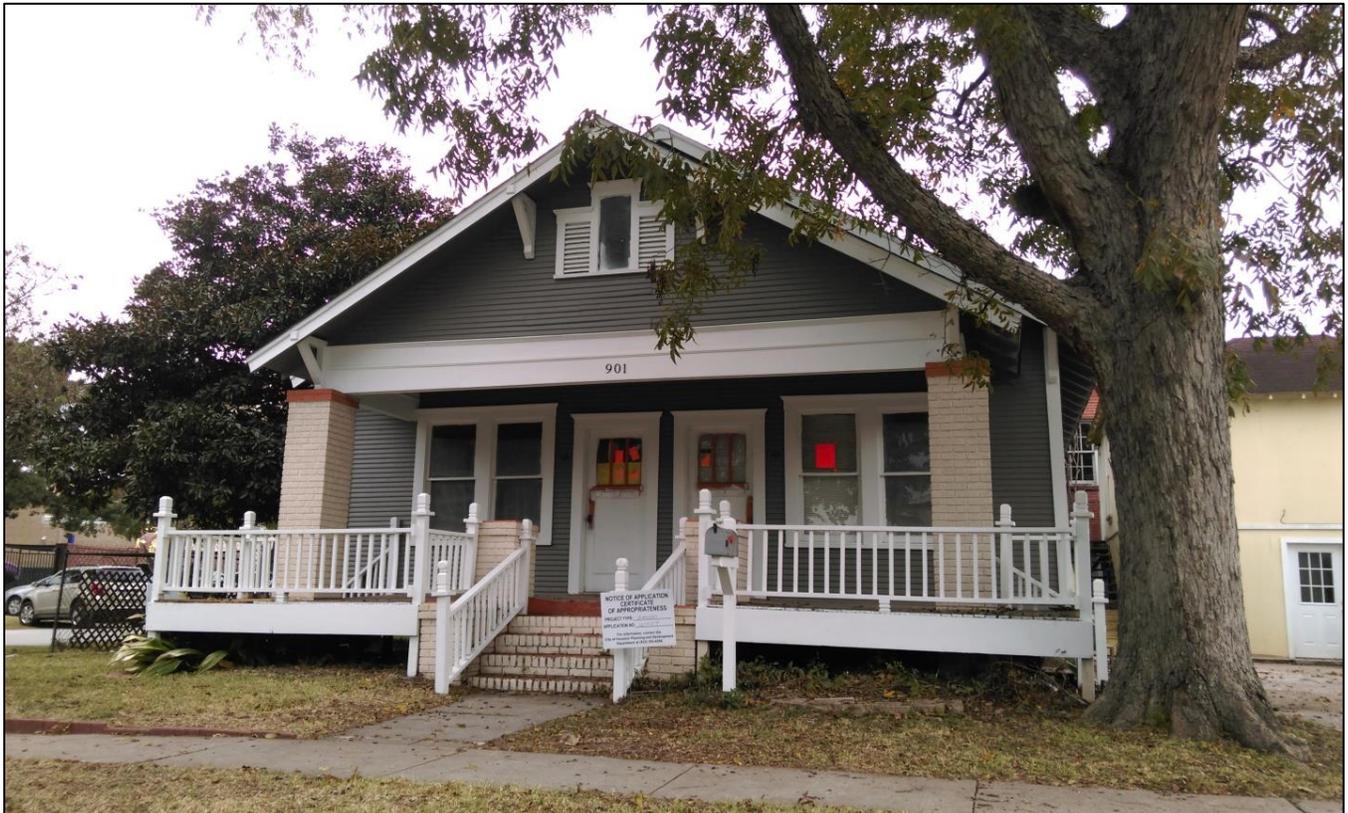
EAST ELEVATION – FRONT FACING CORTLANDT STREET

NO PROPOSED CHANGES

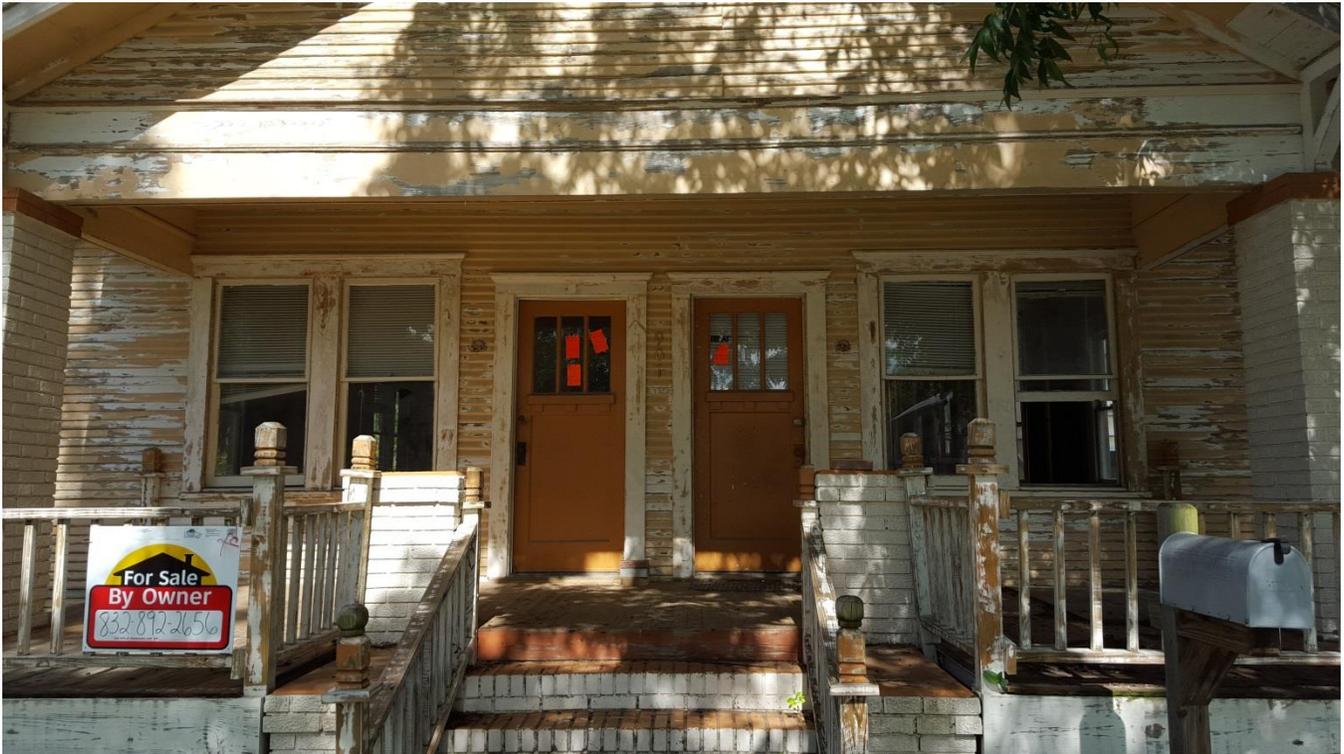
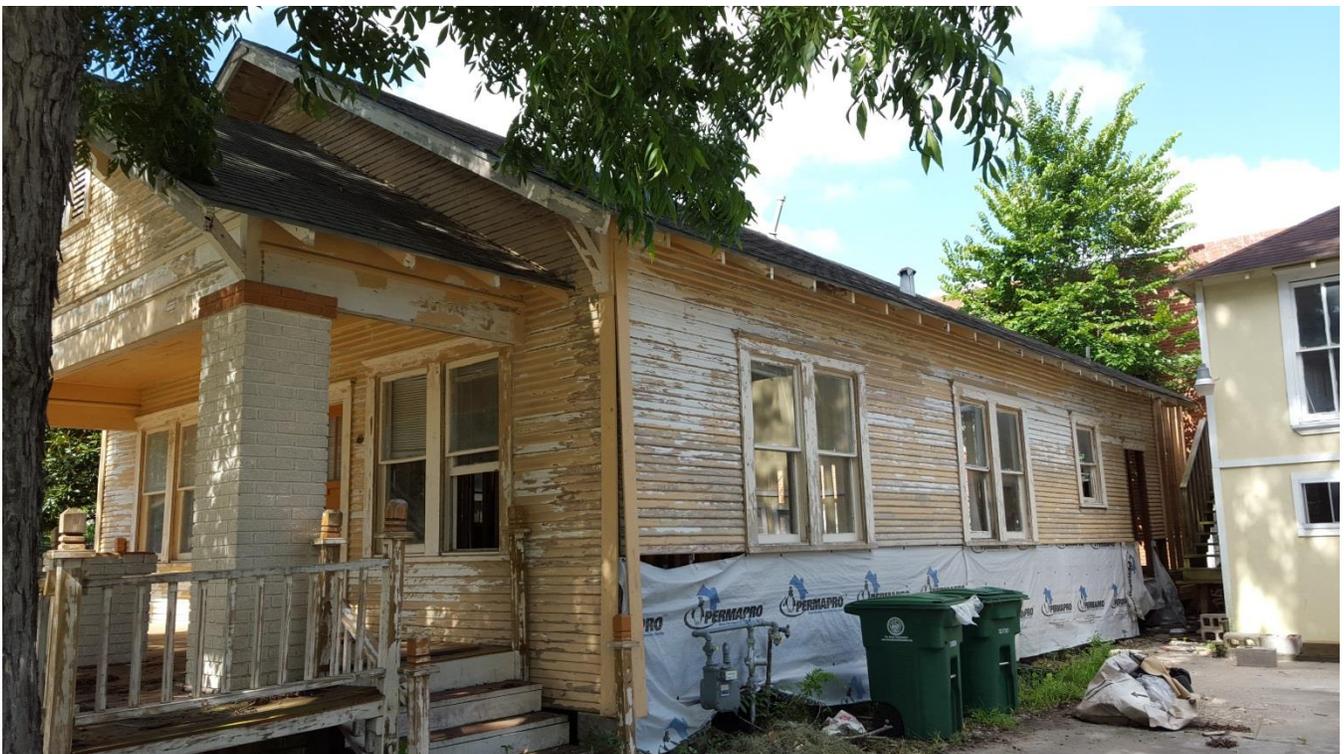
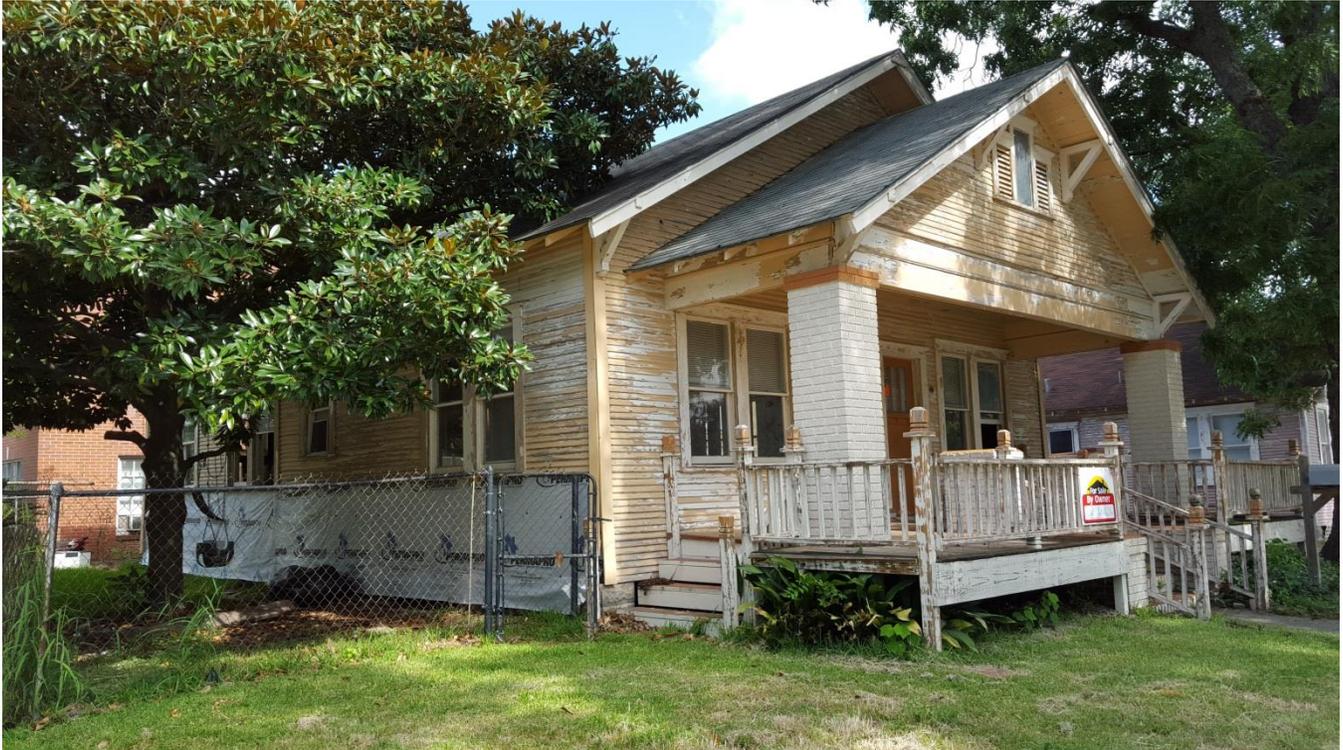
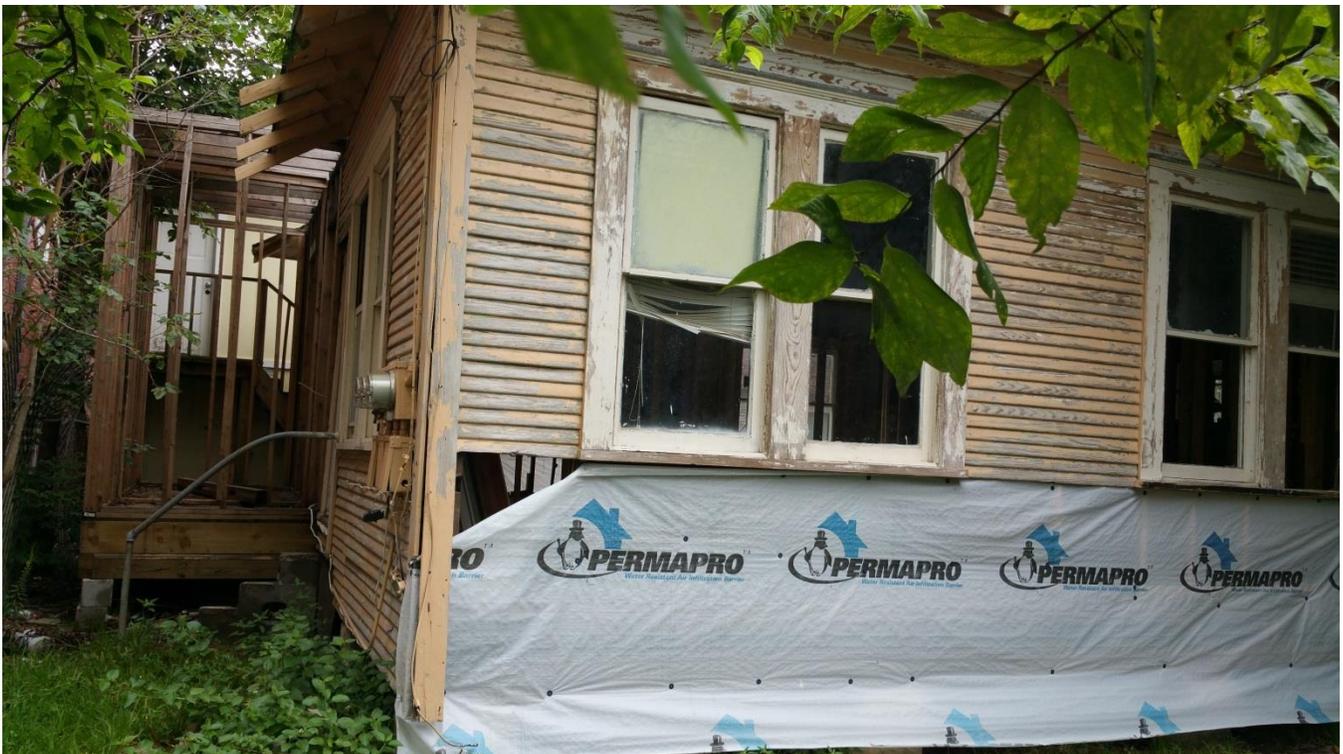
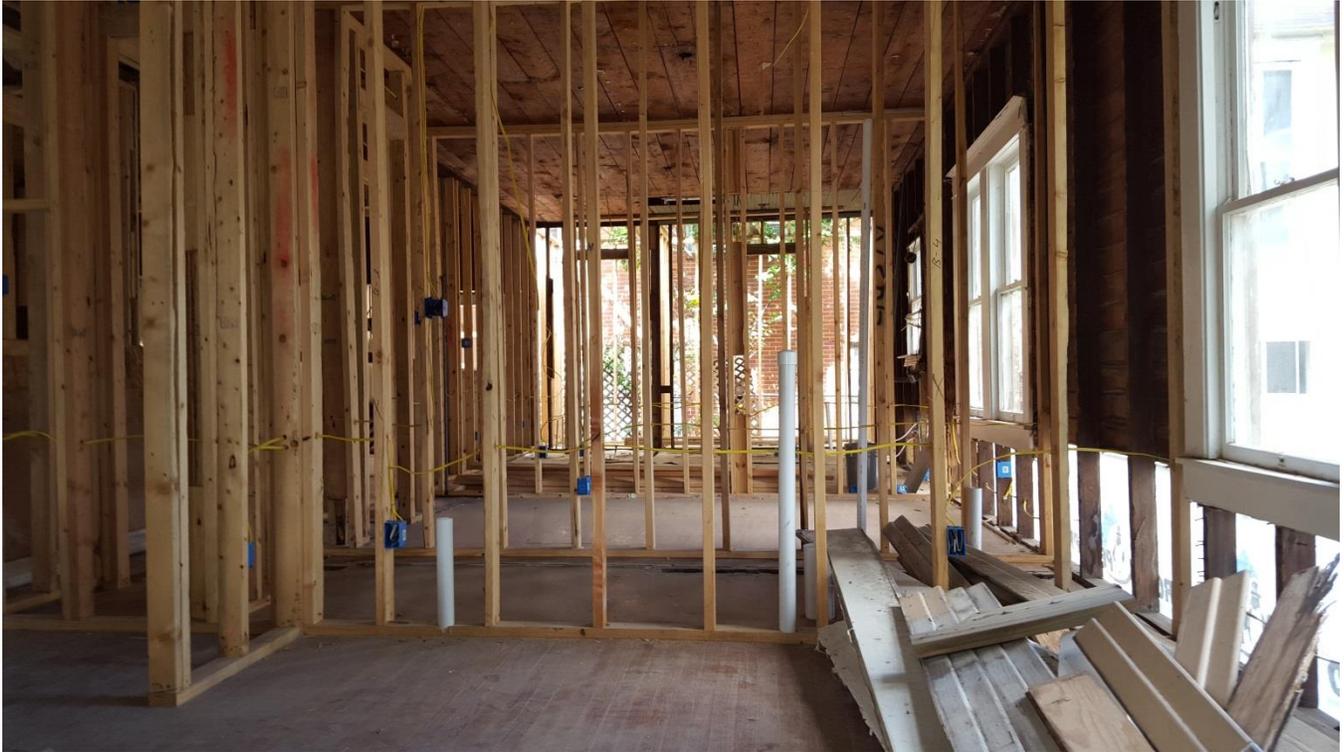
INSPECTOR PHOTOS

- Removed three windows on the south elevation
- Removed and reduced the size of an original window/opening on the north elevation
- Removed a non-original door on the north elevation
- Removed and replaced about half the original 117 wood siding with new 117 wood siding on the north and south elevations

Portions of the original siding were removed by the previous owner. On the north and south side elevations, the siding below the window sills was removed. It has since been replaced with new 117 wood siding to match existing. Wood siding was also installed over three of the existing window opening on the south side elevation and patched over the reduced window opening on the north elevation. All wood siding on the rear was replaced. See photos for more details.
