CERTIFICATE OF APPROPRIATENESS

Property: 1120 East 14th, per HCAD legally described as, LT 5, BLK 118, North Norhill, the property has a 1,064 SF house on a 5,200 SF lot

Significance: Contributing circa 1926 Bungalow in the Norhill Historic District

Proposal: Demolition – Applicant proposes to demolish the house

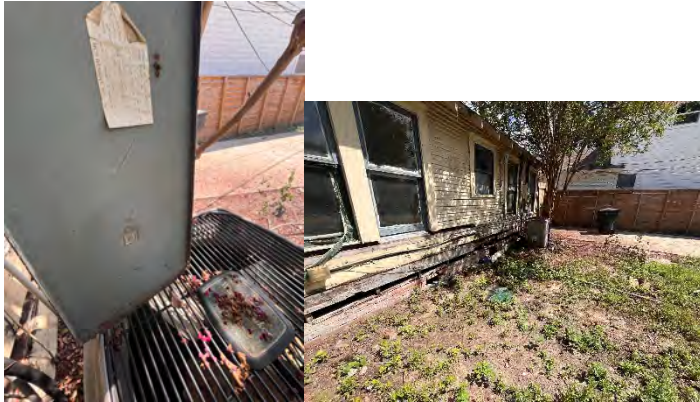
HVAC system for the subject property

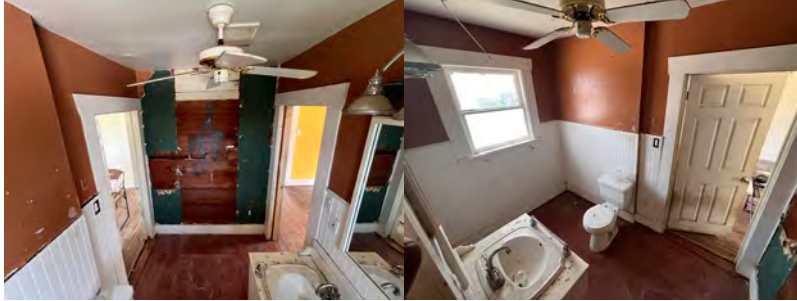
Subject property bathroom.

Finding during assessment
Nonfunctional

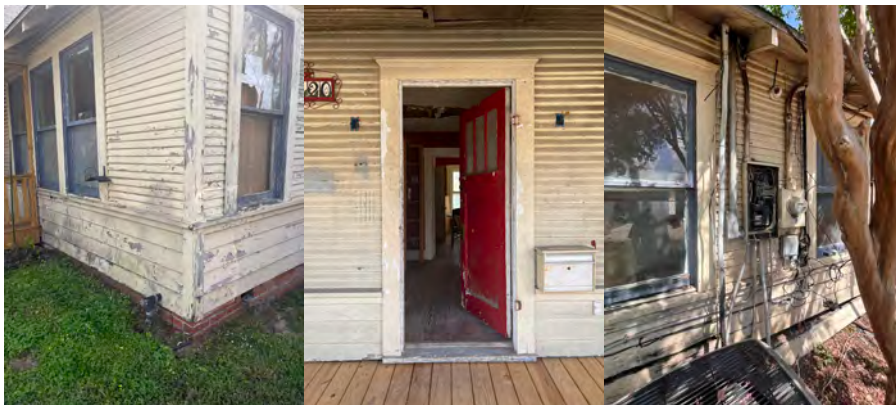
View of subject property exterior siding.

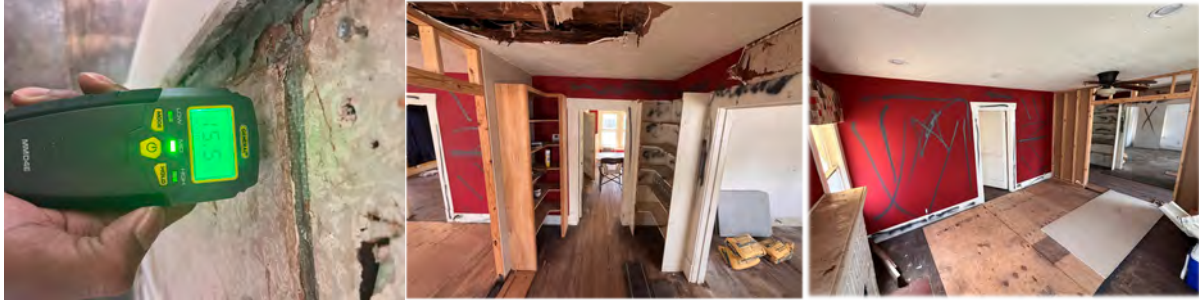
Subject property interior walls and conditions.

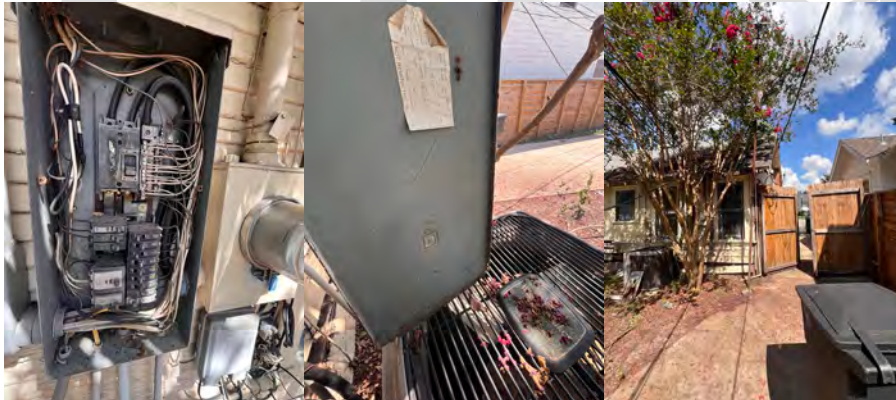
The subject property includes the electrical panel, service lines, and condition of breakers.

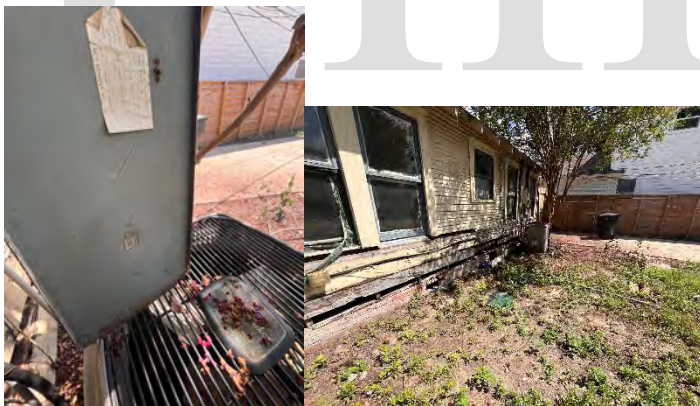
HVAC system for the subject property

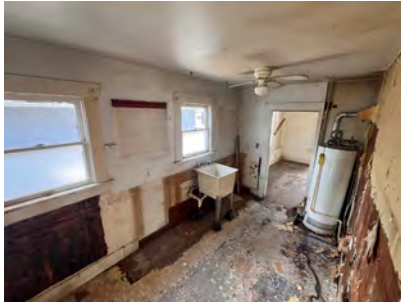
Kitchen area with nonfunctional water heater.

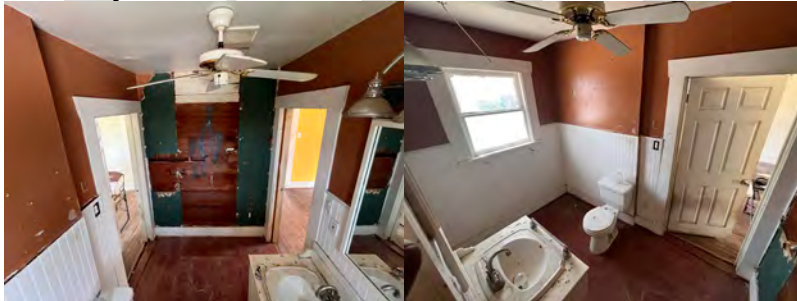
Subject property bathroom.

Require complete replacement during renovation.
