CERTIFICATE OF APPROPRIATENESS

- Property: 1714 South Boulevard, Tract 7A & 8A, Block 4, West Edgemont Subdivision. The property includes a historic 5,255 square foot two-story wood frame single-family residence and a detached garage situated on a 17,745 square foot (105' x 169') interior lot.
- Significance: Contributing Colonial Revival residence, constructed circa 1929, located in the Boulevard Oaks Historic District.

Proposal: Alteration – Front entry, shutters, side and rear addition

July 28, 2022 HPO File No. HP2022_87

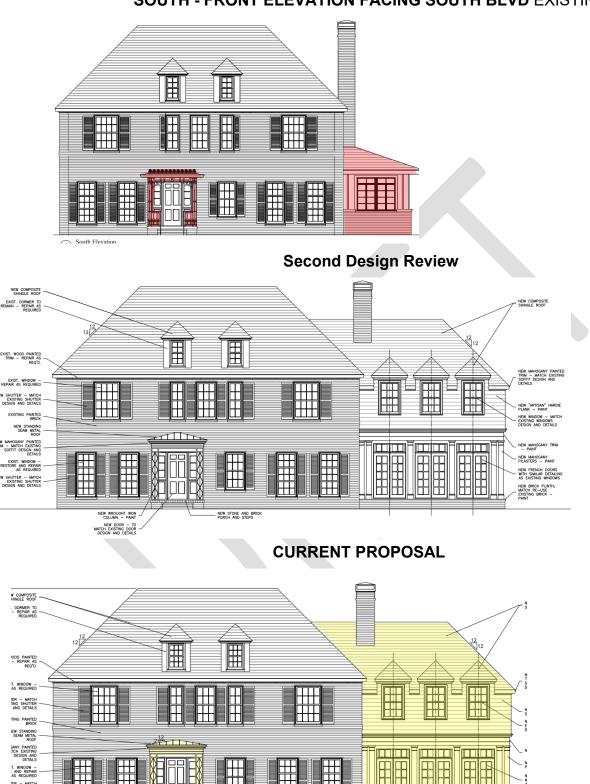
NEW STONE AND BRICK PORCH AND STEPS

NEW WROUGHT IRON COLUMN - PAINT

T. WINDOW -AND REPAIR AS REQUIRED IER - MATCH ING SHUTTER AND DETAILS

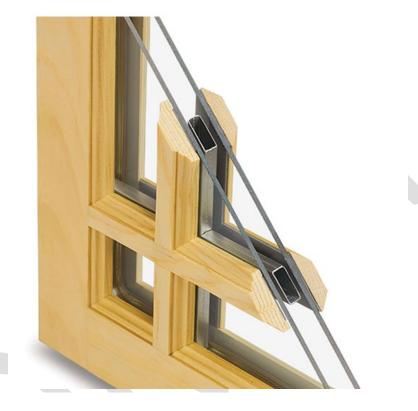
Window characteristics-

- · Metal clad exterior frame and muntins with pre-finished factory color (white to match existing)
- Wood interior frame and muntins (to be painted)
- Insulated glass
- Stainless steel spacer bar at frame and muntins simulates the appearance of true divided lights while allowing window to meet energy conservation requirements
- Muntins are available in 5/8" width which will match existing muntin width (historic windows tend to have narrow width muntins)
- · Light divisions and sizes are available that will closely mirror the dimensions of the existing windows

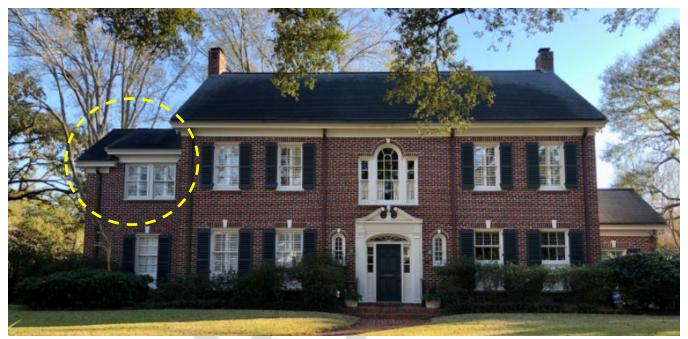
APPLICANT PHOTOS -CONTEXT, 1707 SOUTH BLVD_PRECEDENT 1, CONTRIBUTING COLONIAL REVIVAL C. 1927

SETBACK SIDE ADDITION, RAISED ROOFLINE CURRENT LIVING AREA 5,794SQFT AND 26,684 SQFT LOT *SIDE ADDITION EXISTED BEFORE DISTRICT CREATED*

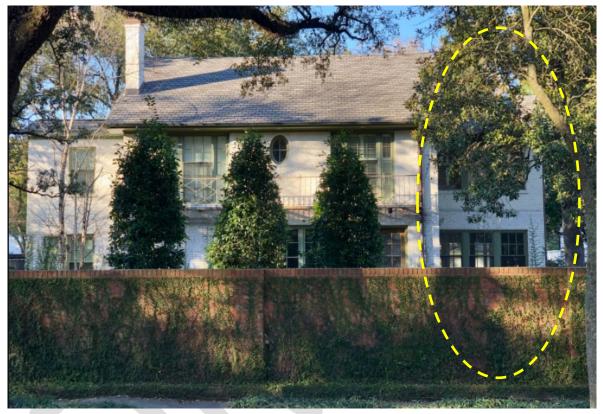
APPLICANT PHOTOS -CONTEXT, 1710 SOUTH BLVD_PRECEDENT 2, CONTRIBUTING COLONIAL REVIVAL C. 1928,

SETBACK SIDE ADDITION REFERENCE, REMODELED C. 2010 AND C. 2011, CURRENT LIVING AREA 4,262 SQ FT ON 15,210 SQFT LOT *SIDE ADDITION EXISTED BEFORE DISTRICT CREATED*

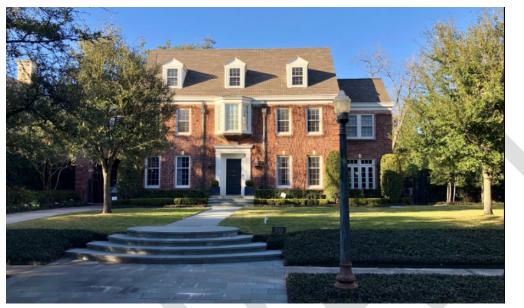
APPLICANT PHOTOS -CONTEXT, 1740 SOUTH BLVD_PRECEDENT 3 CONTRIBUTING MANORIAL C. 1936

SETBACK SIDE ADDITION, RAISED ROOFLINE CURRENT LIVING AREA 5,794SQFT AND 26,684 SQFT LOT *SIDE ADDITION EXISTED BEFORE DISTRICT CREATED*

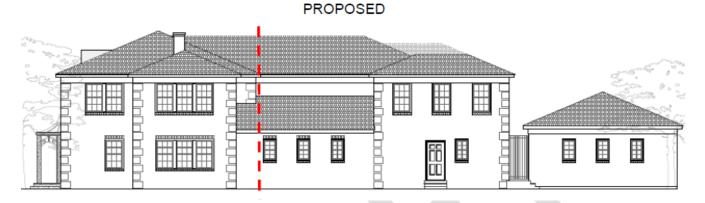
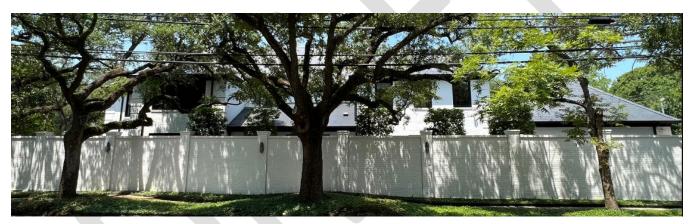
ADDITIONAL CONTEXT: 1702 SOUTH BLVD, REMODELED 2018, APPROVED BY HAHC 2/23/2017

c.1927, Contributing Colonial Revival, 7,509 sq ft living area on 13,267 sq ft lot, (56%) CURRENT CORNER VIEW:

- Remove an existing 1,085 square foot 1980s one -story addition on the rear (north) elevation of the two-story residence.
- Construct a rear 2,836 square foot one and two-story addition with a detached garage.

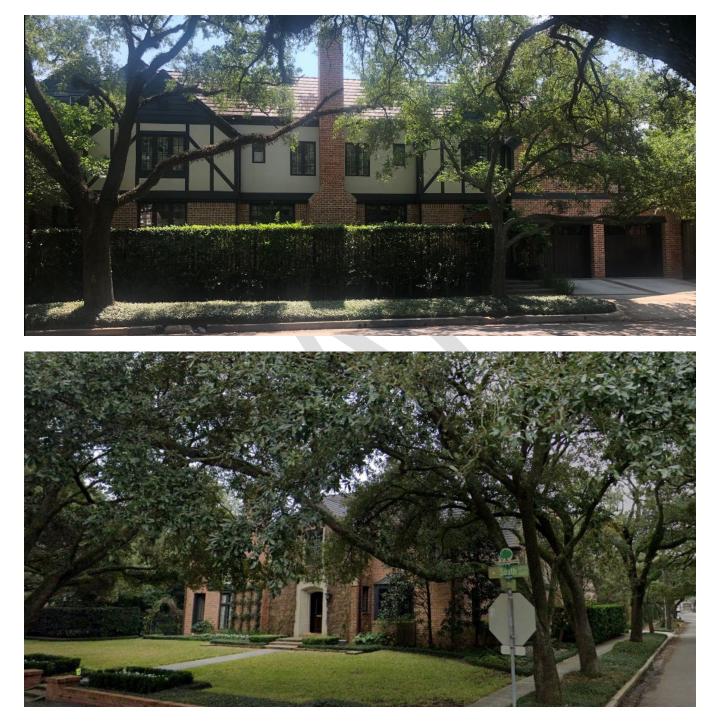
ADDITIONAL CONTEXT: 1659 SOUTH BLVD, REMODELED 2009, before district was created

c.1928, Contributing Tudor Revival, 7,684 sq ft living area on 22,176 sq ft lot (34%), CURRENT CORNER VIEW:

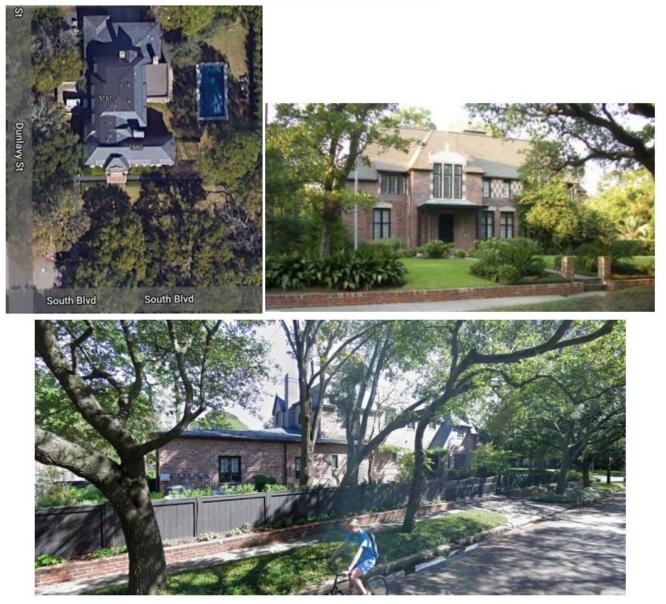
CONTRIBUTING CONTEXT: 1660 South Blvd (corner lot)

Lot size: 24,505 sqft – Living Space 6,137 sq ft (25%) Addition approved by HAHC c. 2013
