CERTIFICATE OF APPROPRIATENESS

Property: 1754 North Blvd., Lot 1, Block 5, Ormond Place Subdivision. The property includes a historic 4,409 square foot two-story single-family residence and a two-story detached garage situated on a 10,500 square foot (75' x 140') corner lot.

Significance: Contributing Colonial Revival residence and detached garage; constructed circa 1928, located in the Boulevard Oaks Historic District. Significant alterations took place c. 1977 and c. 1988.

Proposal: Alteration – *Windows, Doors, and Addition with attached garage that connects existing closed in two story historic garage and primary residence.*

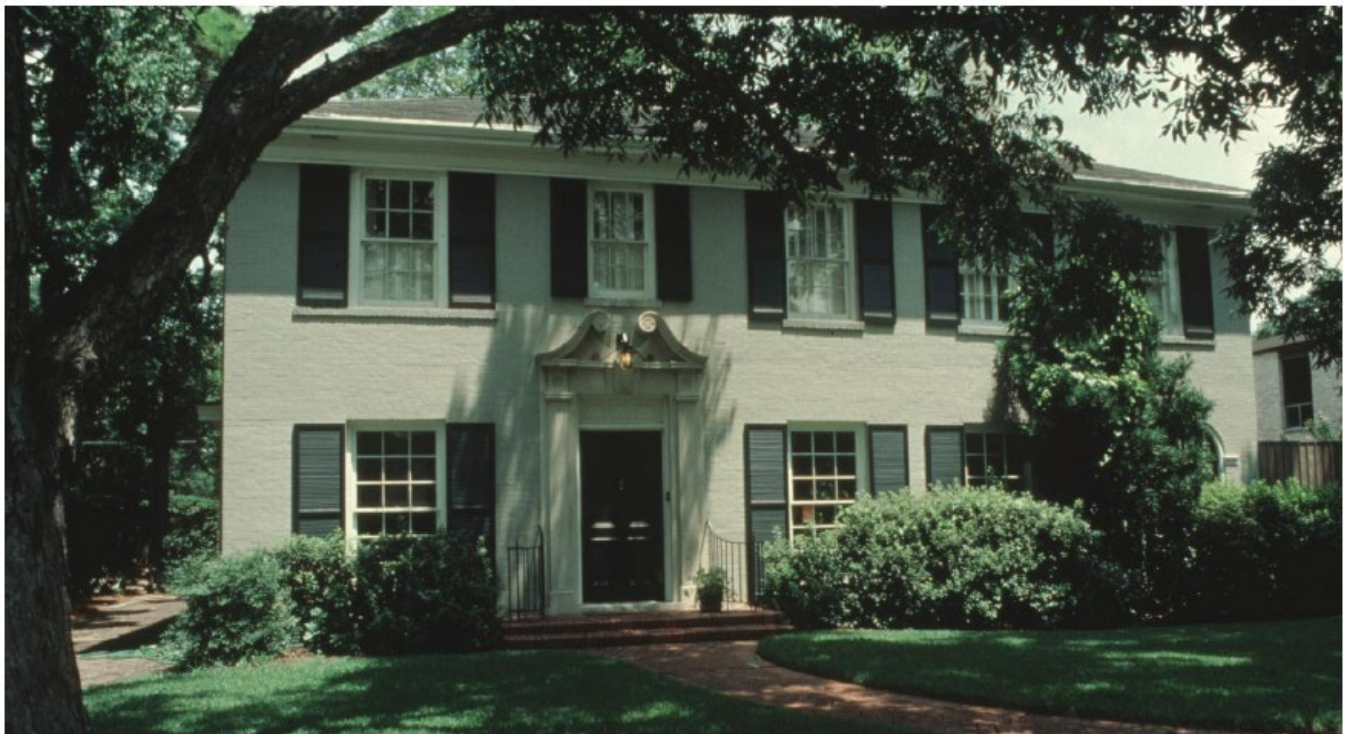
Exhibit 1: Undated photo (likely taken between 1969 and 1979) of the S, front facade of 1754 North Boulevard. View N. Photo courtesy of the Texas Historical Commission, from the THC National Register Collection and The Portal to Texas History, a digital repository hosted by the UNT Libraries.

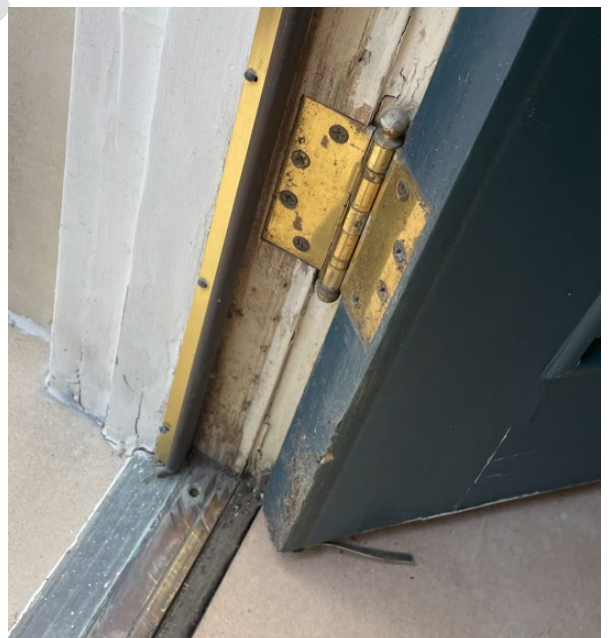
BOULDER FULL HANDLESET

MODEL #: 6402.056

← MORTISE BOX

Baldwin 6321 Handed Residential Entrance Emergency Egress Mortise Lock with 2-1/2" Backset

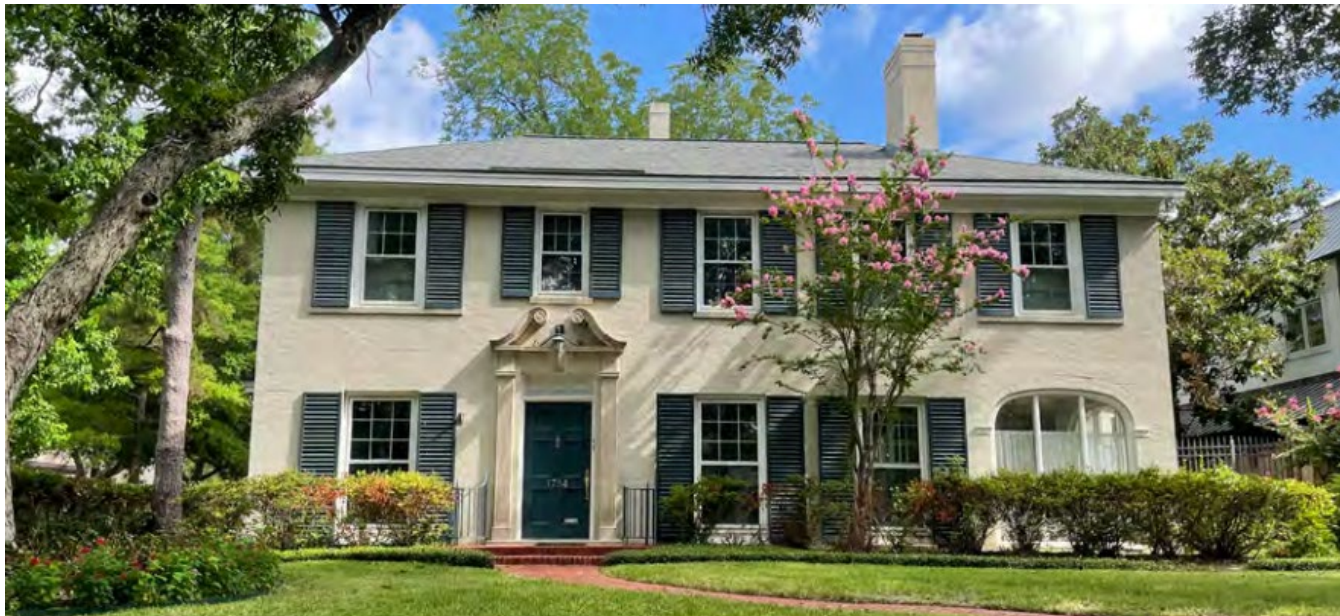
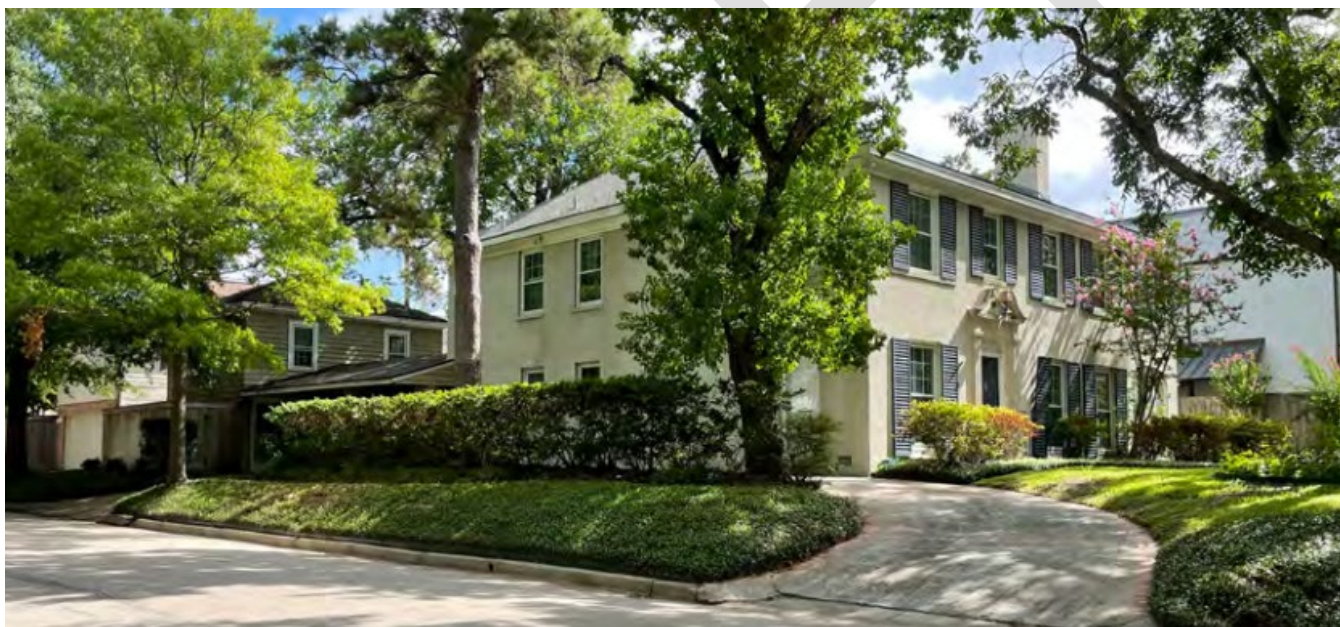
CURRENT PHOTO

3. Front, S facade (along North Boulevard) and W elevation (along Woodhead Street) with 1977 carport addition and original, two-story garage apartment (built in 1928) in the rear of the main house. View NE.

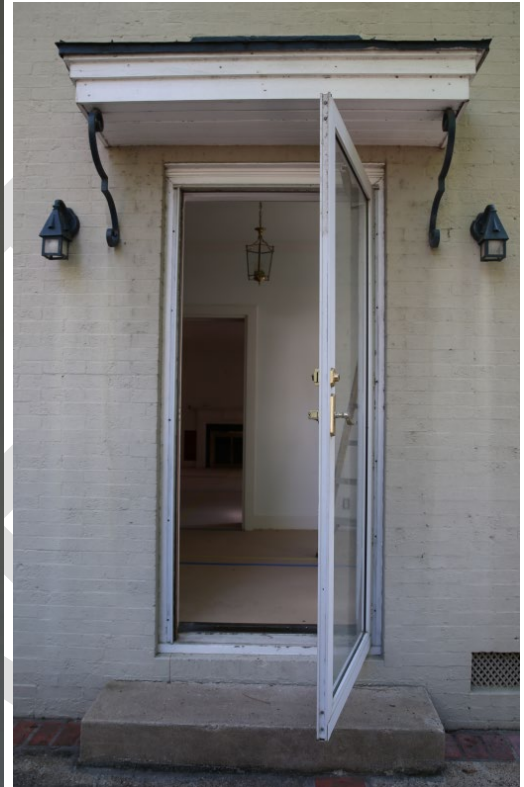
CURRENT PHOTOS – SIDE DOOR PROPOSED TO CHANGE TO WINDOW

11. Non-original side door (likely added during 1977 remodel) at SW corner of W elevation of main house (along Woodhead Street) in place of an original window. View W.

- Existing side door facing Woodhead to be replaced with window to match front façade opening. This door could potentially be historic motor car or service entrance. Measurements proposed to change – opening will widen by 3” and shorten by 5” to match window in same roof facing front façade.

Recommendation: Approval with conditions: retain existing opening dimensions for side door A1 facing Woodhead and repair exterior awning.

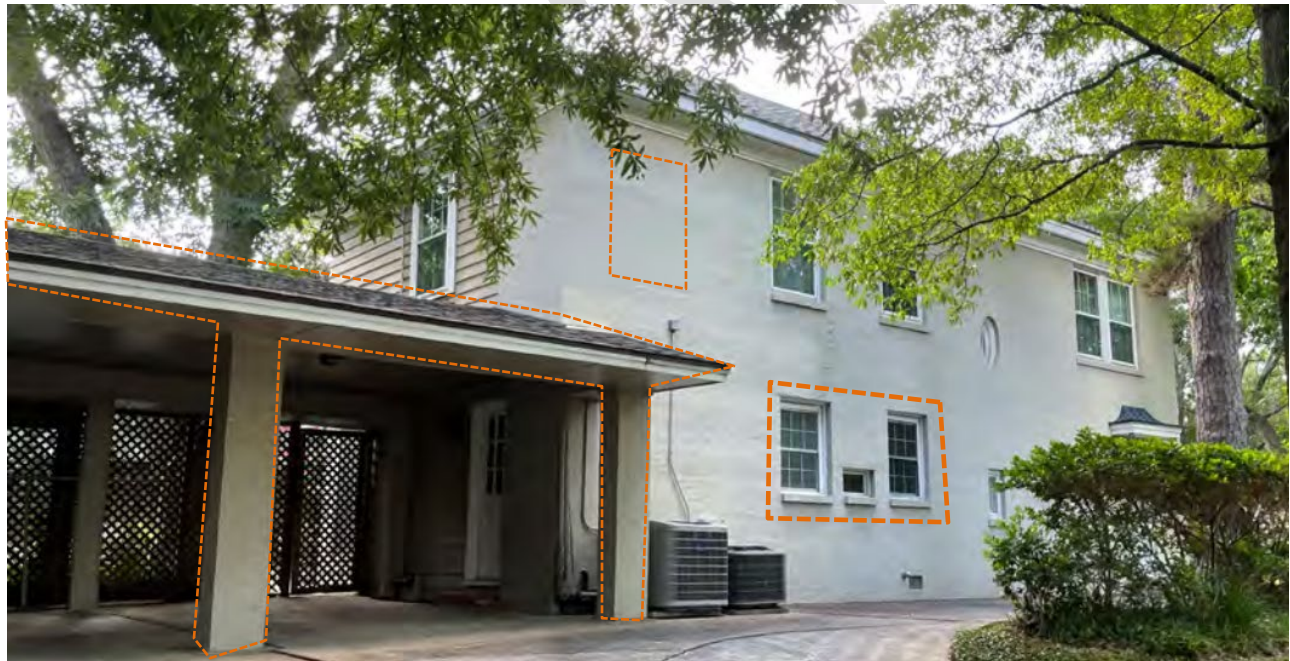
5. W and partial rear, N elevation of main house. This portion of the main house was an extension added in 1977. Original wood windows on second-story, non-original windows and doors on first-floor. View SE.

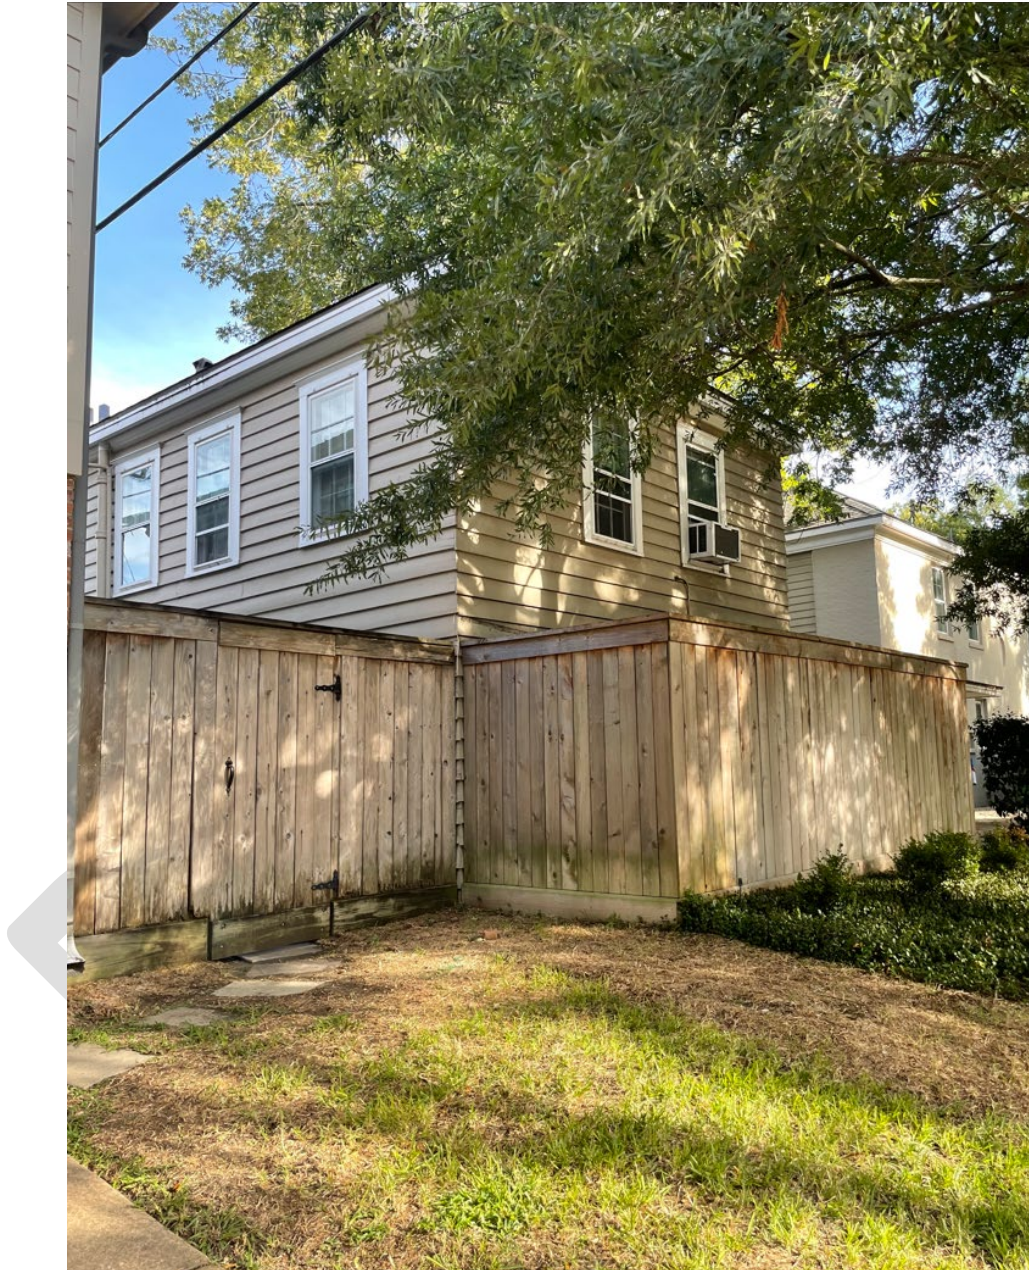
**HISTORIC GARAGE FROM WOODHEAD – NO CHANGE EXCEPT
WINDOW REPLACEMENTS TO MATCH PRIMARY RESIDENCE**

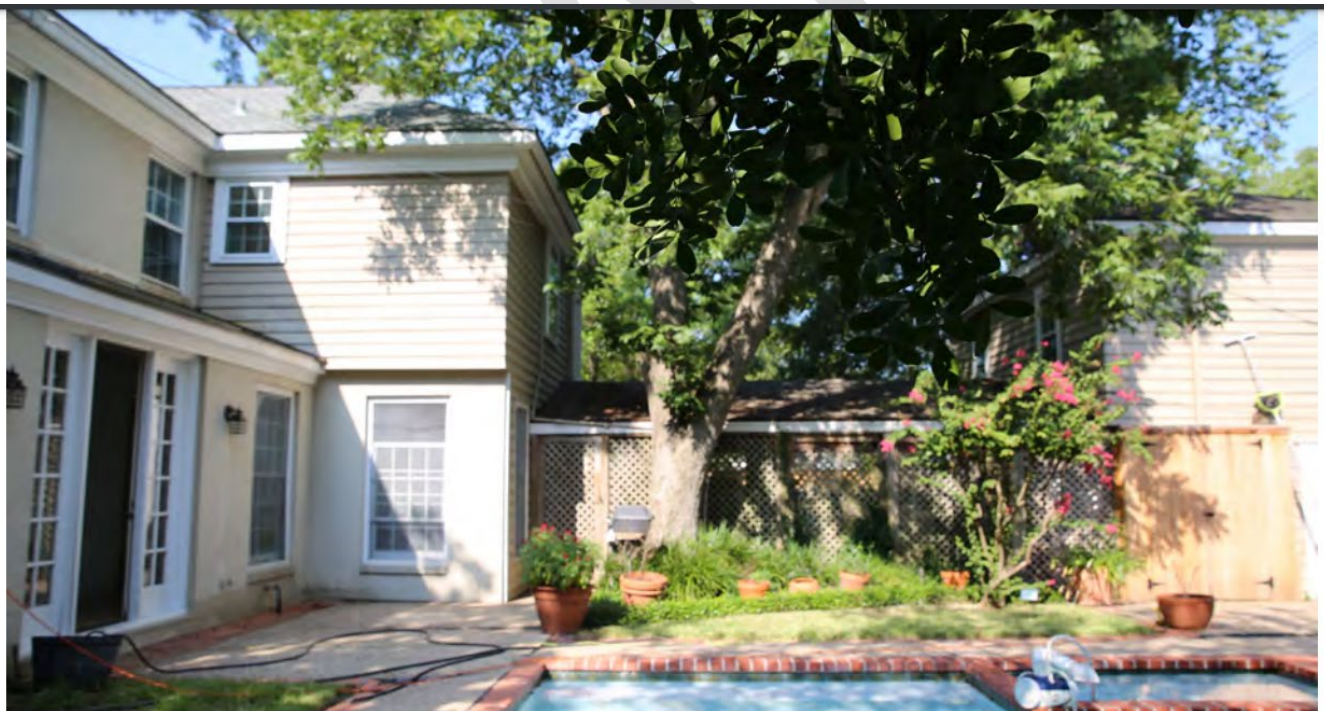
9. E elevation (rear view) of 1977 extension of main house along Woodhead Street, connecting to carport (middle) and original, garage apartment (right). View W.

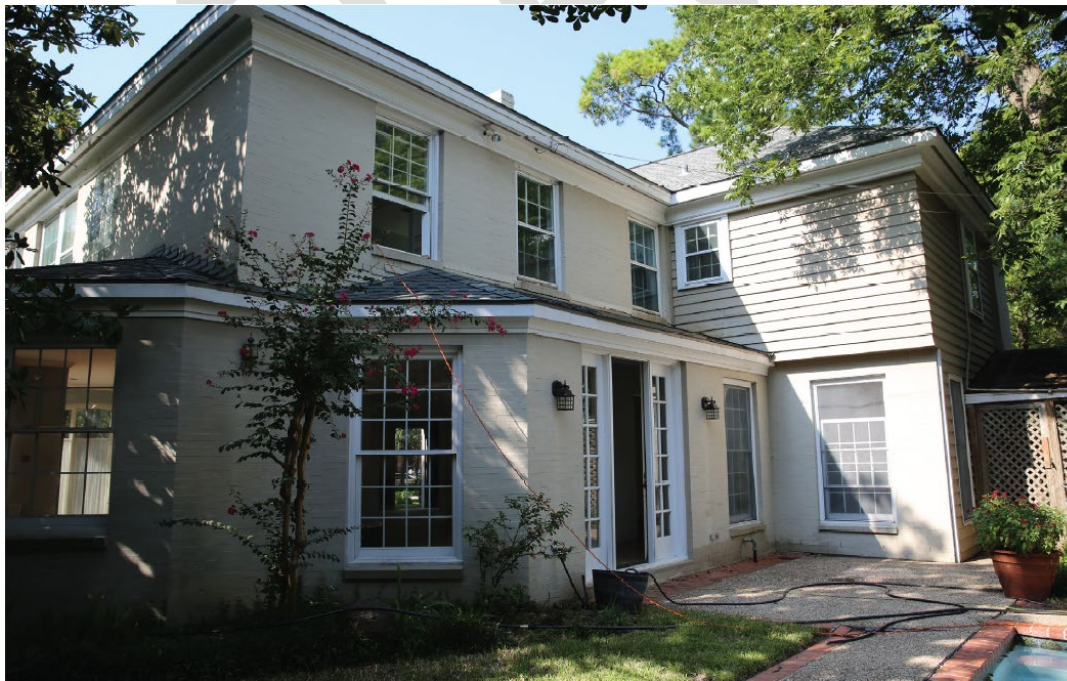
Exhibit 6: September 2022 photo of rear, N elevation of main house. View SE. Two-story addition and one-story carport (along Woodhead Street) from 1977 remodel on right. First-floor, angled addition along rear, N elevation added during a 1988 remodel. Second-floor extension also added to the rear, N elevation during 1988 remodel. Bay window along E elevation (left) also added during 1988 remodel.

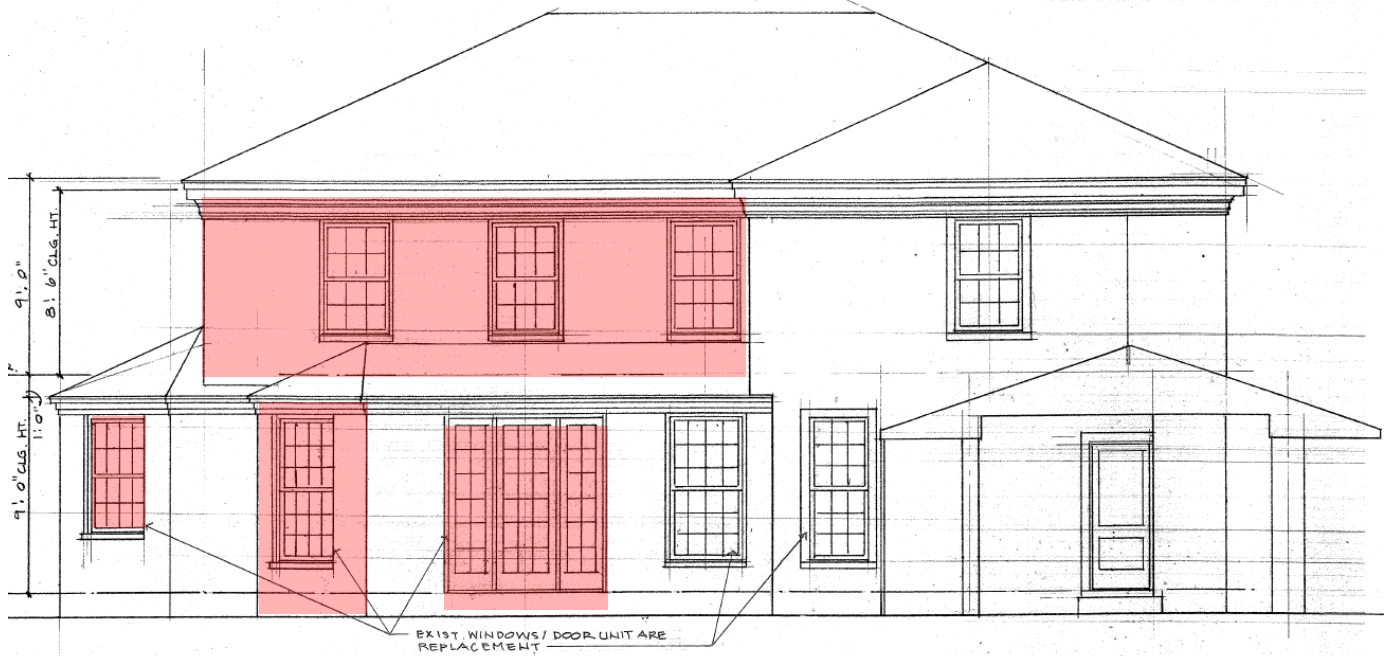
EXISTING - CROSS SECTION

SOUTH (REAR) ELEVATION

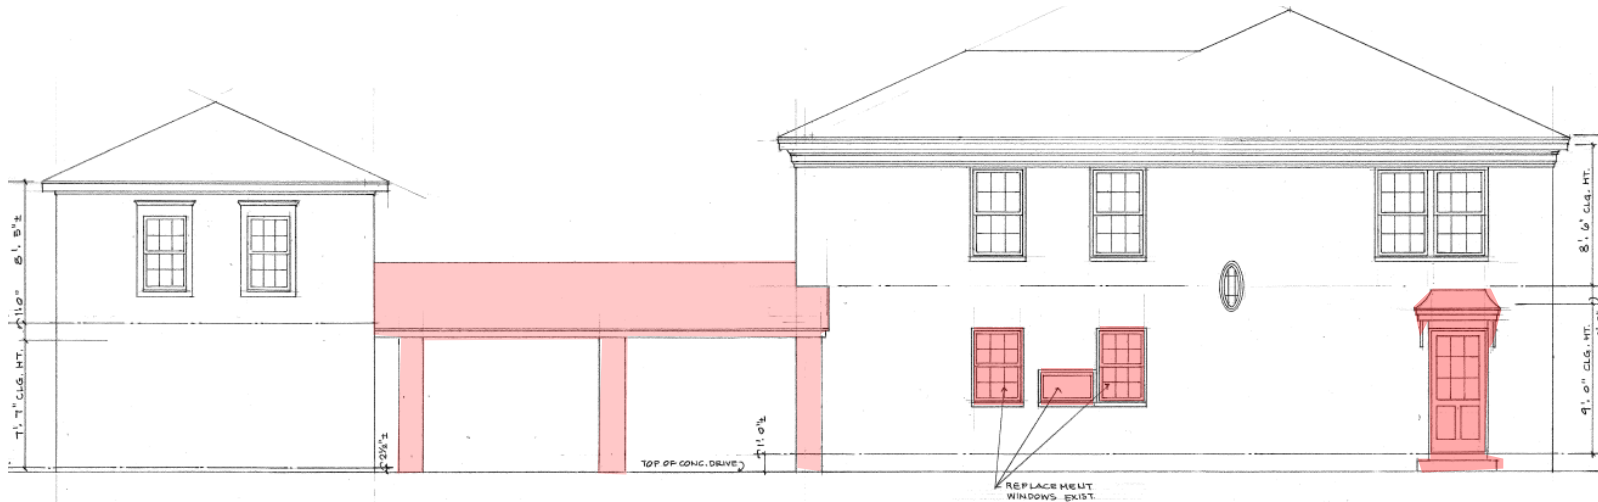
EXISTING

WEST SIDE ELEVATION – FACING WOODHEAD

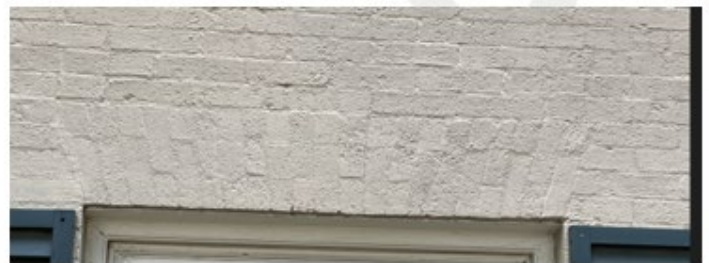
Should altered windows have matching course differentiation as the historic front façade?

Vertical Brickwork on front facade windows:

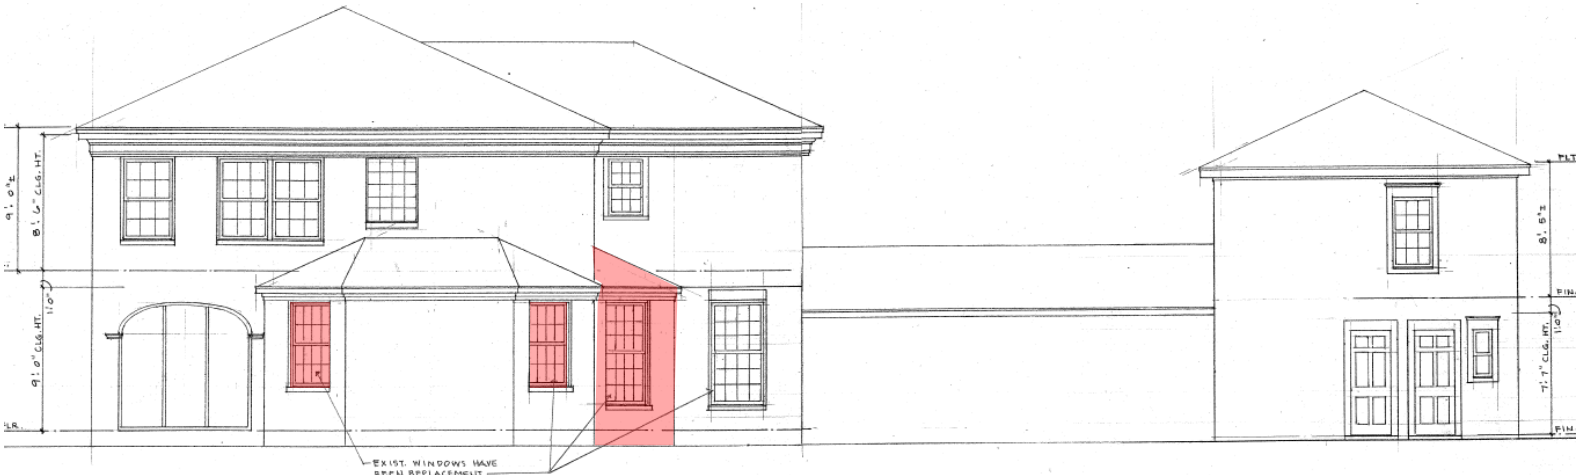
EXISTING

EAST SIDE ELEVATION

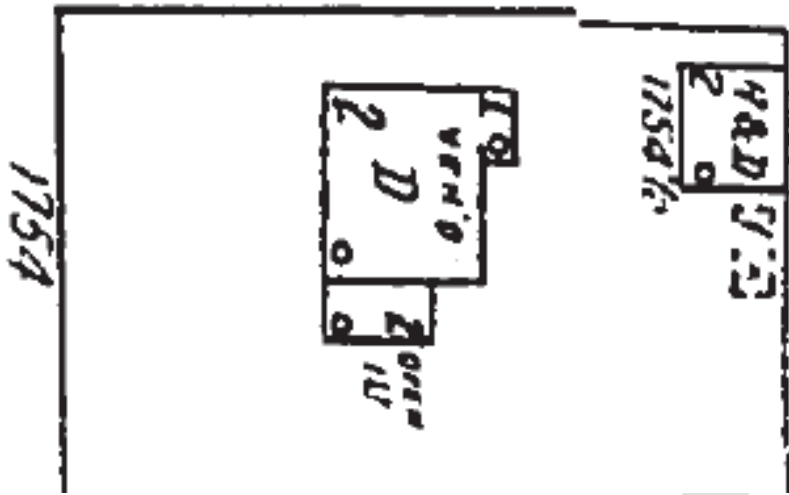
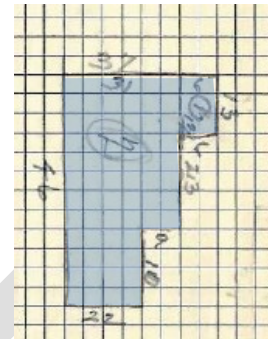
HISTORIC FOOTPRINT/SANBORNS

Archive document c. 1930

Exhibit 2: 1754 North Boulevard on the 1924-Feb 1951 Sanborn Map, vol. 5, sheet 594. Two-story main house with two-story extension on E elevation (open at first floor, likely a porch) and a one-story extension on the rear of the house to the N, along the W elevation. Separate, two-story automobile and dwelling structure in the rear, NW corner of the corner lot. All structures with asbestos shingled roofs.

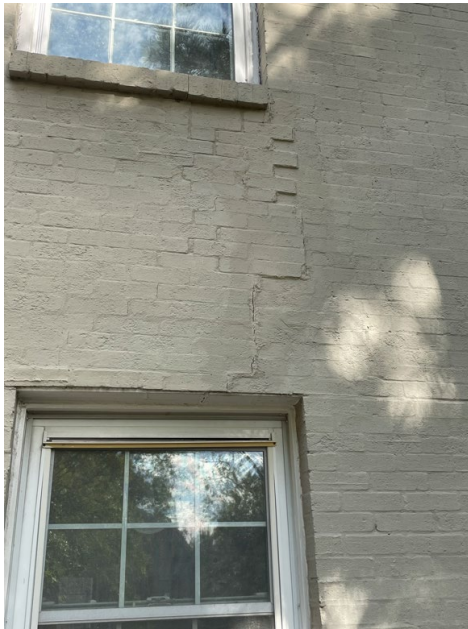
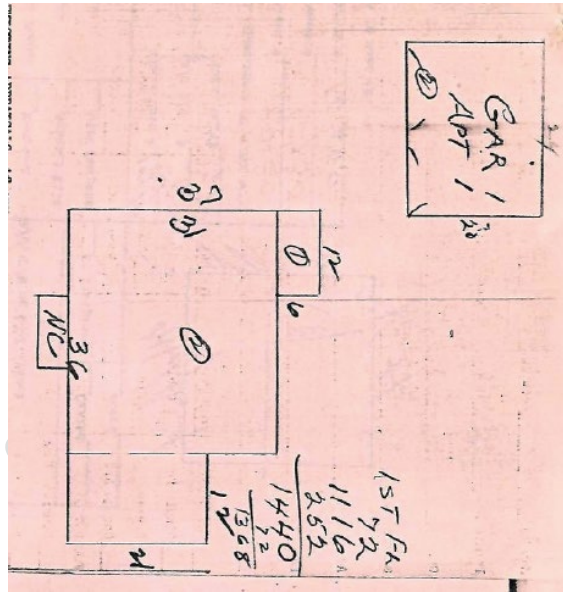
ADDITION/ALTERATIONS

Current damage located near c. 1970 addition

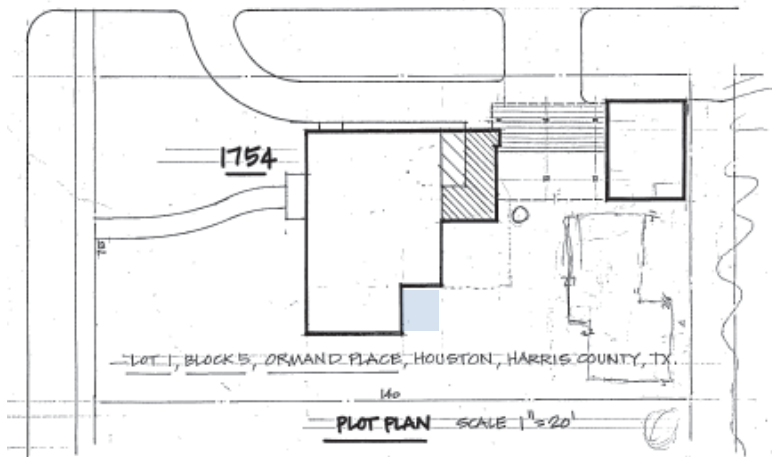
C1977 rear addition/carport

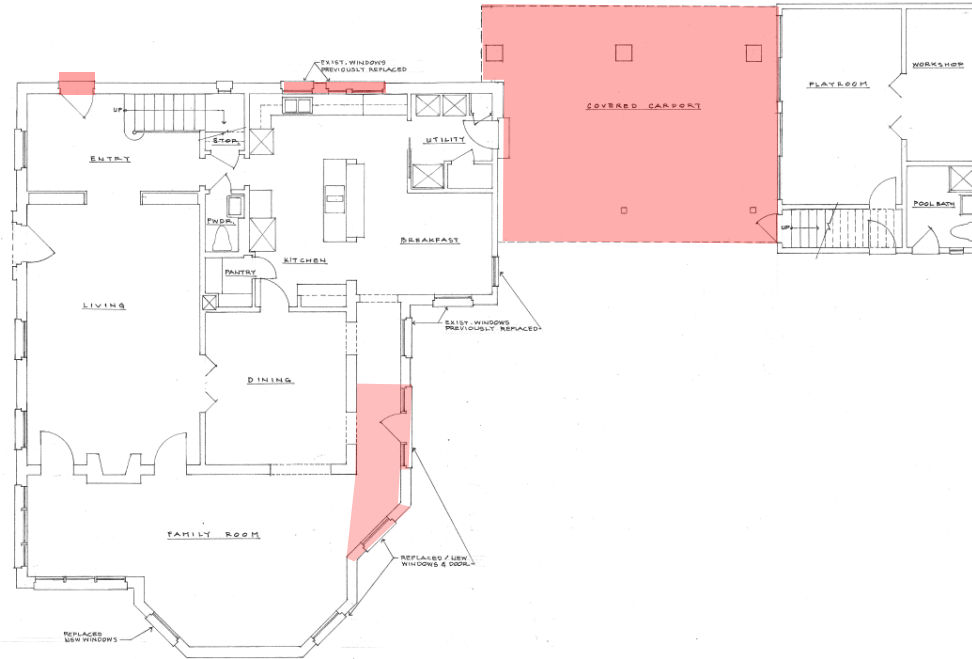
EXISTING

FIRST FLOOR PLAN

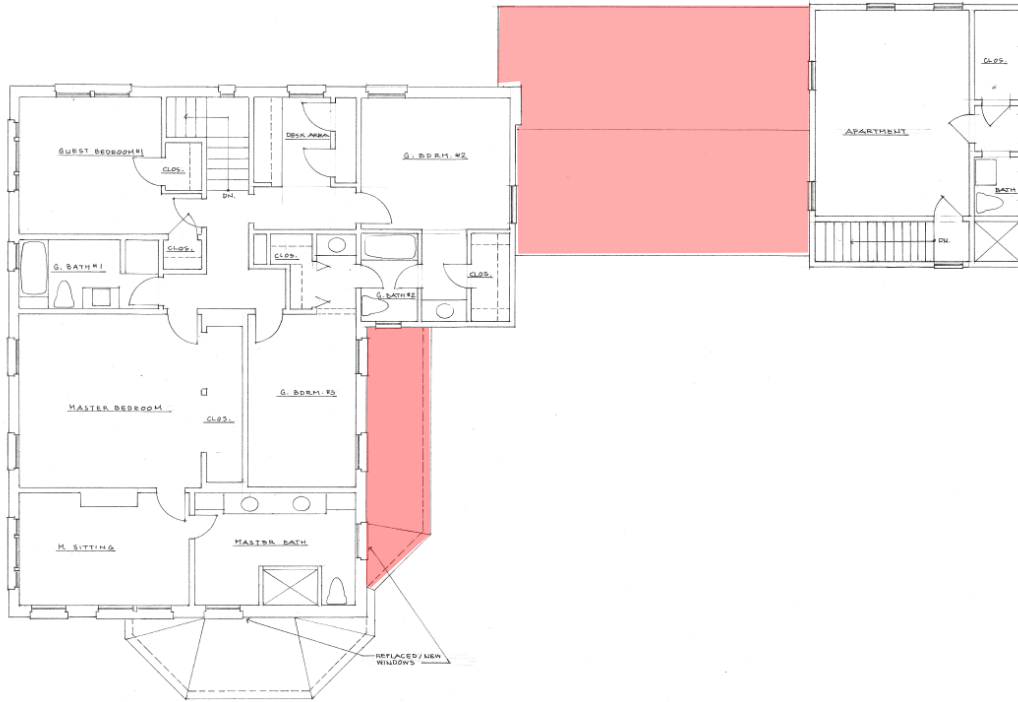
EXISTING

SECOND FLOOR PLAN

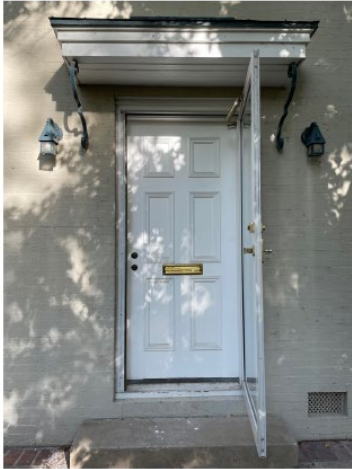
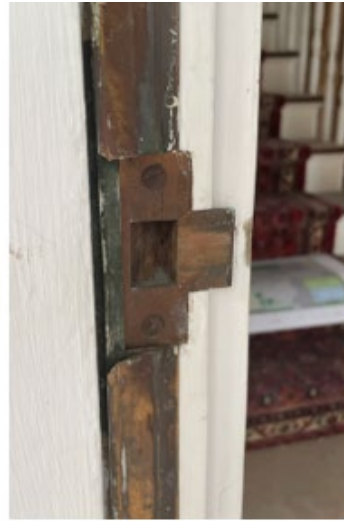
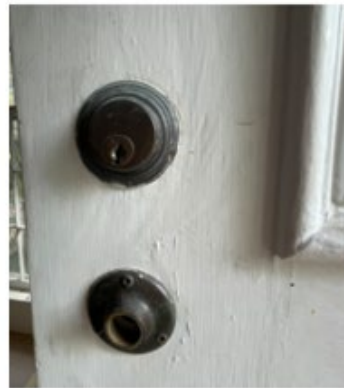
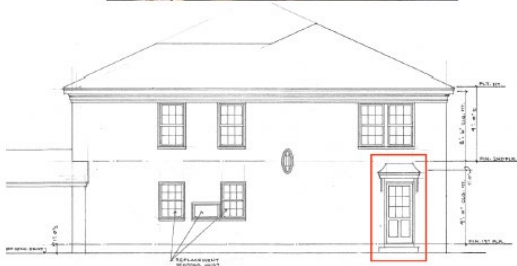
A1 – EXISTING: Non-original door on west elevation facing Woodhead Street. Likely added during 1977 renovation. Brick course above door does not match brick coursework above original windows. Door is 1.33 inches thick.

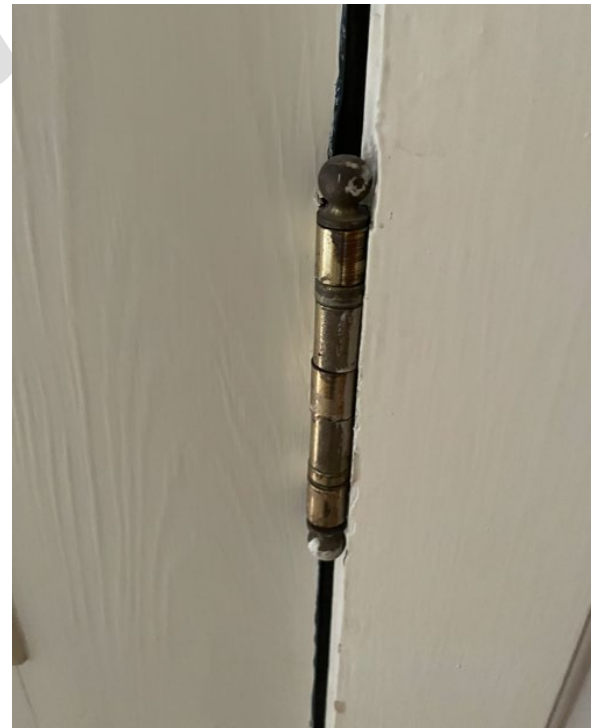
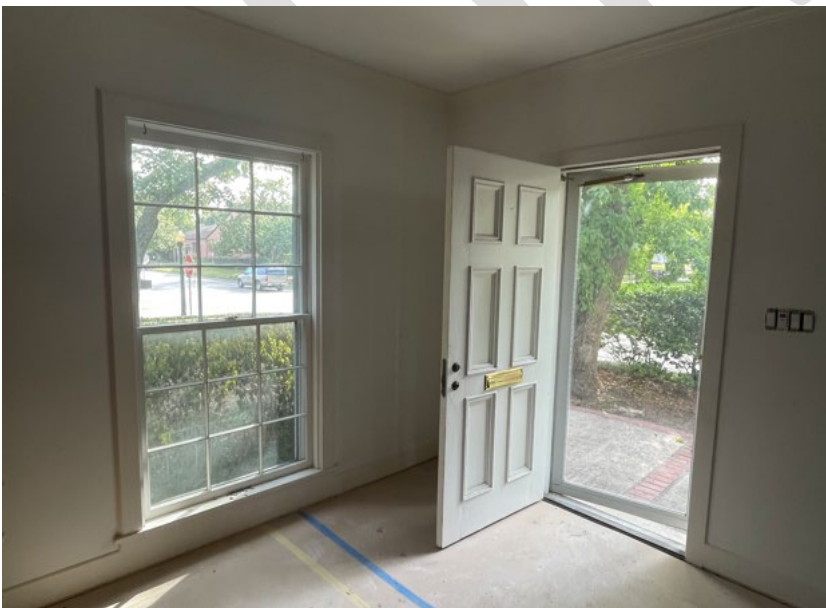
A1 – REPLACEMENT: To be replaced with new wood window made to match the original wood windows found on the front façade. The vendor is Kolbe. Specs can be found in attached PDF and dimensions can be found on the window worksheet and window schedule.

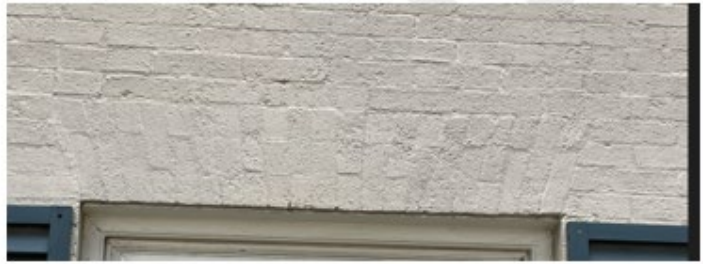
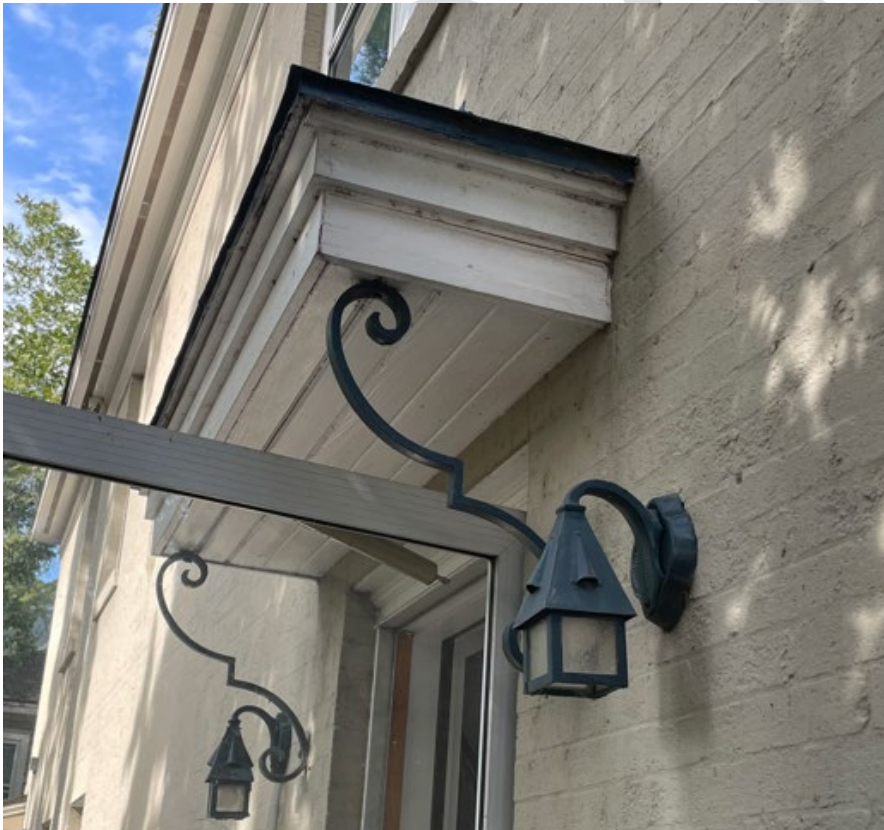
Vertical Brickwork on front facade windows:

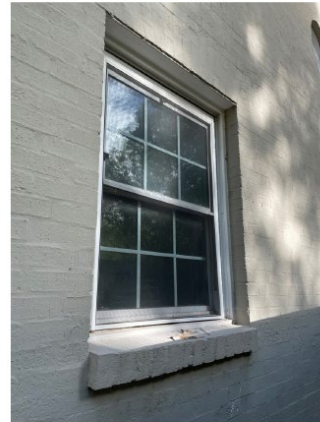
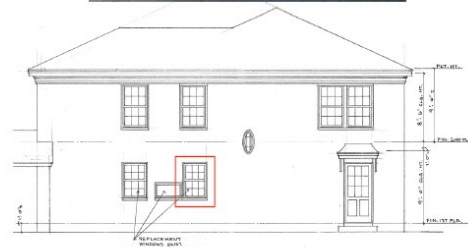
D1 - EXISTING: Non-original window on west elevation facing Woodhead Street. Added during 1977 renovation of kitchen.

D1 - REPLACEMENT: To be replaced with new wood window made to match the original wood windows found on the front façade. The vendor is Kolbe. Specs can be found in attached PDF and dimensions can be found on the window worksheet and window schedule.

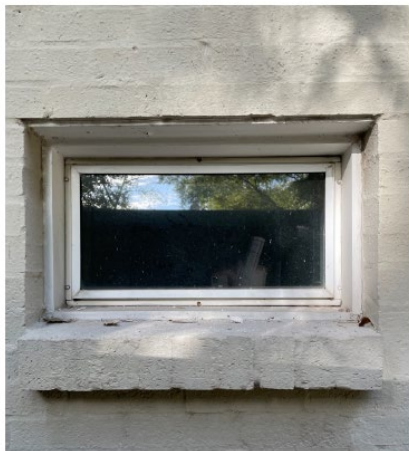
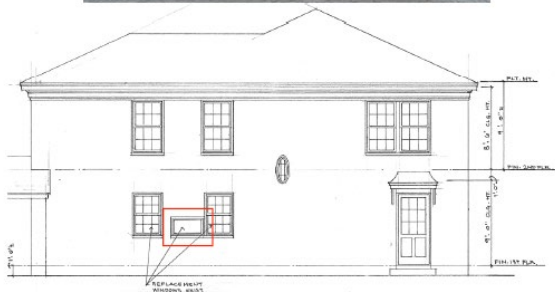
G1 - EXISTING: Non-original window on west elevation facing Woodhead Street. Added during 1977 renovation of kitchen.

G1 - REPLACEMENT: Window only to be removed - no replacement.

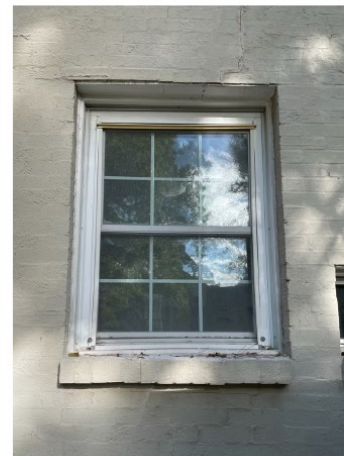
D2 - EXISTING: Non-original window on west elevation facing Woodhead Street. Added during 1977 renovation of kitchen.

D2 - REPLACEMENT: To be replaced with new wood window made to match the original wood windows found on the front façade. The vendor is Kolbe. Specs can be found in attached PDF and dimensions can be found on the window worksheet and window schedule.

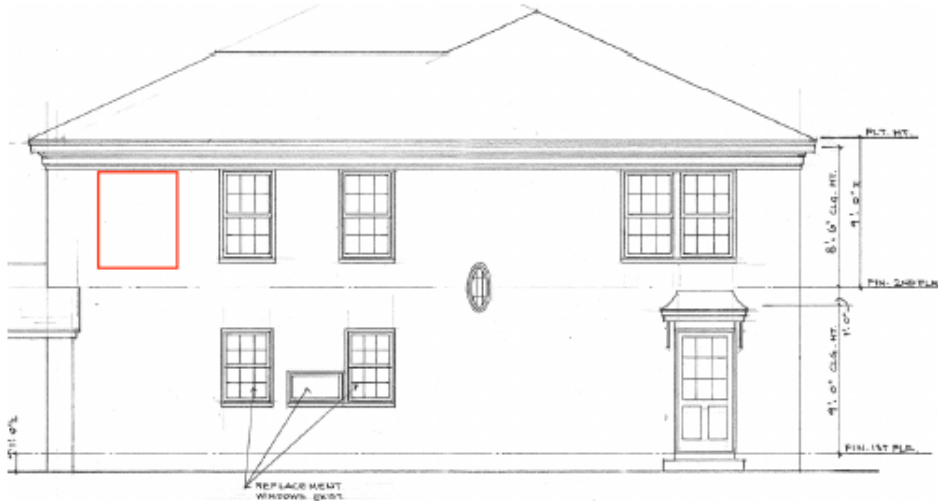
E1 - EXISTING: Window inserted into the non-original portion of second story. This portion of the house was added in 1977.

E1 - REPLACEMENT: If possible, the window inserted into this new window opening will be an original wood window salvaged from a rear elevation (not visible from the street). The rear elevation is to be altered (expanded) therefore the window can be removed and placed in this new location. The window will be the same dimensions as the other original windows on this west elevation on the second story.

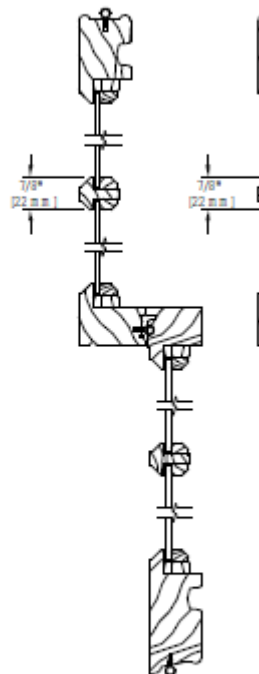
KOLBE HERITAGE SERIES TRUE DIVIDED LITE
WINDOWS & DOORS SINGLE AND DOUBLE TRUE DIVIDED LITE

7/8" BEVELED TOL
SINGLE PANE GLASS

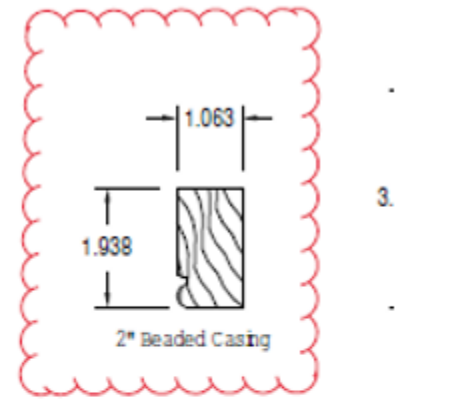
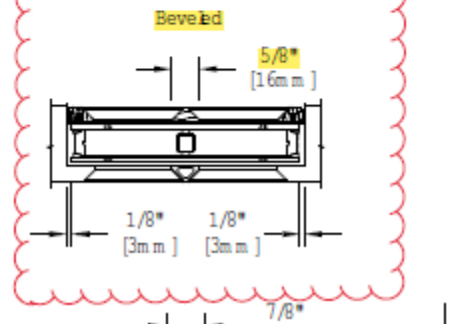
KOLBE HERITAGE SERIES PERFORMANCE DIVIDED LITE
WINDOWS & DOORS DOUBLE PANE GLASS
