**CERTIFICATE OF APPROPRIATENESS**

**Property:** 536 Granberry St, Lot 6, Block 2, Freeland Subdivision. The property includes a historic 1,000 square foot, one-story wood frame single-family residence and a detached three-story garage apartment situated on an 11,900 square foot (50' x 293') interior lot.

**Proposal:** Relocation – Residence

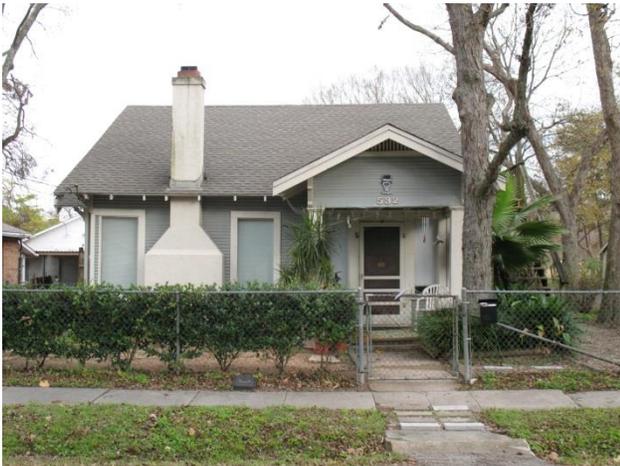
532 Granberry – Contributing – 1925 (neighboring)  
North setback: 2'-6" South setback: 10'-2"

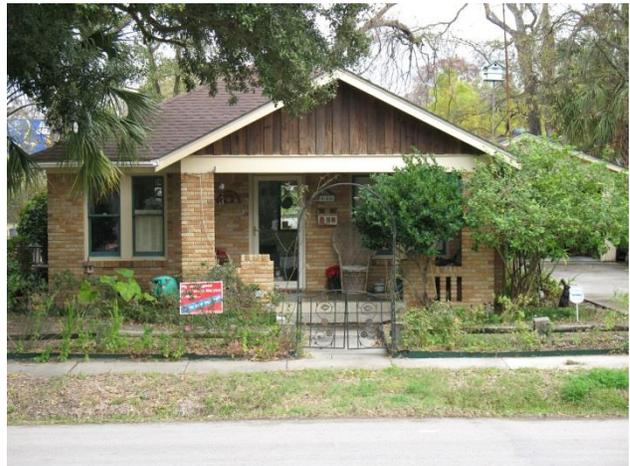
546 Granberry – Contributing – 1931 (neighboring)  
South setback: ≈11'

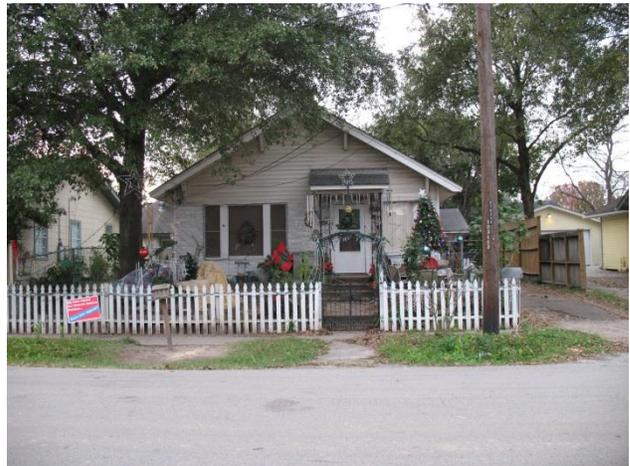
531 Granberry – Contributing – 1925 (across street)  
North setback: 15'-2" South setback: 8'-7"

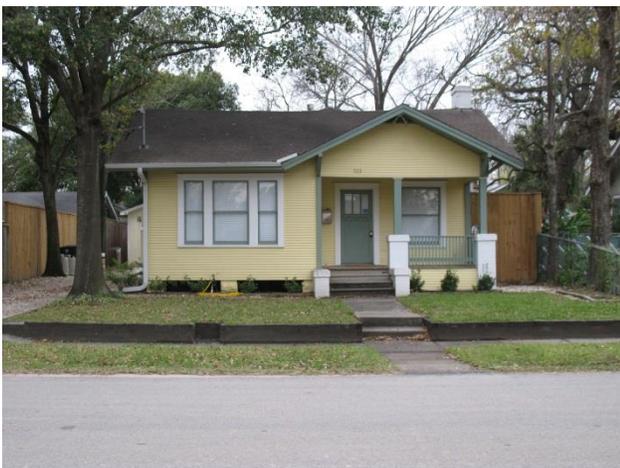
533 Granberry – Contributing – 1925 (across street)  
South setback: 16'-2"

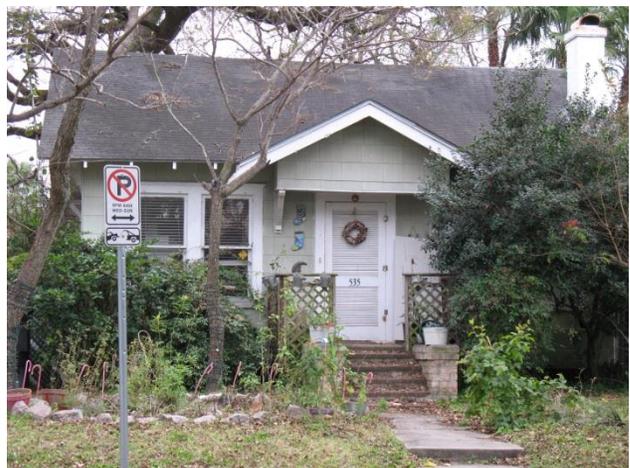
535 Granberry – Contributing – 1922 (across street)  
North setback: 3'-9" South setback: 20'

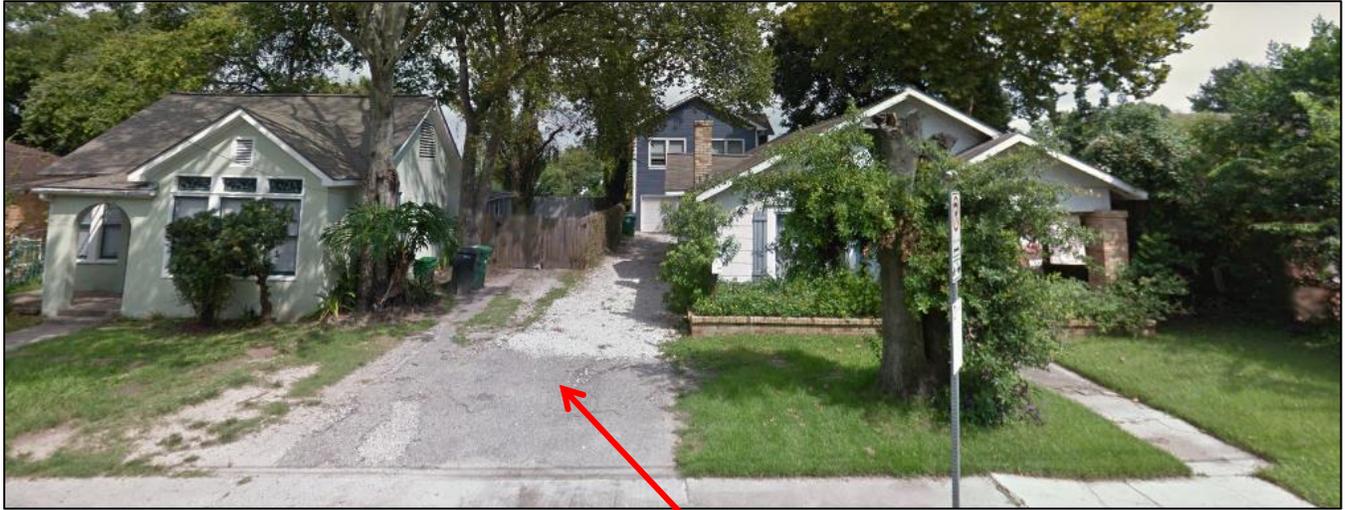
**STREET VIEW**

Existing driveway shared  
with neighbor to the north

The neighbor's fence is 2' north of the north (side) property line which allows access to 536 Granberry's rear garage via a shared driveway. If the neighbor to the north were to reclaim the 2' of their property and close the shared driveway, 536 Granberry would not have enough space to access their garage, which is 6" from the north property line. The applicant proposes to shift the structure 6'-6" to the south to allow for permanent access to the garage.
