**CERTIFICATE OF APPROPRIATENESS**

**Property:** 1810 Kane St, Lot 6, Block 443, Baker W R NSBB Subdivision. The property includes a historic 1,400 square foot, one-story wood frame single-family residence situated on a 5,000 square foot (50' x 100') interior lot.

**Proposal:** Alteration – Replace the existing tapered porch columns with new tapered porch columns and remove a porch header.

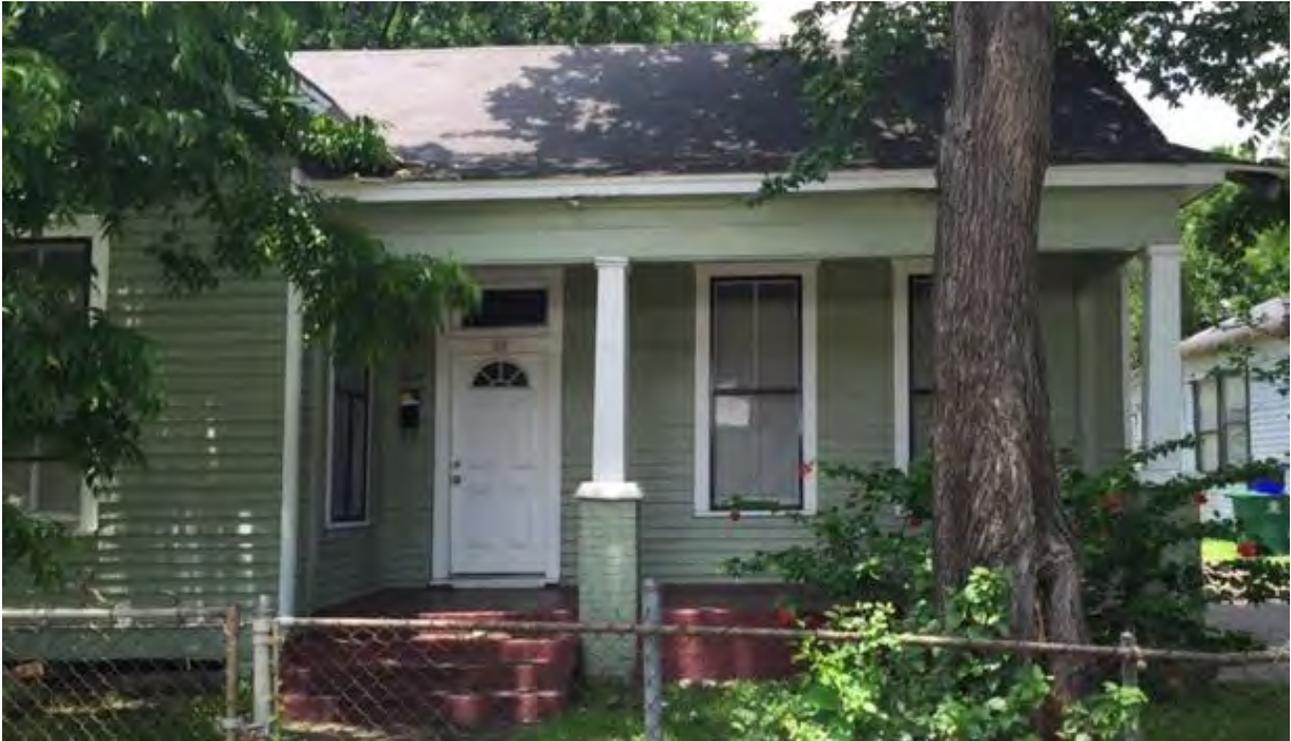
**PHOTO AFTER WORK COMPLETED JULY 2015 PHOTO**

The applicant reframed the porch roof, removed a header and replaced the tapered columns without a COA or permits.

**Front Elevation:** The elevation contained two brick piers with plywood tapered columns. The applicant removed a porch header and the tapered columns and installed thinner and taller fibrous board columns with a wood-grain finish.  
**(South)**

**Recommendation:** **Approval with conditions: Reinstall the missing header above the porch and install turned columns to match the existing engaged columns.**

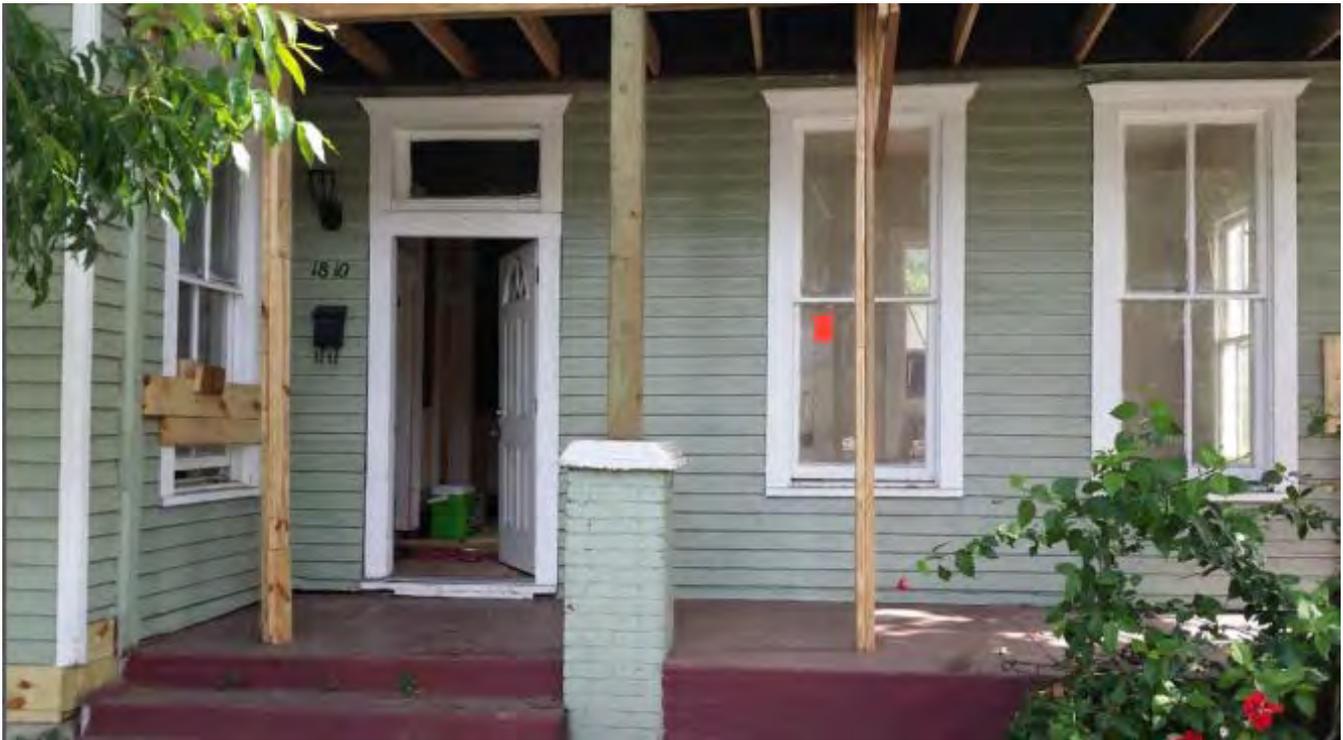
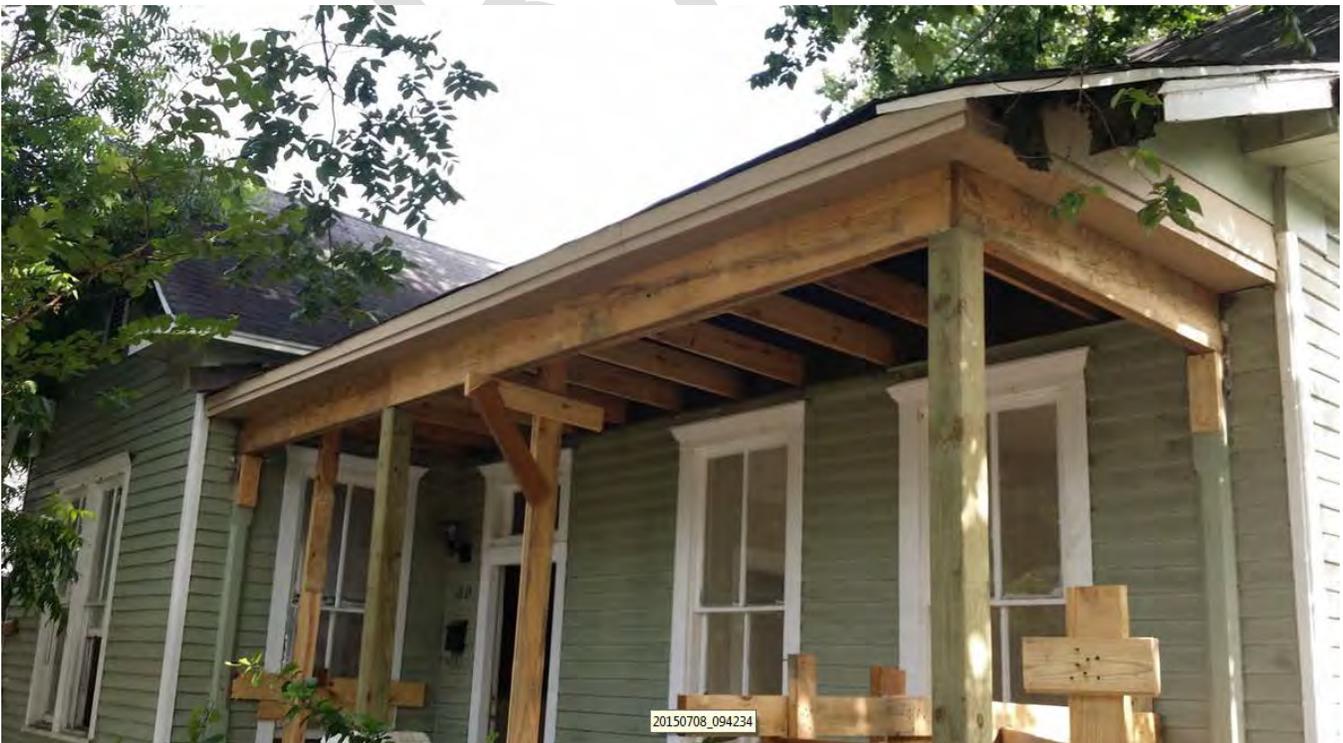
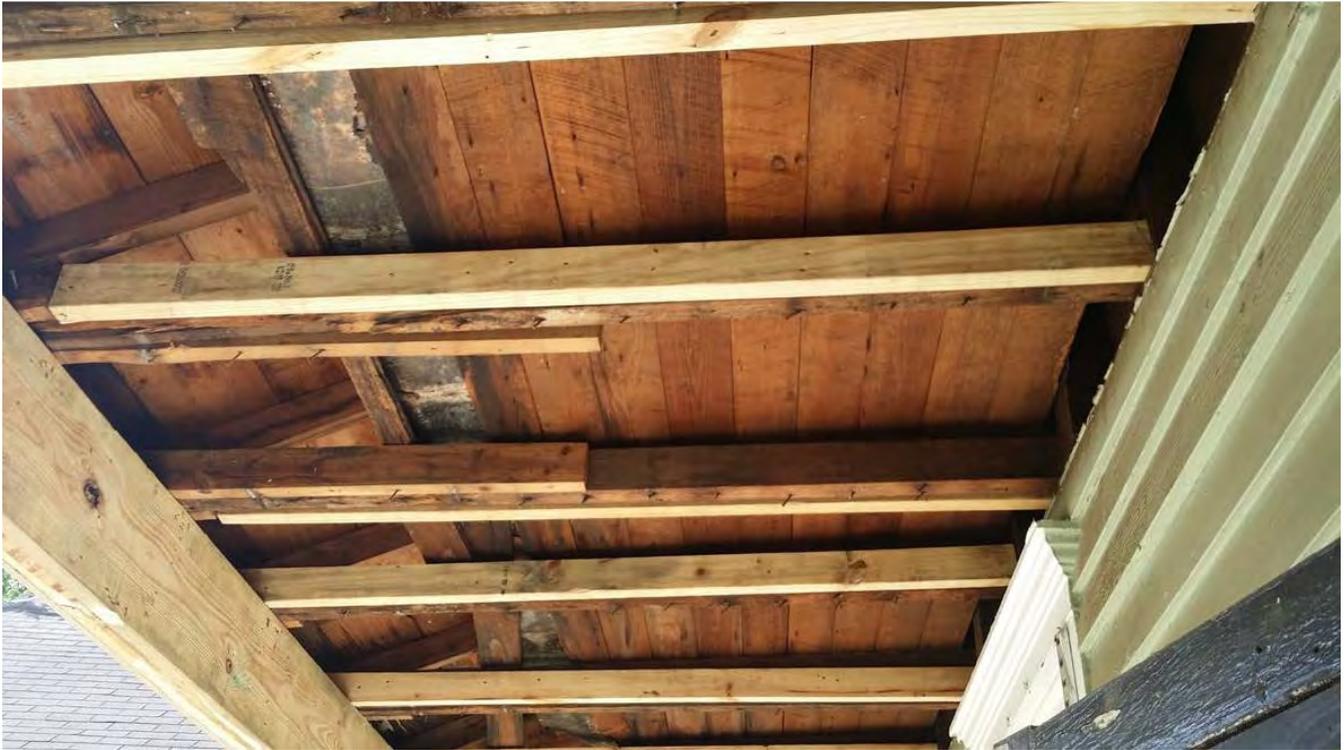
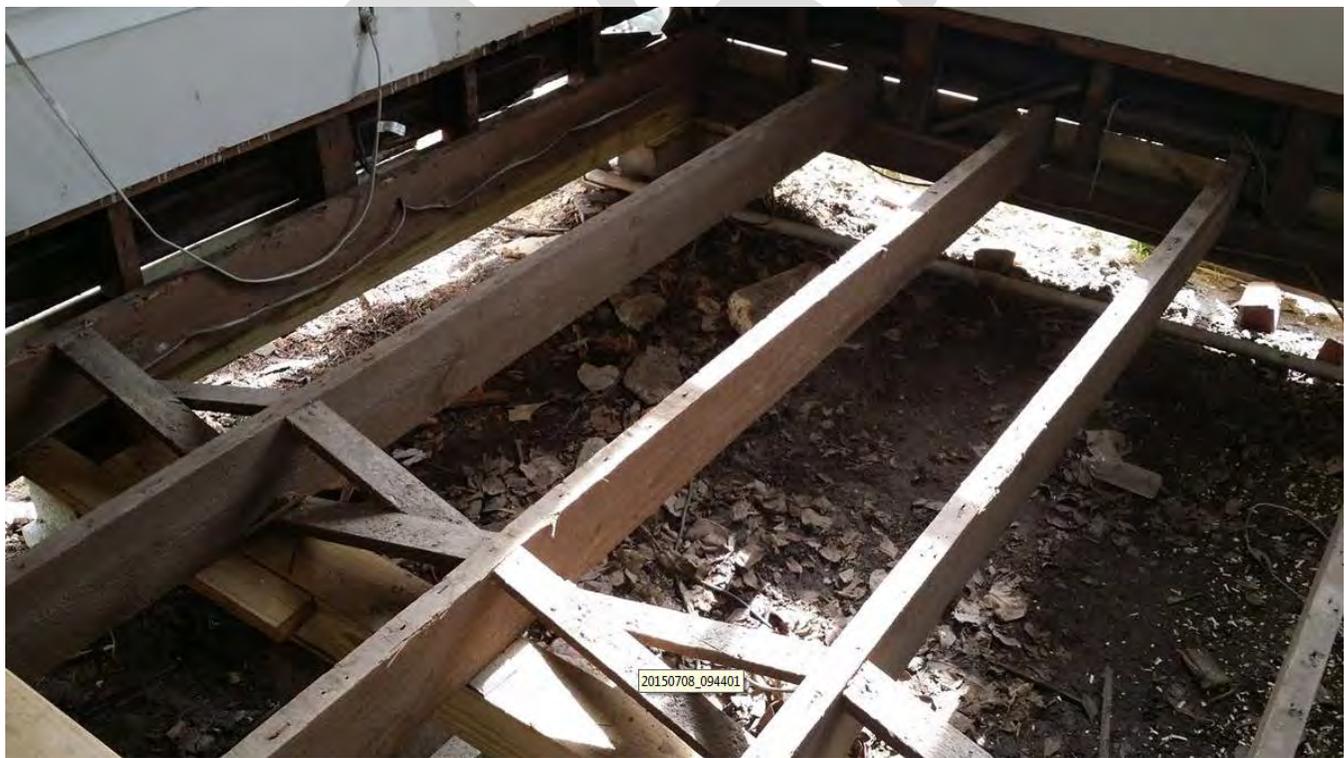
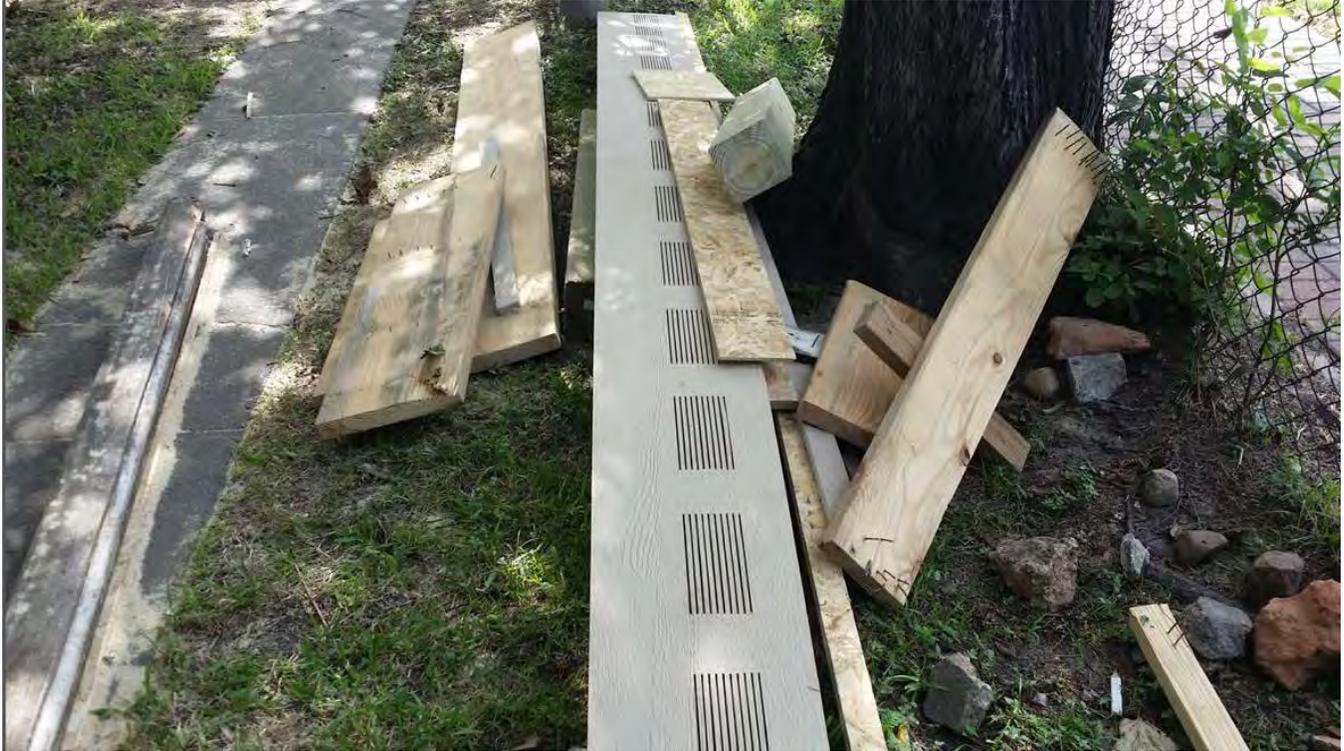
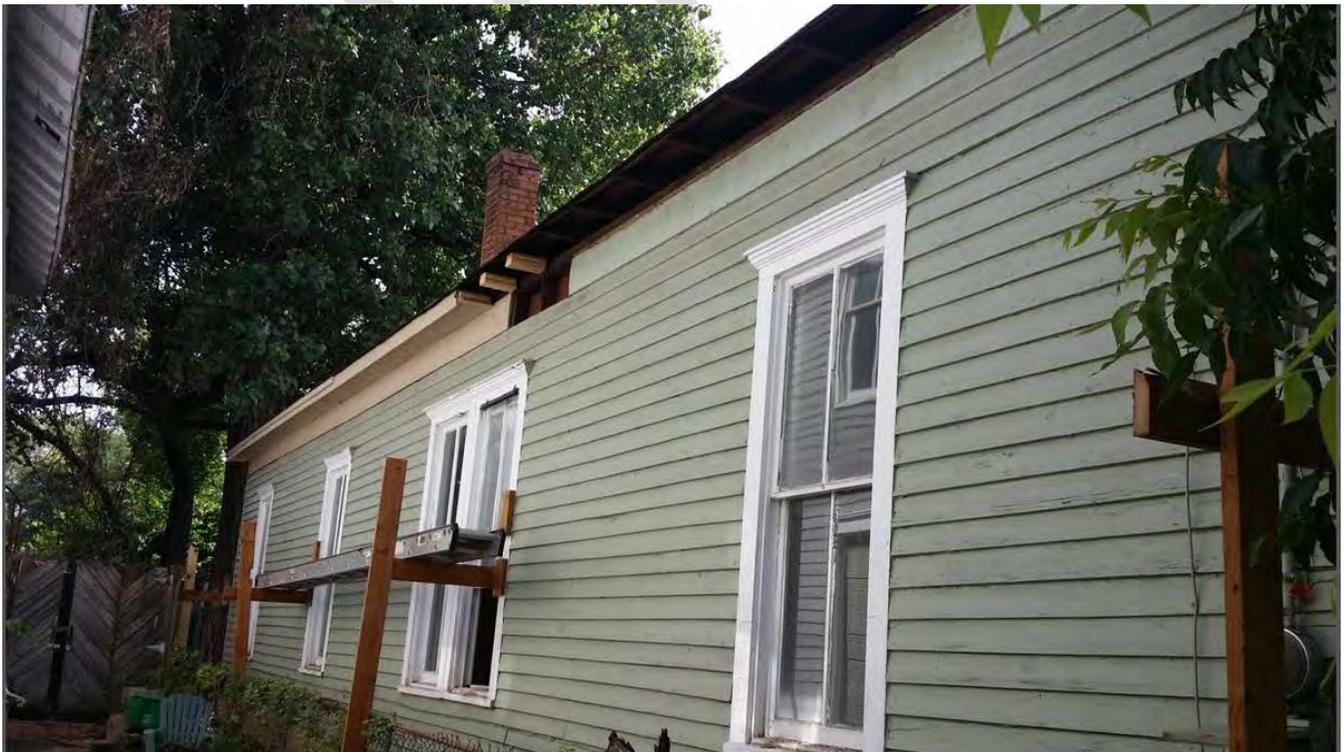
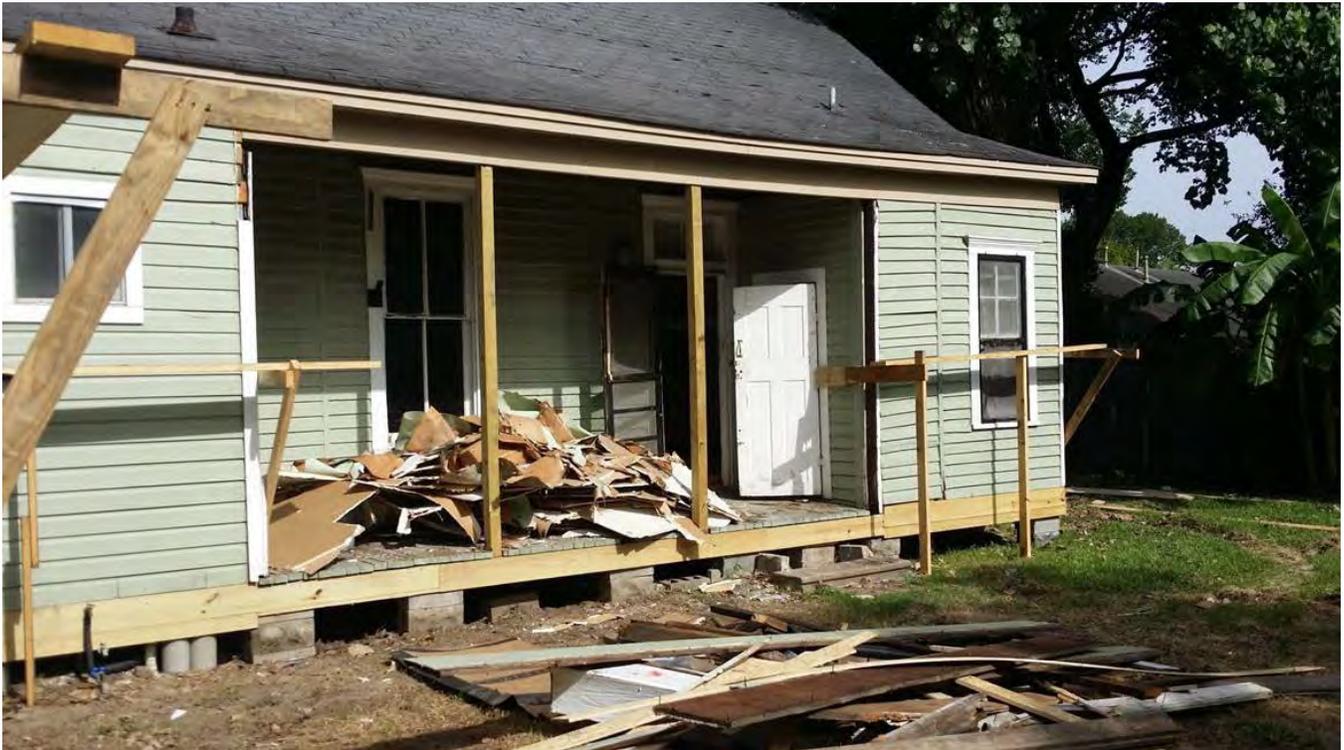
PHOTOS FROM INSPECTOR 7/8/2015

The applicant received a red tag to stop all unpermitted work on 7/8/2015 and is proposing to install tapered columns that are taller than the ones that were removed using a wood-grain finish fibrous board.

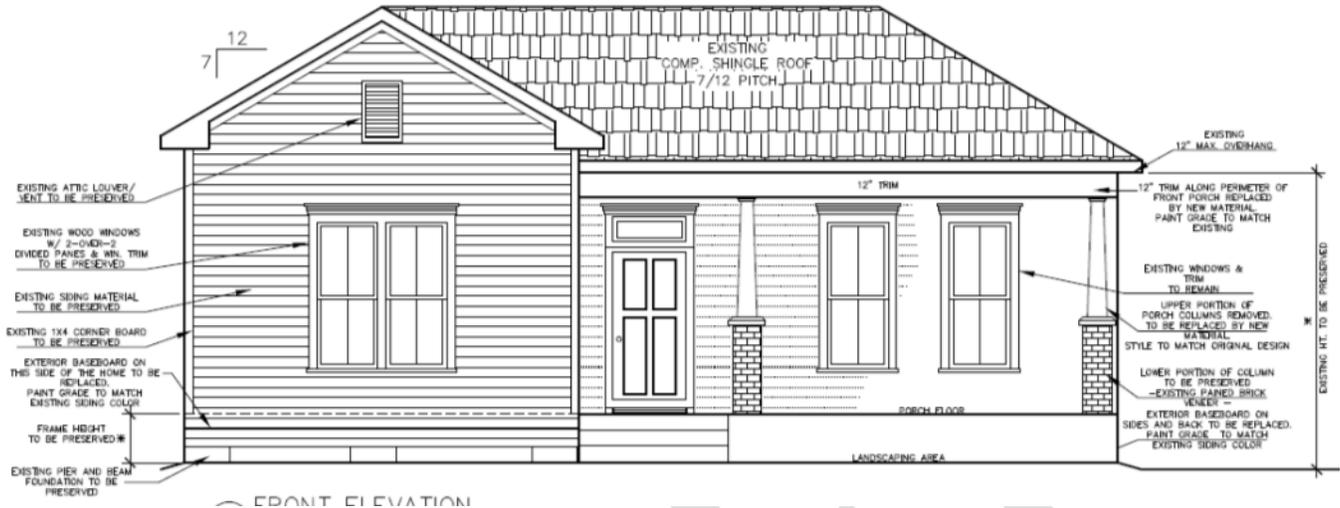
**SOUTH ELEVATION – FRONT FACING KANE STREET**

**PROPOSED**

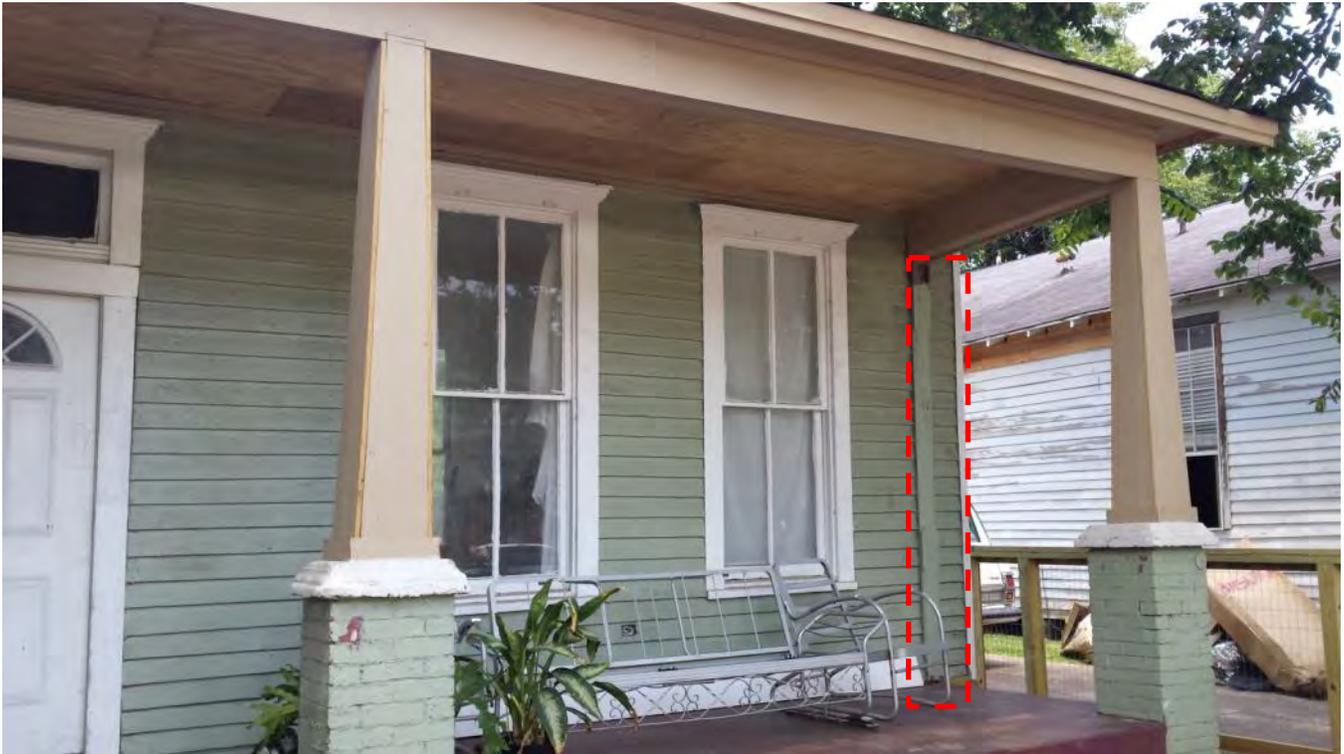
STAFF PHOTOS

EXISTING ENGAGED COLUMN
