CERTIFICATE OF APPROPRIATENESS

Property: 1120 East 14th, per HCAD legally described as, LT 5, BLK 118, North Norhill, the property has a 1,064 SF house on a 5,200 SF lot

Significance: Contributing circa 1926 Bungalow in the Norhill Historic District

Proposal: Demolition – Applicant proposes to demolish the house

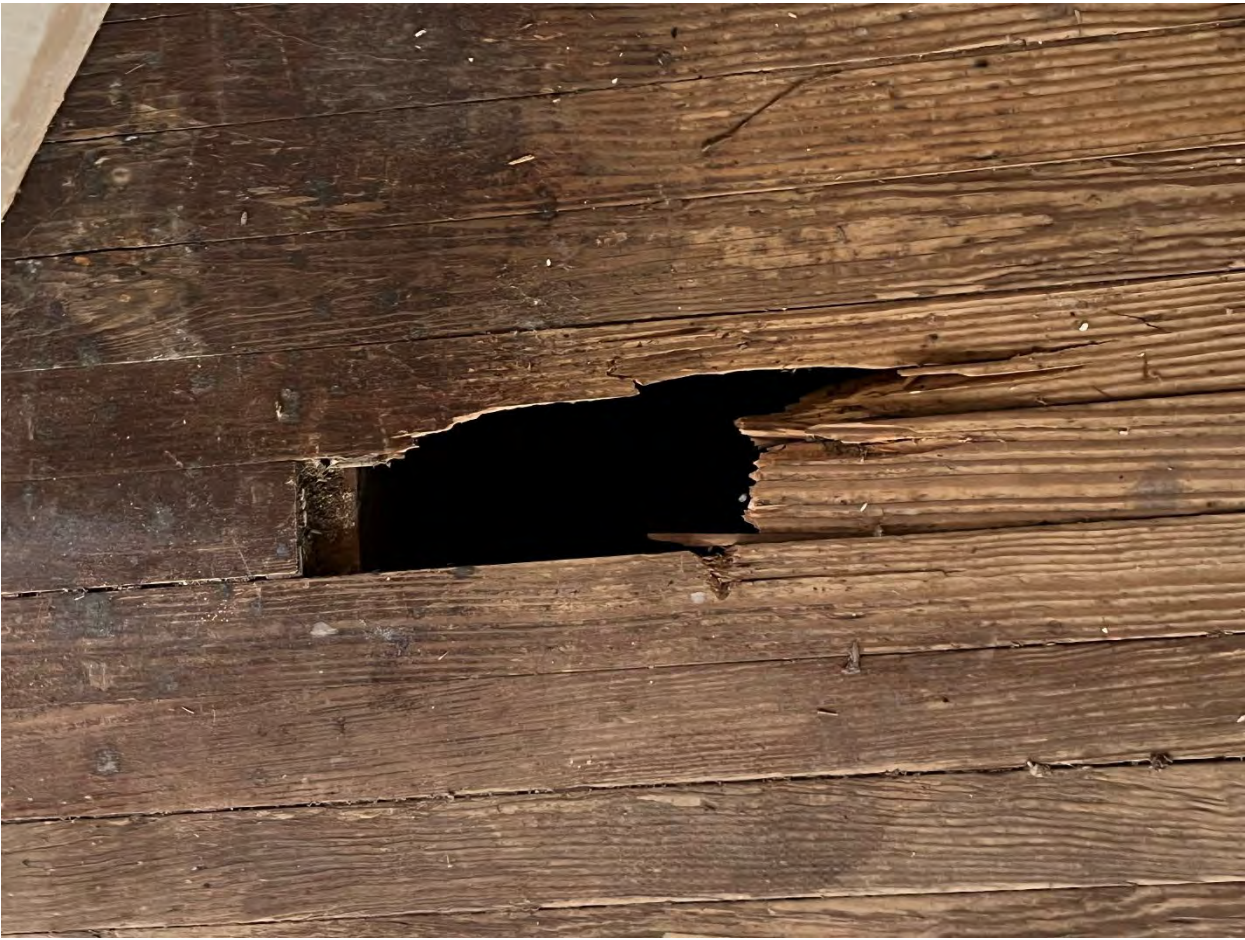
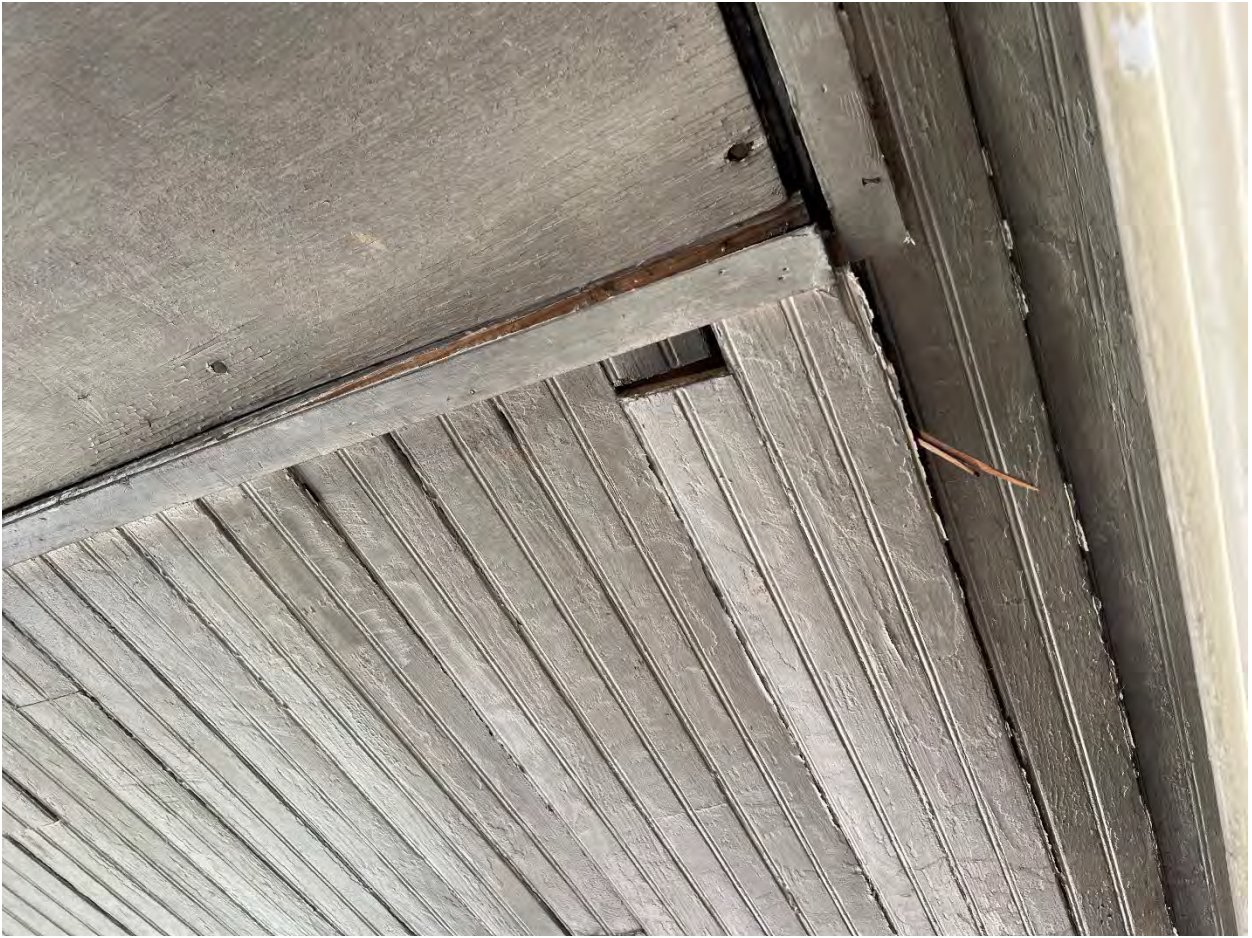
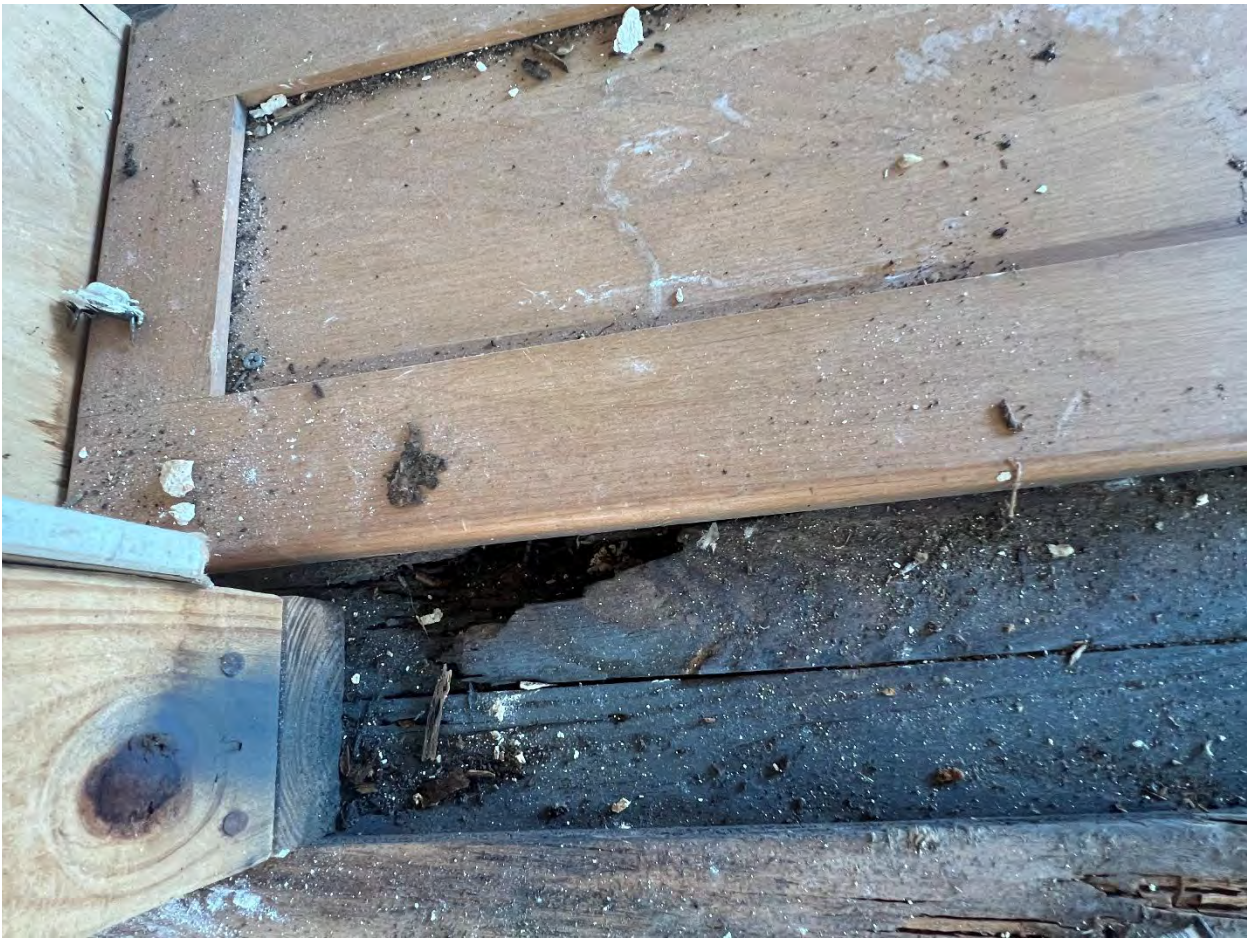
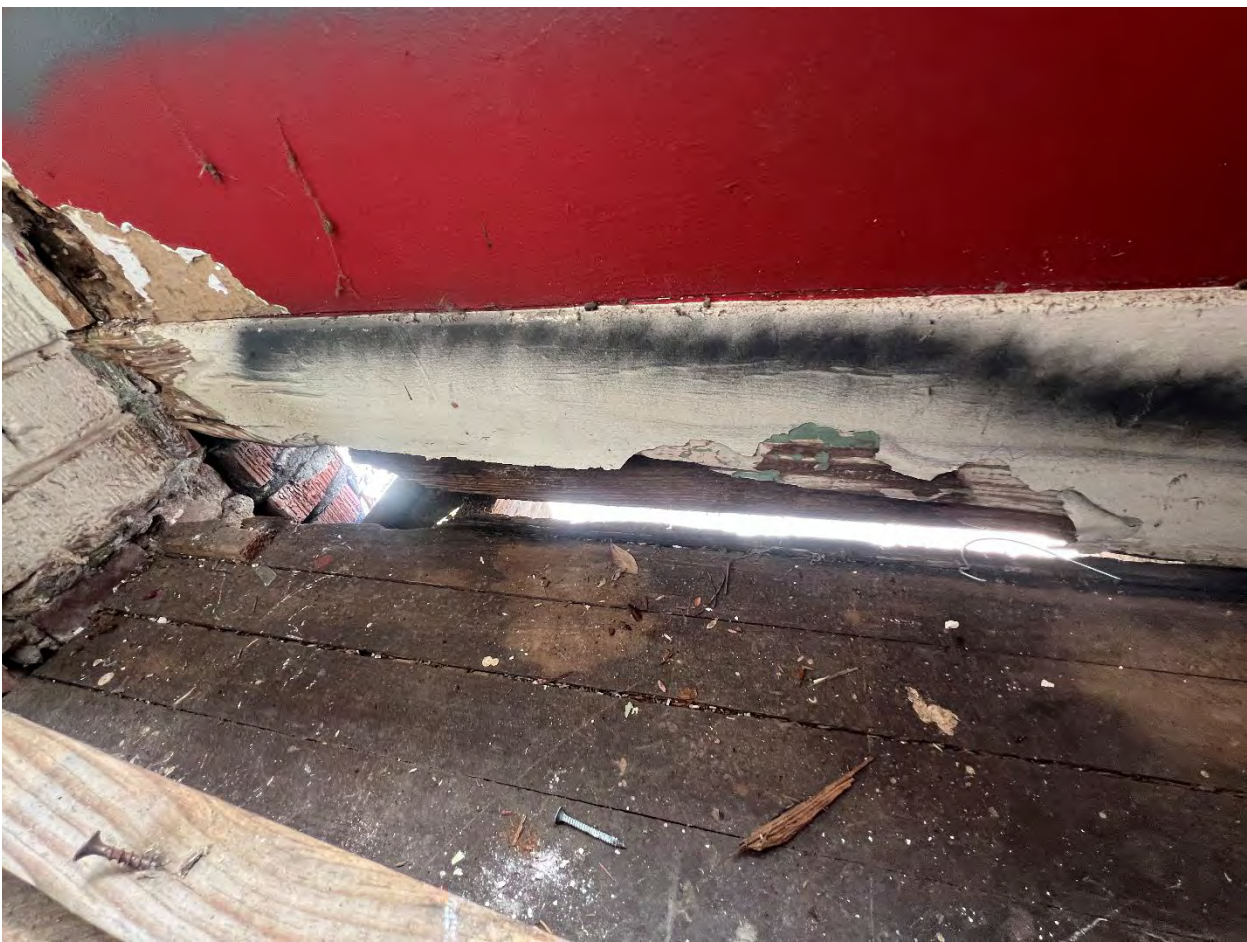
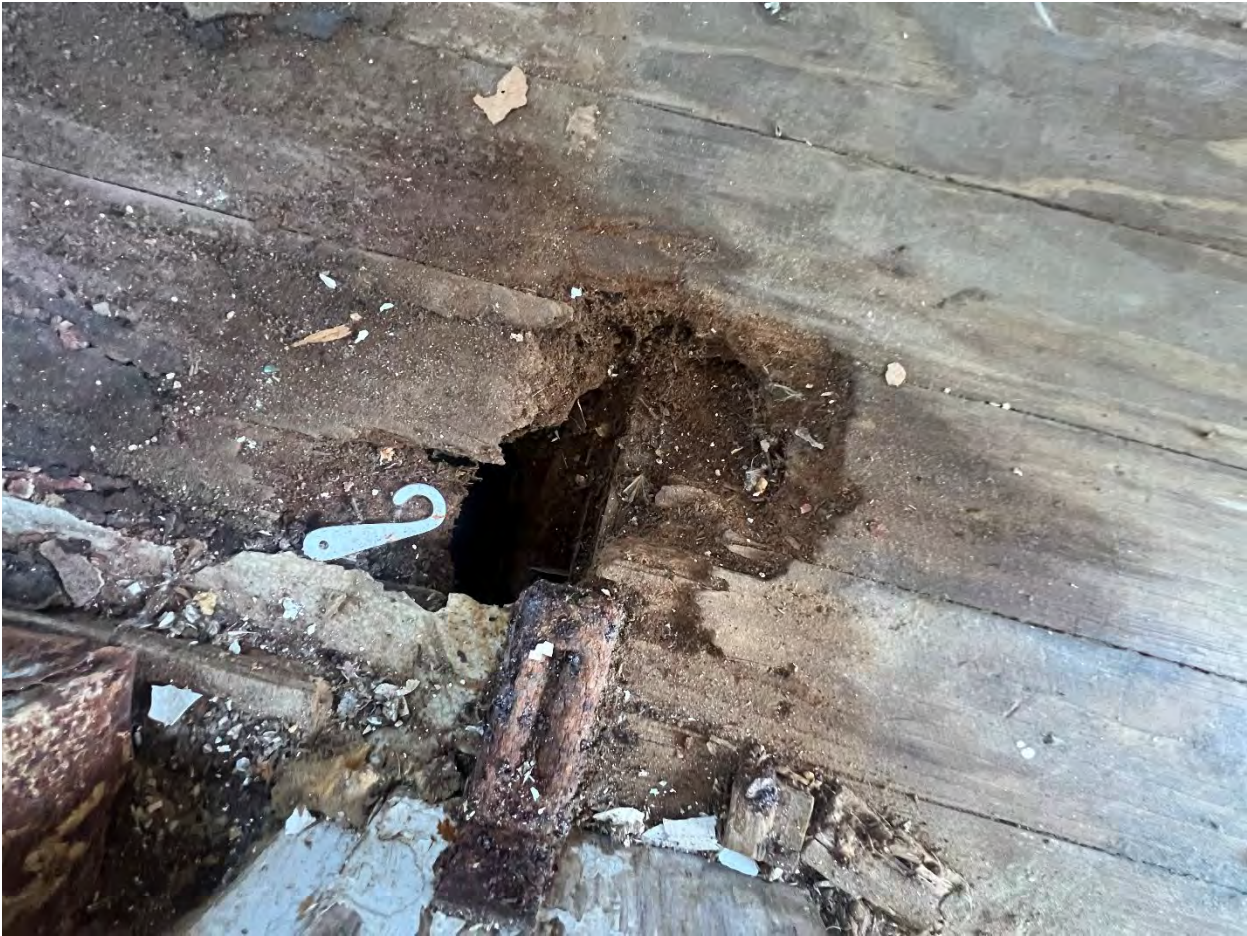
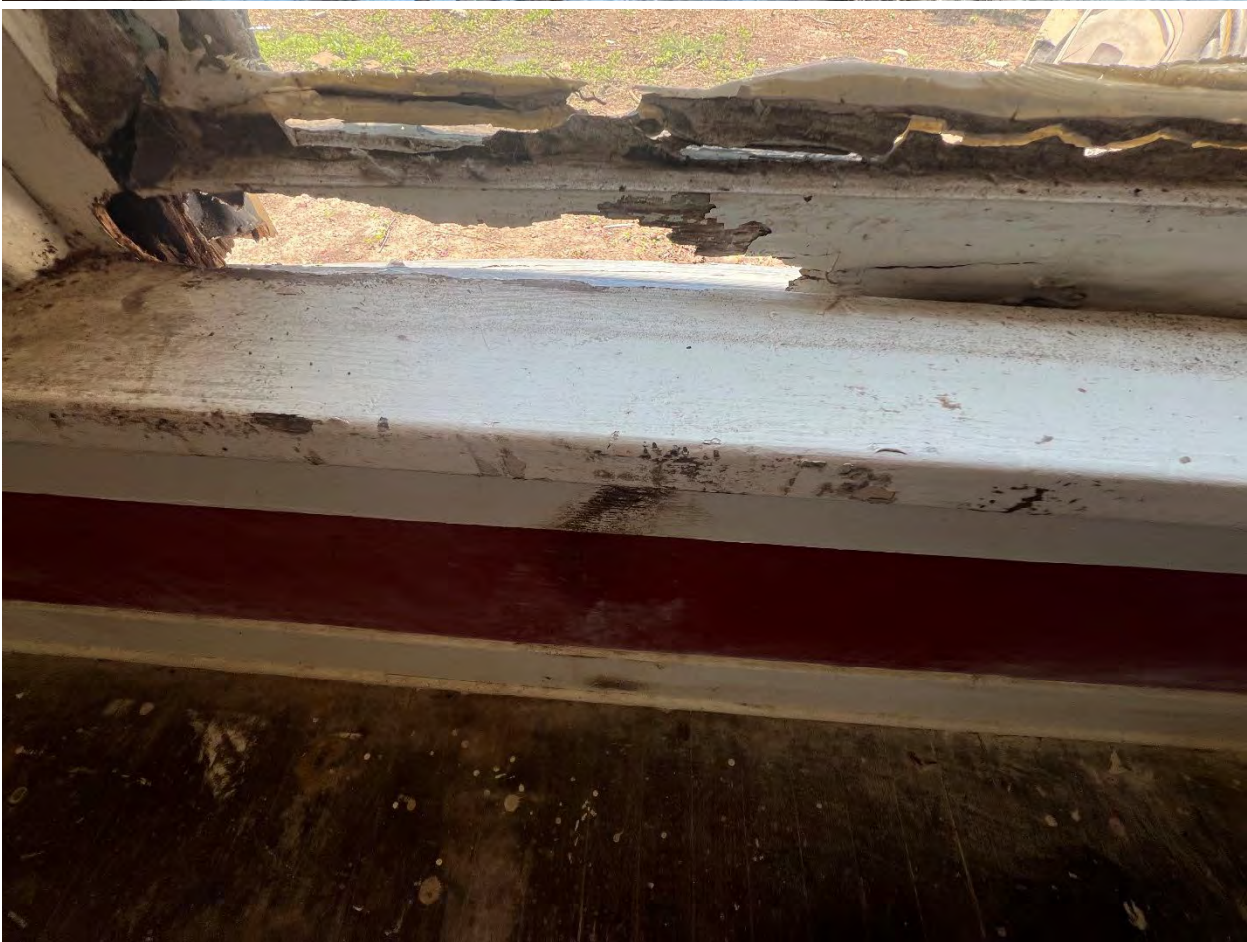
Decay photos from Applicant

Much of the exterior siding, on all elevations, has rotted away allowing rain water to enter the structural wall framing (the 2X4 stud framing) of the exterior walls. This has led to the studs rotting away at the bottom plate. The house has a wooden floor joists framing system, and the wooden plates atop the exterior brick foundation walls have also rotted away in numerous places - because of the exterior siding damage. The wooden floor joists show signs of distress - causing the floor to flex under load in several locations. The back porch is almost falling off.

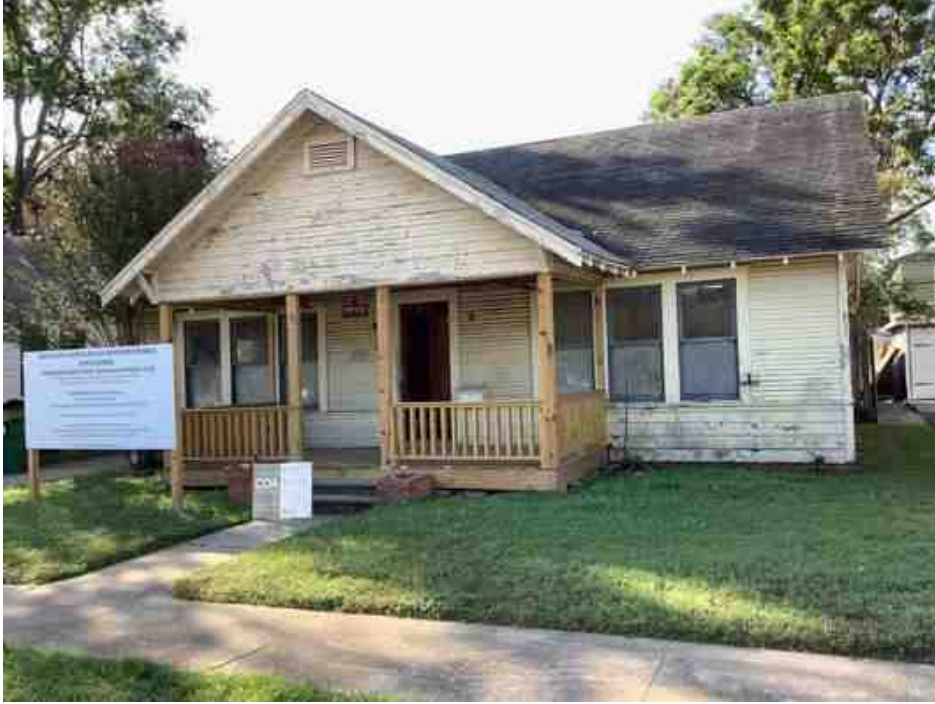
Subject Front

Describe the condition of the property (including needed repairs, deterioration, renovations, remodeling, etc.). C6;No updates in the prior 15 years;Upon inspection, the subject was found to be in poor condition and uninhabitable. There are multiple structural defeiciens found as well mechanical deficiencies. The roof also needs to be replaced along with all windows and much of the siding, flooring and interior walls. Due to the subject's condition, the improvements do not contribute value. See photos.

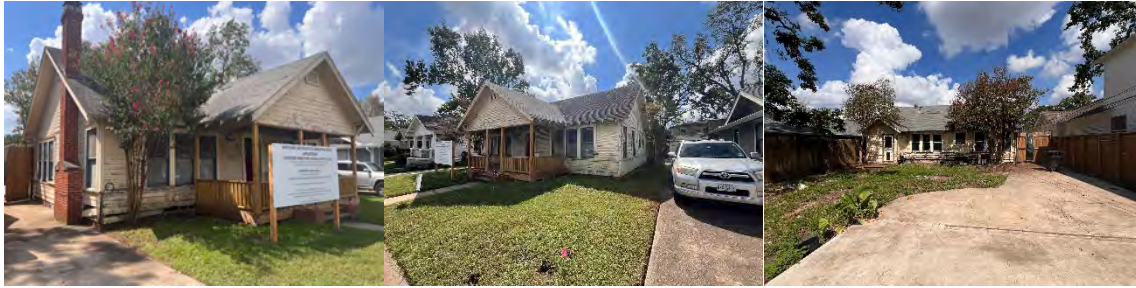
Subject Property front and back yard view.

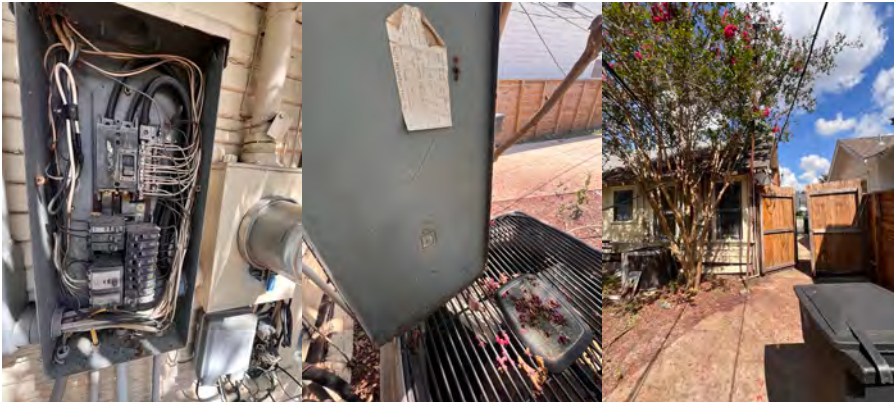
The subject property includes the electrical panel, service lines, and condition of breakers.

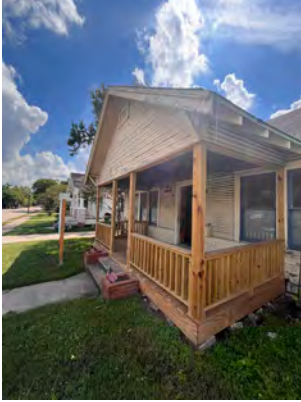
The front porch of the subject property.

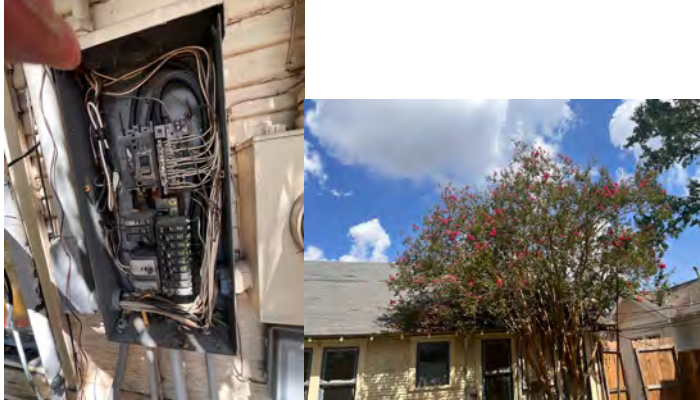
The current electrical panel box and service line pose a risk of fire or injury.

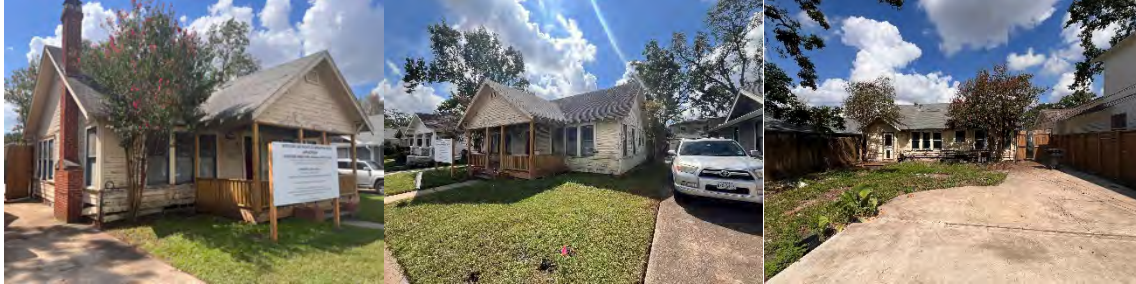
Subject Property front and back yard view.

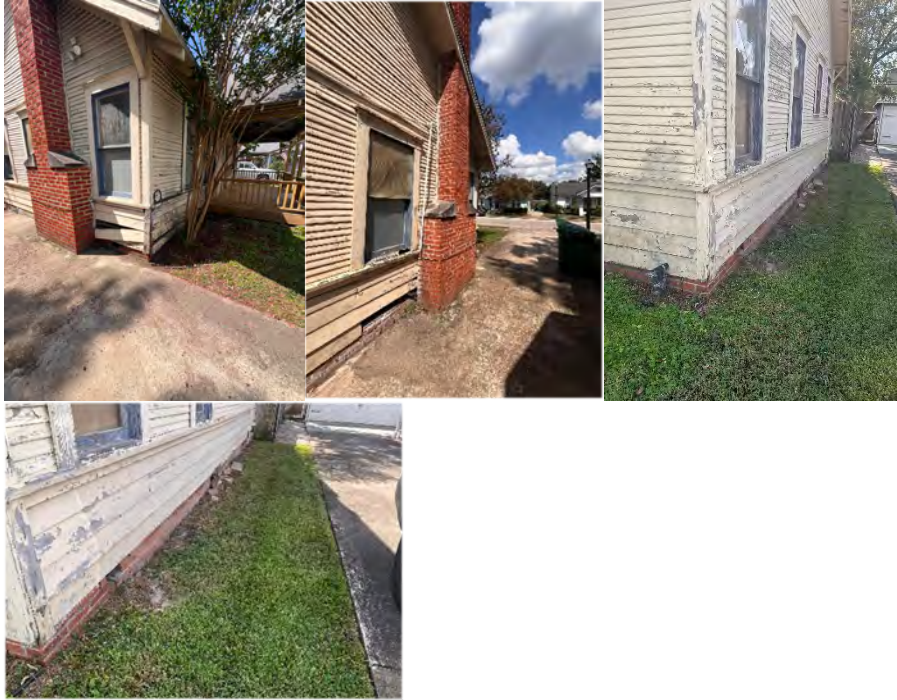
Foundation area for the subject property.

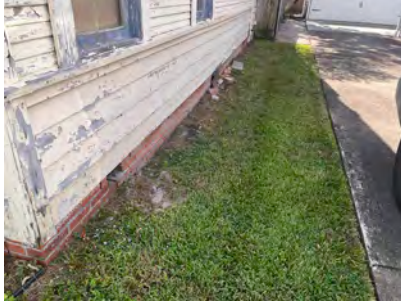
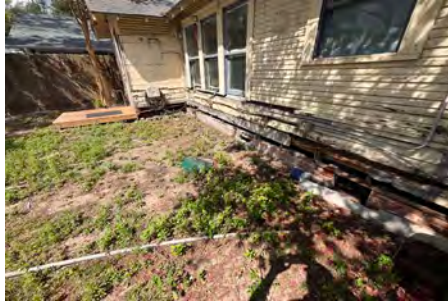
Foundation support for the subject property.

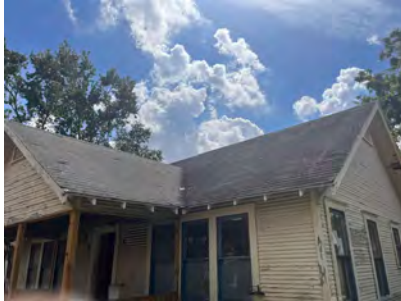
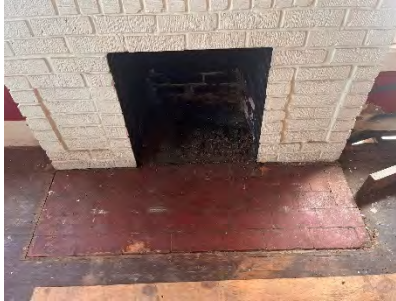
The roofline of the subject property and interior flooring condition.

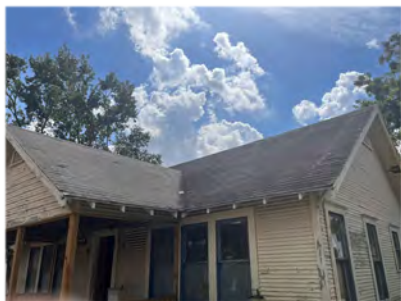
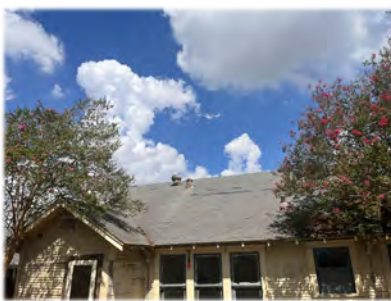
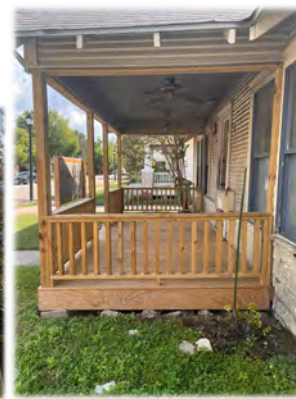
Roofing conditions of the subject property.

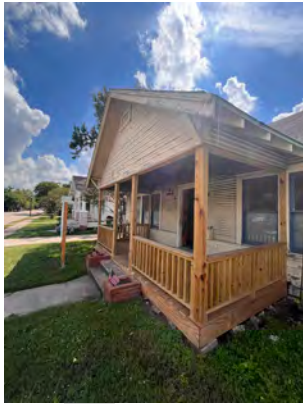
The front porch of the subject property.

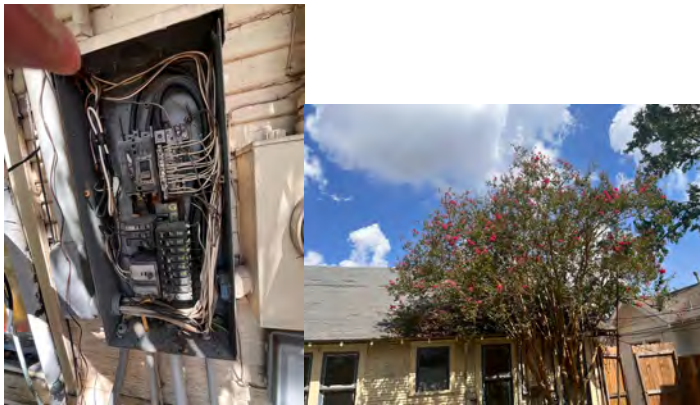
The current electrical panel box and service line pose a risk of fire or injury.

Mitigation measures: Do not access electrical equipment; requires immediate repairs.
